Birmingham City Council

**May 2018 Flooding:
Flood and Water Management Act,
Section 19 Investigation**

DATE ISSUED: 30 AUGUST 2019
VERSION: V2.0
STATUS: FINAL

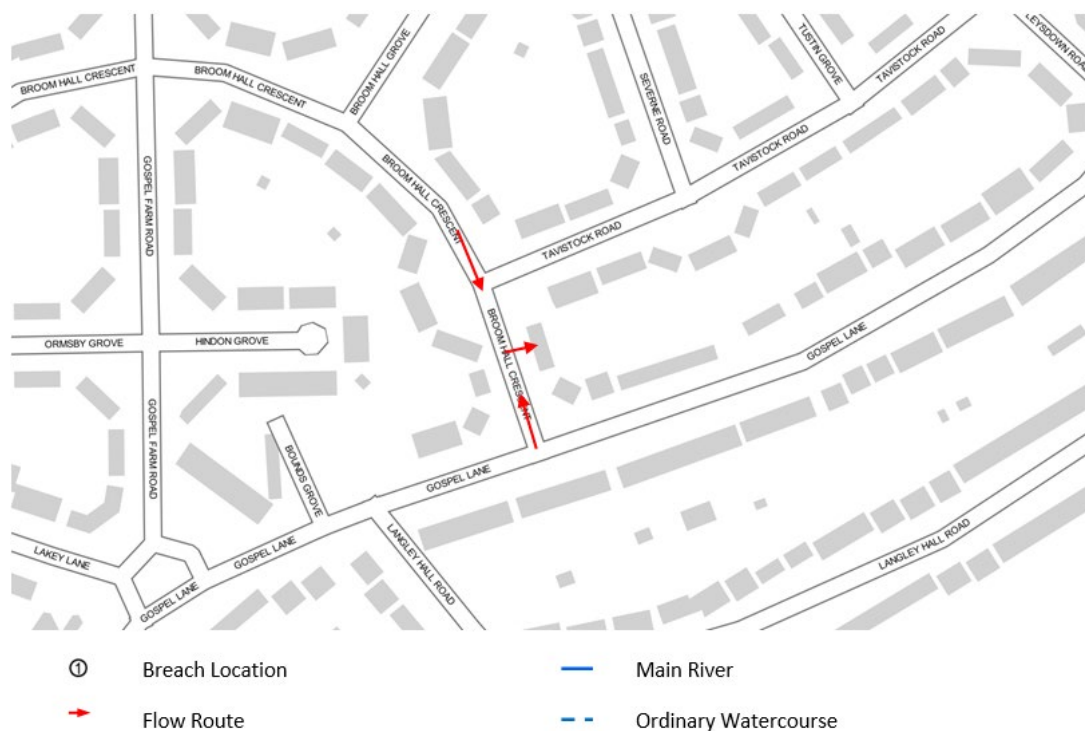
Figure 5.1 - Flood Flow Route

5.1.4 Due to the magnitude of the storm on 27th May 2018, runoff from the surrounding area followed the natural topography via the highway network, ultimately ponding in the low spot in Broom Hall Crescent. As the storm progressed the level of water built up as it couldn't discharge into the drainage system quickly enough. Bow waves from passing vehicles caused water to overtop kerbs and flood into properties that lie lower than the road level.

Recommended Actions	Identified Party / RMA
Assess condition and capacity of sewer network	Severn Trent Water

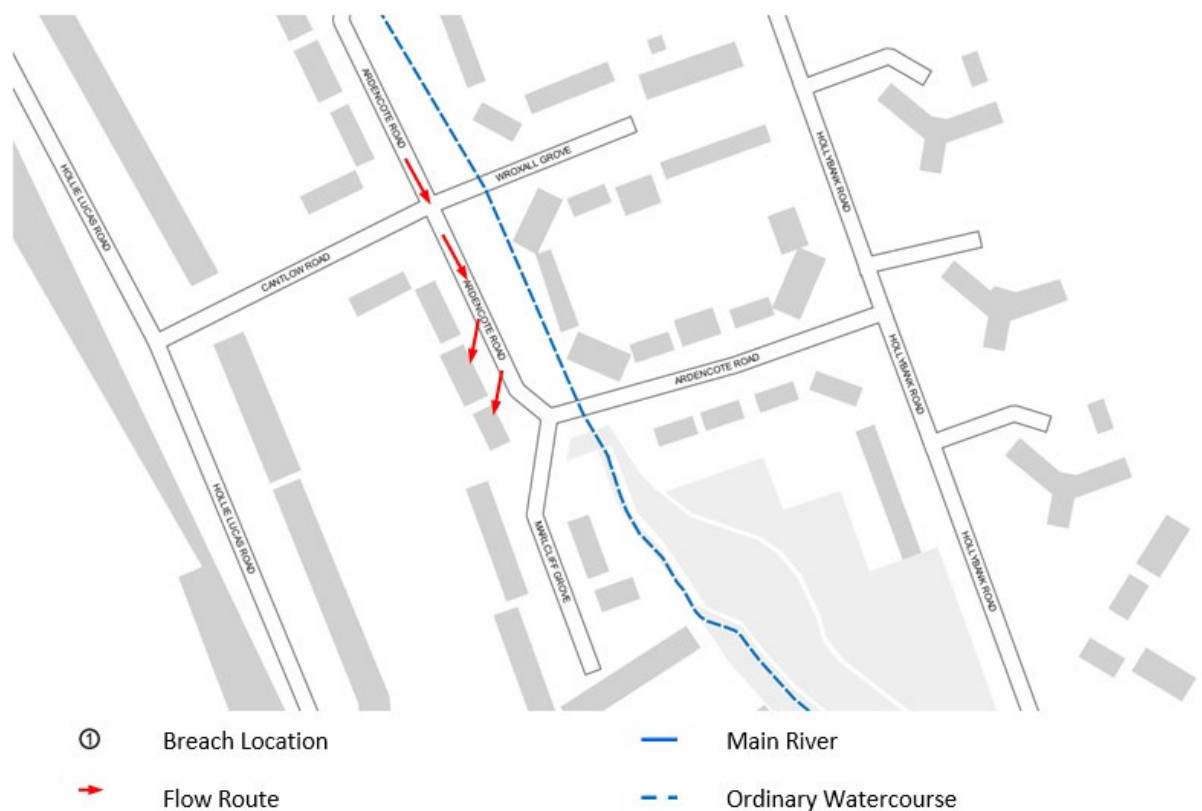
Figure 5.2 - Flood Flow Route

5.2.4 Due to the magnitude of the storm on 27th May 2018, runoff from the surrounding area followed the natural topography, via the highway network ultimately ponding outside properties. As the storm progressed the level of water built up and overtopped kerbs flowing towards properties which lie lower than the road level.

Recommended Actions	Identified Party / RMA
Explore the potential for community scale flood mitigation	Birmingham City Council (Housing) Birmingham City Council (LLFA)

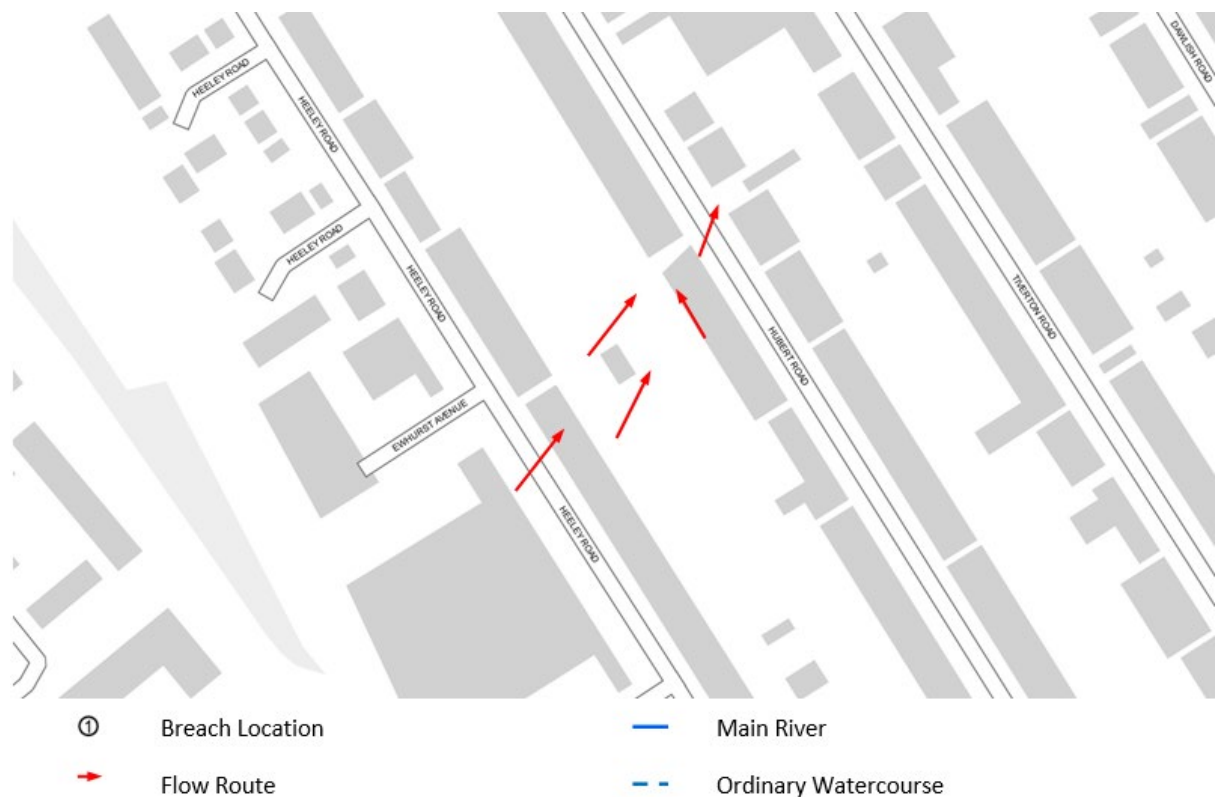
Figure 5.3 - Flood Flow Route

5.3.4 Due to the magnitude of the storm on 27th May 2018, runoff from the Heeley Road area followed the natural topography of the land, resulting in flooding to the rear of properties in Hubert Road. Flood water also found its way between properties to cause flooding of the highway in Hubert Road. As the storm progressed the level of water built up, entering properties from the rear.

Recommended Actions	Identified Party / RMA
Explore potential for property flood resilience	Birmingham City Council (LLFA) Property Owners
Review maintenance schedule for highway assets	Highway Maintenance and Management Partner

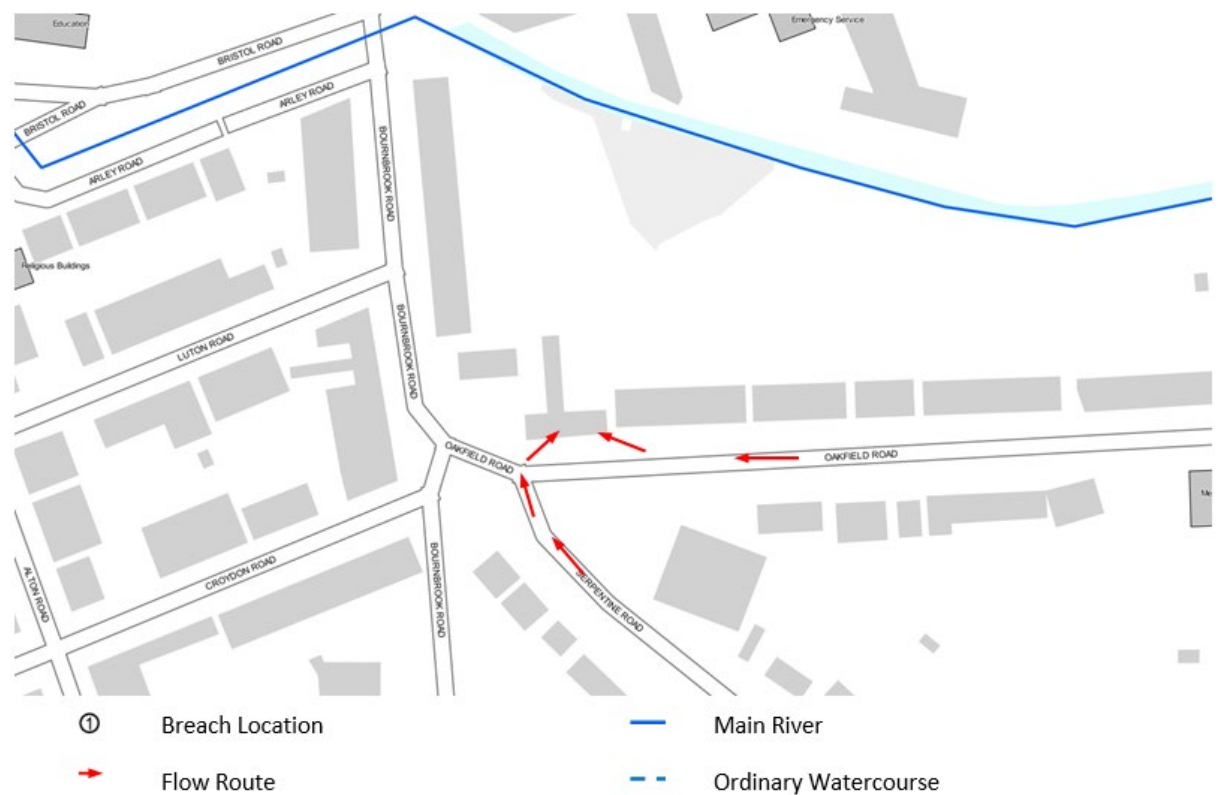
Figure 5.4 - Flood Flow Route

5.4.4 Due to the magnitude of the storm on 27th May 2018, runoff from highway catchment draining Oakfield Road and Serpentine Road followed the natural topography of the land via the highway network to the low spot in Oakfield Road. As the storm progressed the volume of water overtopped kerbs and flowed towards the properties. Flooding occurred as the affected property does not have a raised threshold.

Recommended Actions	Identified Party / RMA
Explore potential for property flood resilience	Birmingham City Council (LLFA) Property Owners

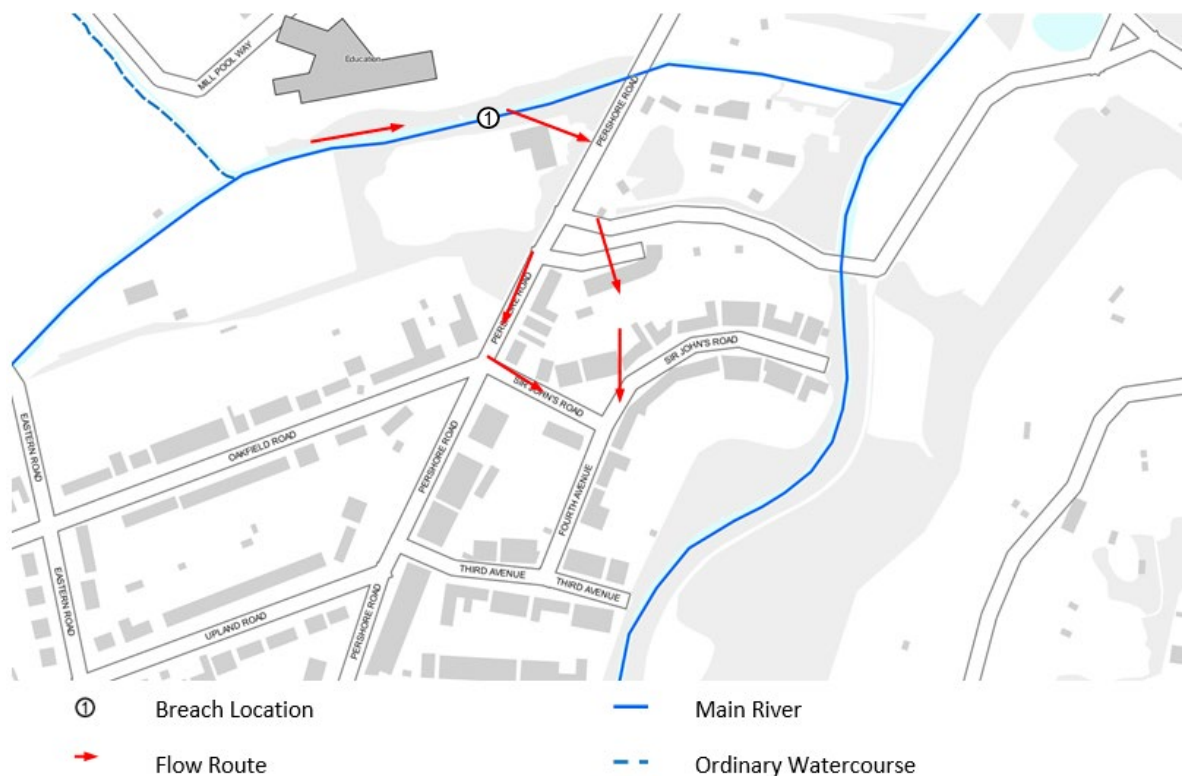
Figure 5.5 - Flood Flow Route

5.5.4 Due to the magnitude of the storm, the capacity of the Bourn Brook was overwhelmed and it is understood to have breached resulting in water flowing across Pershore Road into the front of properties fronting onto Riverside Drive. The topography of the land and network directed surface water runoff into St John's Road, via Pershore Road, and from there into Fourth Avenue and Third Avenue.

Recommended Actions	Identified Party / RMA
Implementation of flood alleviation scheme	Environment Agency
Review residual flood risk from surface water	Environment Agency
Assess capacity of existing drainage infrastructure	Highway Maintenance and Management Partner
Assess condition and capacity of sewer network	Severn Trent Water

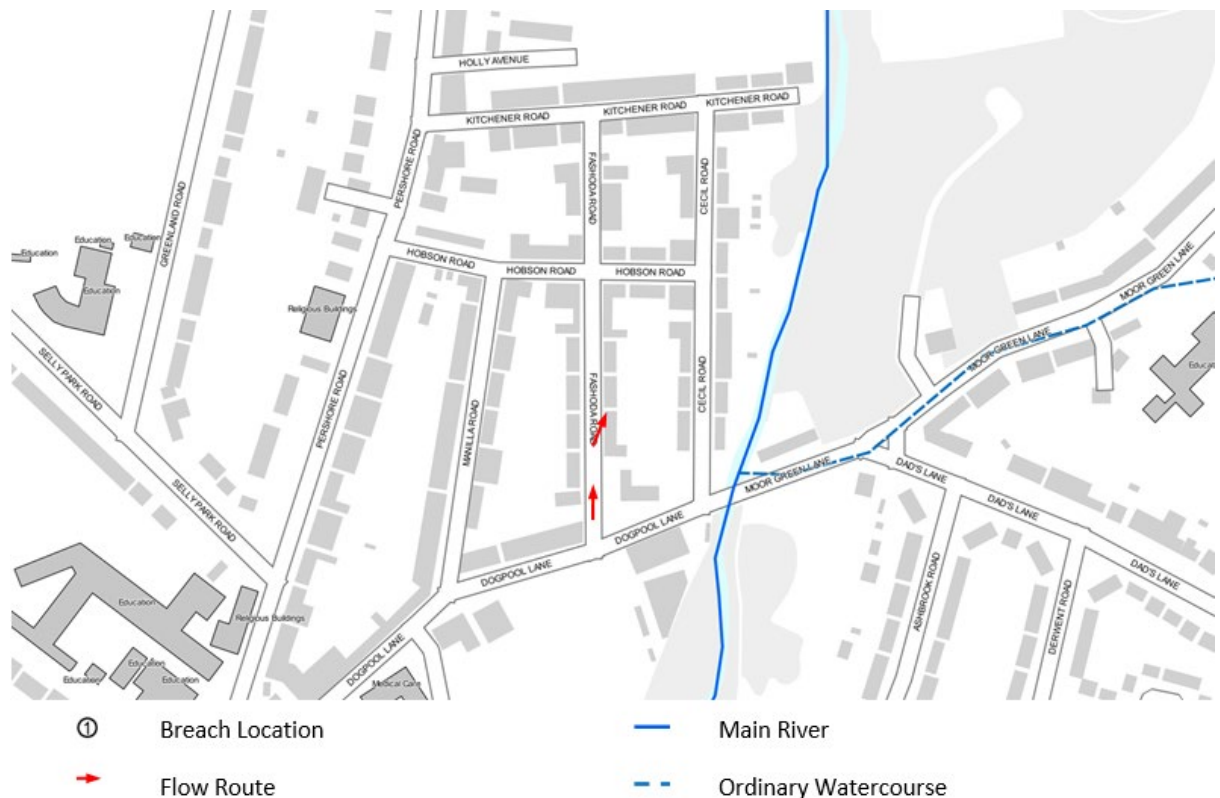
Figure 5.6 - Flood Flow Route

5.6.4 Due to the magnitude of the storm, surface water runoff flowed from Dogpool lane, following the natural topography of the area, via the highway network into Fashoda Road. Once in Fashoda Road it collected in a low spot before overtopping the kerbs and eventually flooding into the lowest lying properties.

Recommended Actions	Identified Party / RMA
Explore the potential for property flood resilience	Environment Agency Property Owners

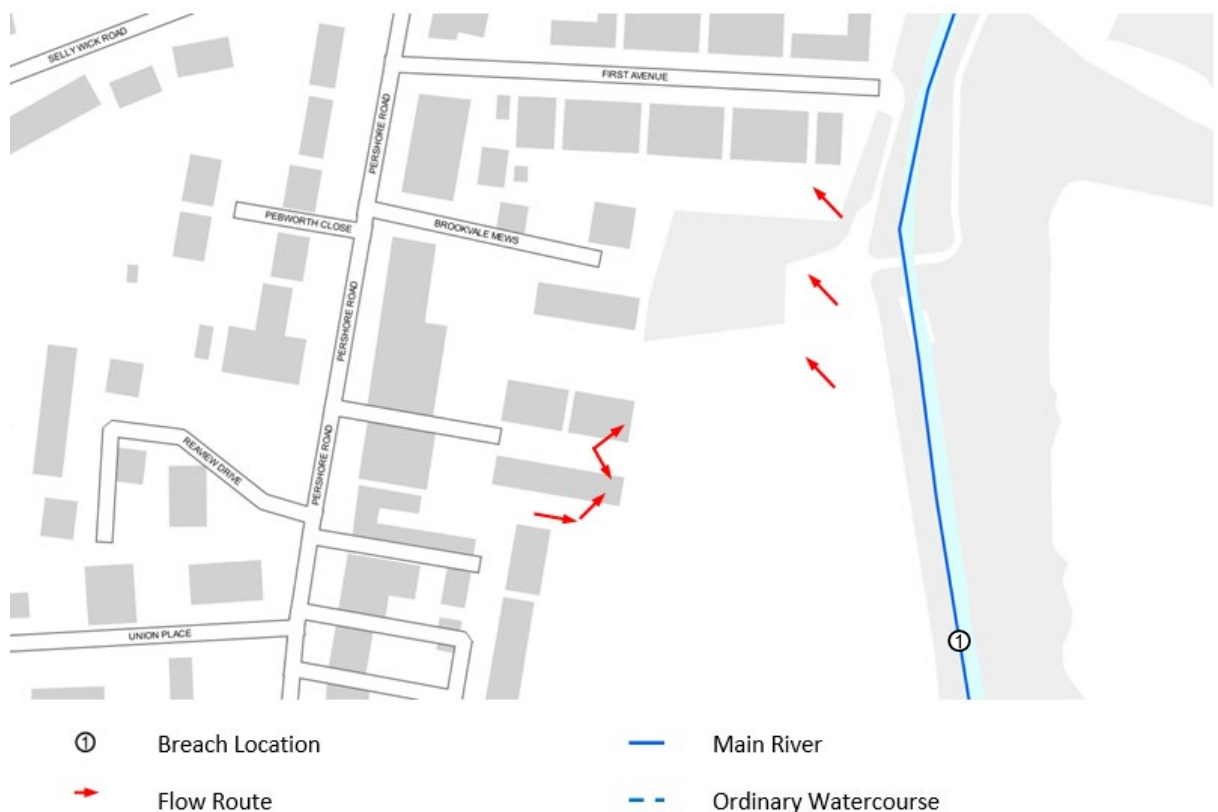
Figure 5.7 - Flood Flow Route

5.7.4 Due to the magnitude of the storm, sewers and the local drainage system were overwhelmed and water backed up flowing out of gullies and into properties. In addition to this the river rea broke its banks and flowed across the adjacent playing fields toward the rear of properties in First Avenue.

Recommended Actions	Identified Party / RMA
Assess condition and capacity of local drainage	Property Owners
Explore the potential for community scale mitigation	Environment Agency
Assess condition and capacity of sewer network	Severn Trent Water

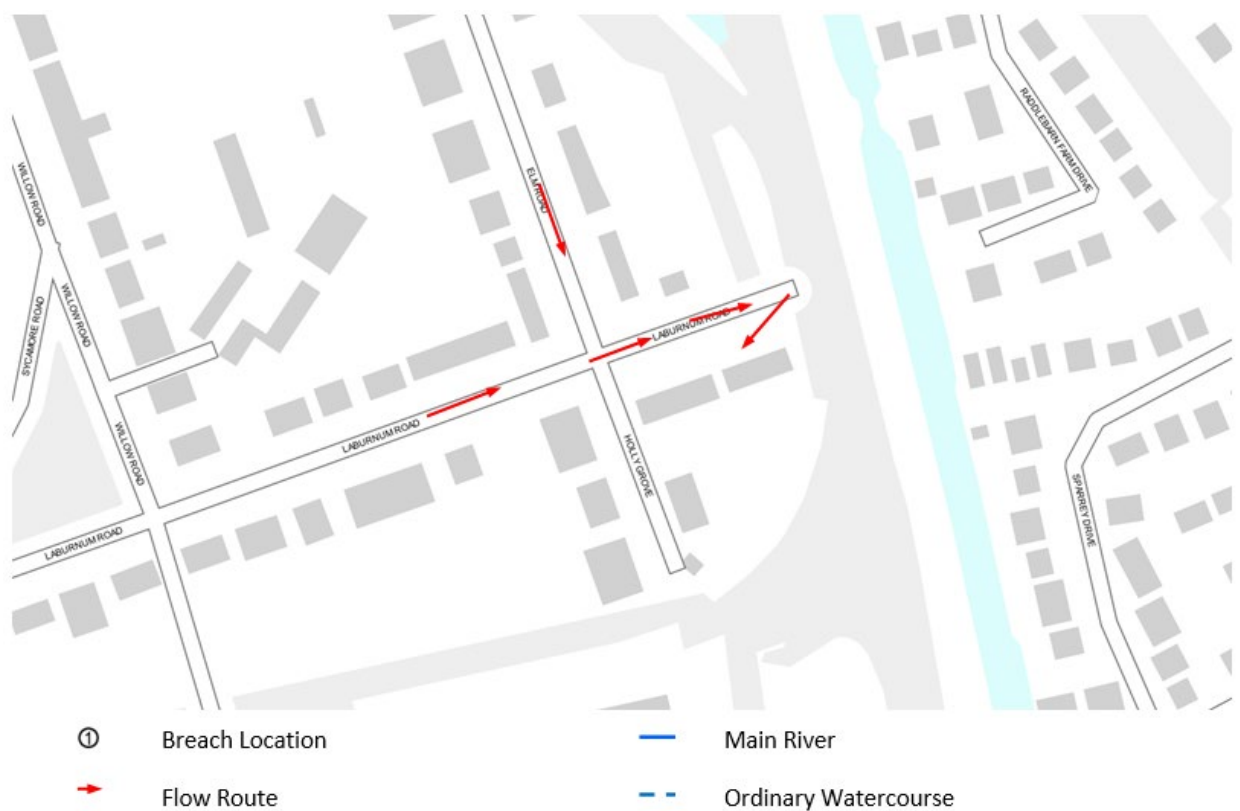
Figure 5.8 - Flood Flow Route

5.8.4 Due to the magnitude of the storm, runoff from the surrounding area followed the natural topography via the highway network, ultimately ponding in the low spot in Laburnum Road. As the storm progressed the level of water built up as it couldn't discharge into the drainage system quickly enough and overtop kerbs and flooded into properties that lie lower than the road level.

Recommended Actions	Identified Party / RMA
Explore the potential for community scale mitigation	Birmingham City Council (LLFA)

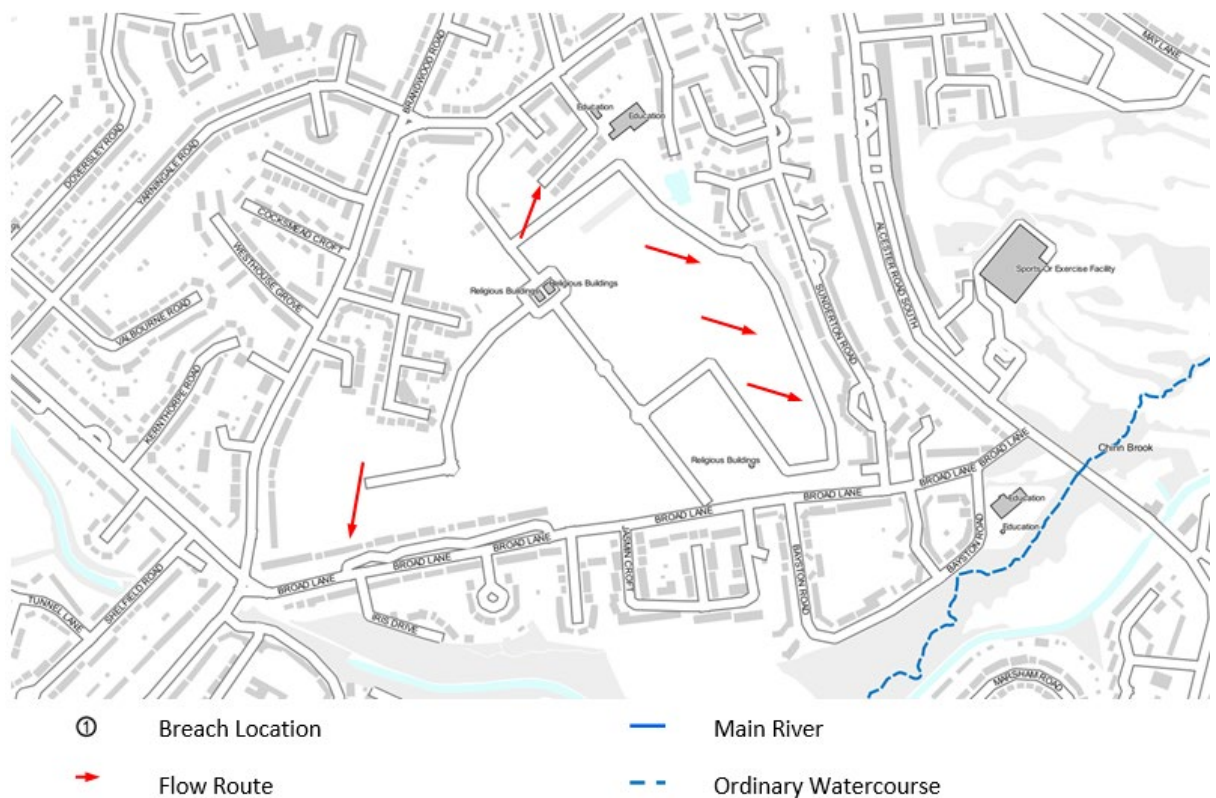
Figure 5.9 - Flood Flow Route

5.9.4 Due to the magnitude of the storm, surface water runoff from Brandwood Cemetery overwhelmed the cemetery drainage and flowed into the rear of properties, following the natural topography of the land.

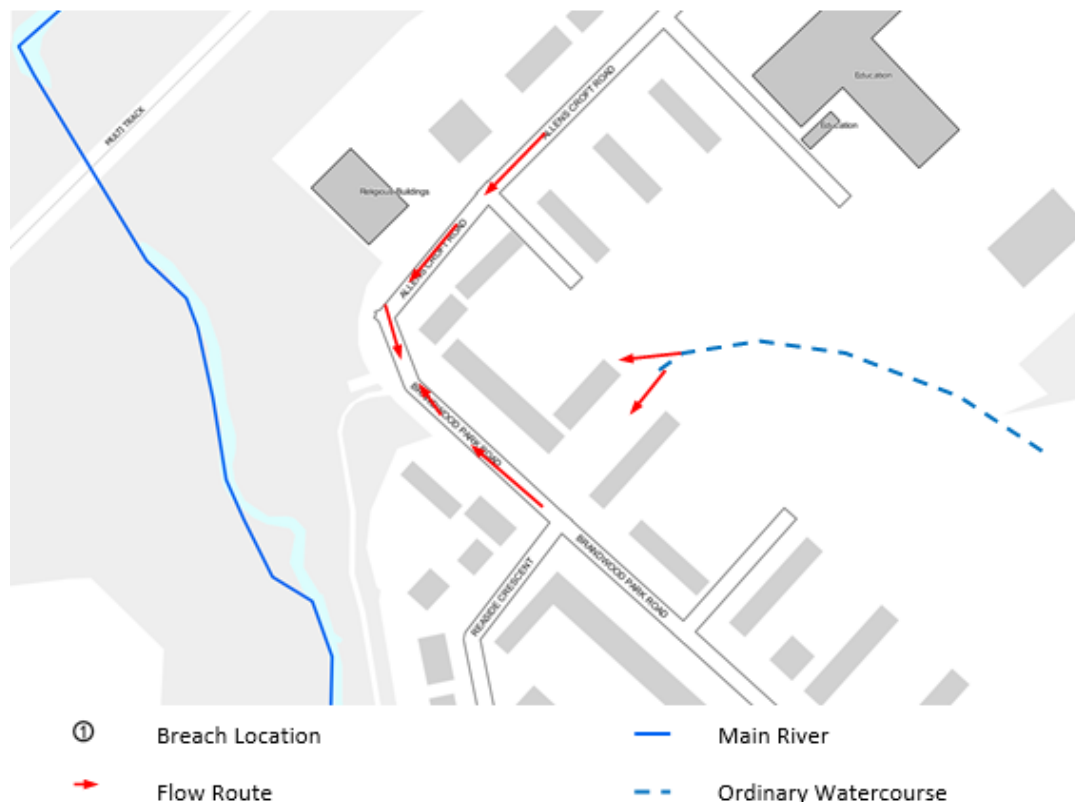
Figure 5.10 - Flood Flow Route

5.10.4 Due to the magnitude of the storm, the capacity of the watercourse in Dawberry Fields was exceeded, flow overtopped the channel and flooded across surrounding land into the rear of properties in Brandwood Park Road. Blockage of the trash screen may have exacerbated the problem. In addition to this runoff from the surrounding area followed the natural topography of the highway network, ultimately ponding in the low spot in Brandwood Park Road.

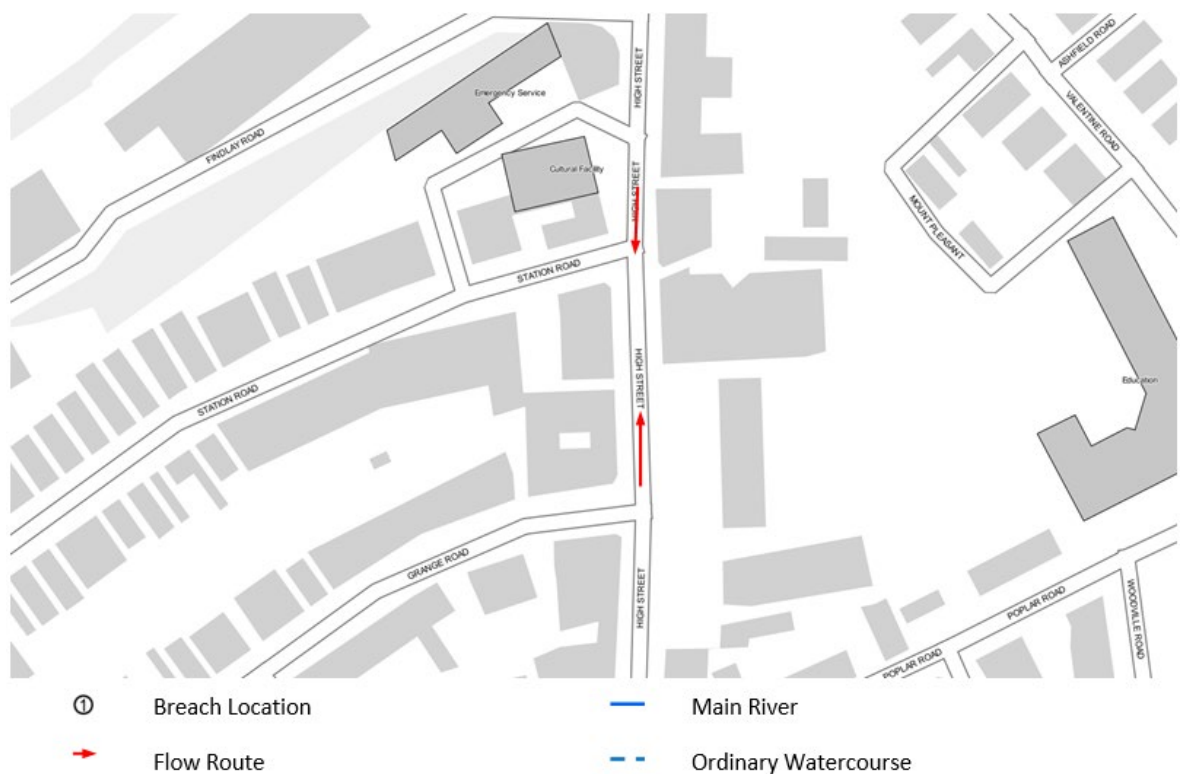
Figure 5.11 - Flood Flow Route

5.11.4 Due to the magnitude of the storm, runoff from the surrounding area followed the natural topography via the highway network, ultimately ponding in the low spot in High Street. As the storm progressed the level of water built up as it couldn't discharge into the drainage system quickly enough and overtop kerbs and flooded into properties.

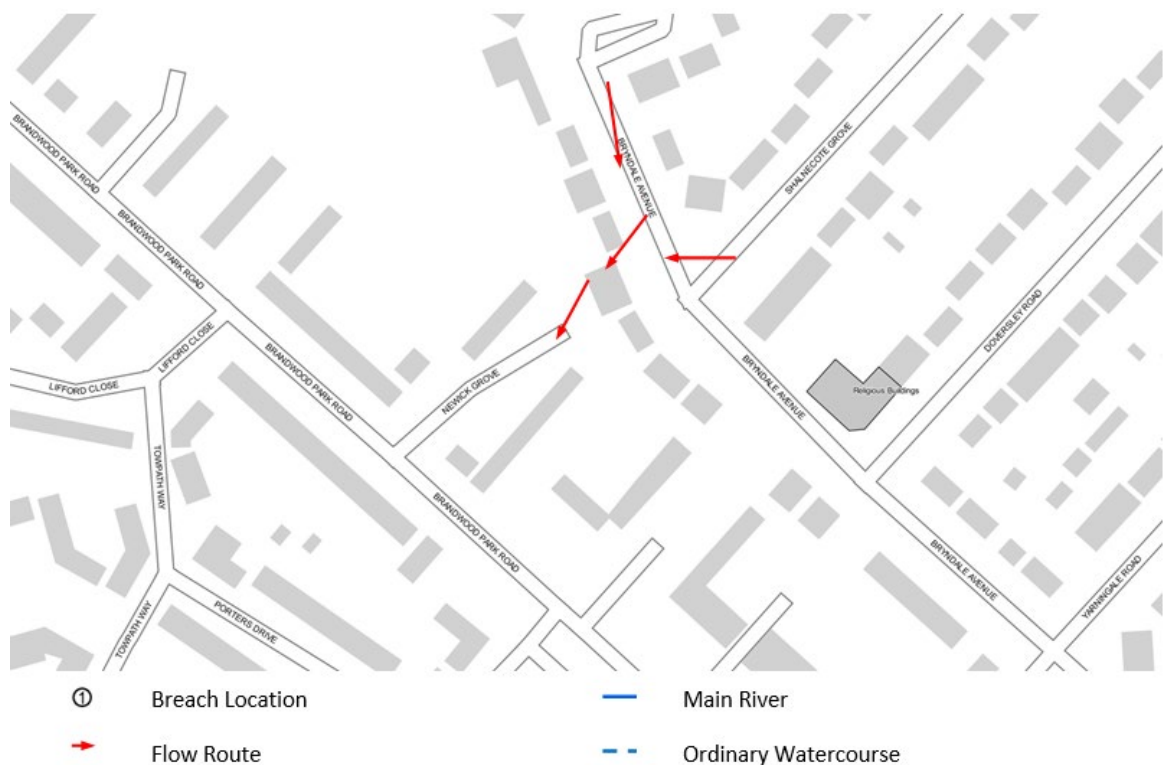
Figure 5.12 - Flood Flow Route

5.12.4 Due to the magnitude of the storm, runoff from the surrounding area followed the natural topography via the highway network, ultimately ponding in the low spot in Bryndale Avenue. As the storm progressed the level of water built up as it couldn't discharge into the drainage system quickly enough and overtopped kerbs and flooded into the property. From here water made its way between the properties in Bryndale Road emerging in Newick Grove. Due to the topography of Newick Grove, water overtopped the kerbs and flowed into the property which sites lower than the road.

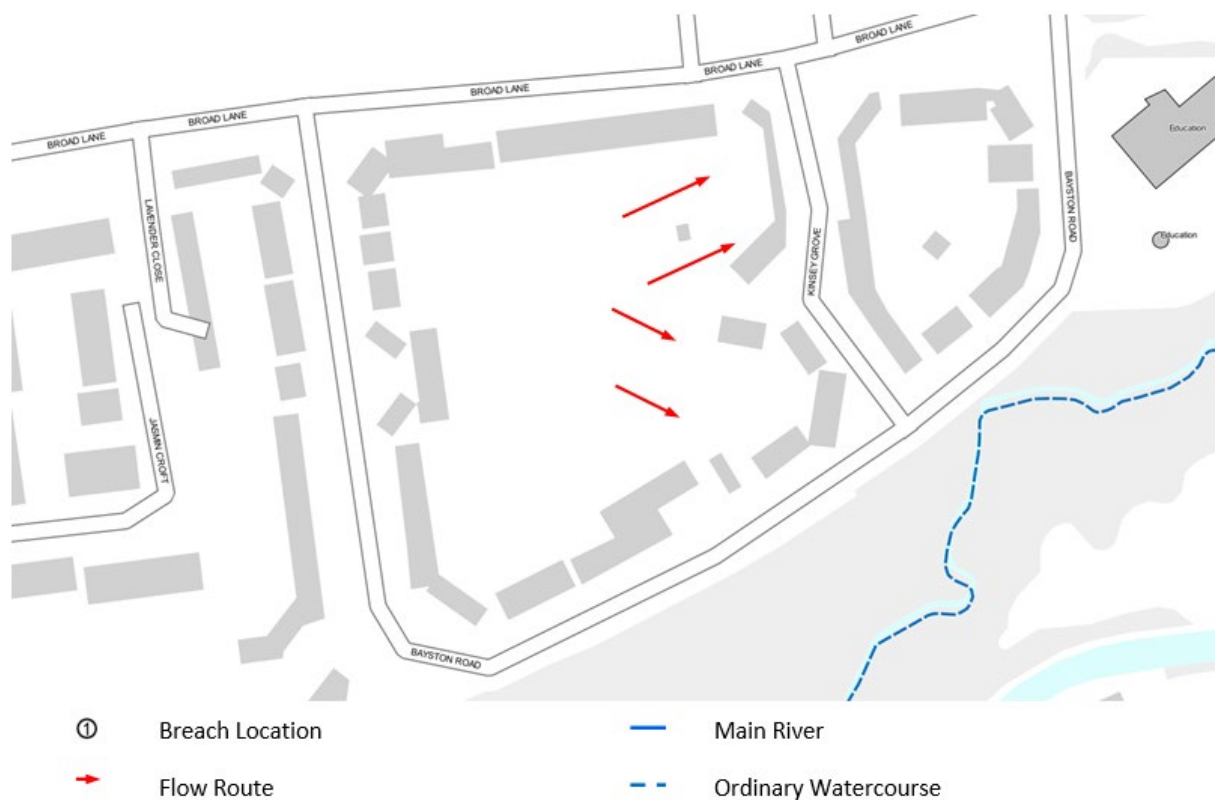
Figure 5.13 - Flood Flow Route

5.13.4 Due to the magnitude of the storm, surface water runoff from the allotment gardens flowed into the rear of properties, following the natural topography of the land.

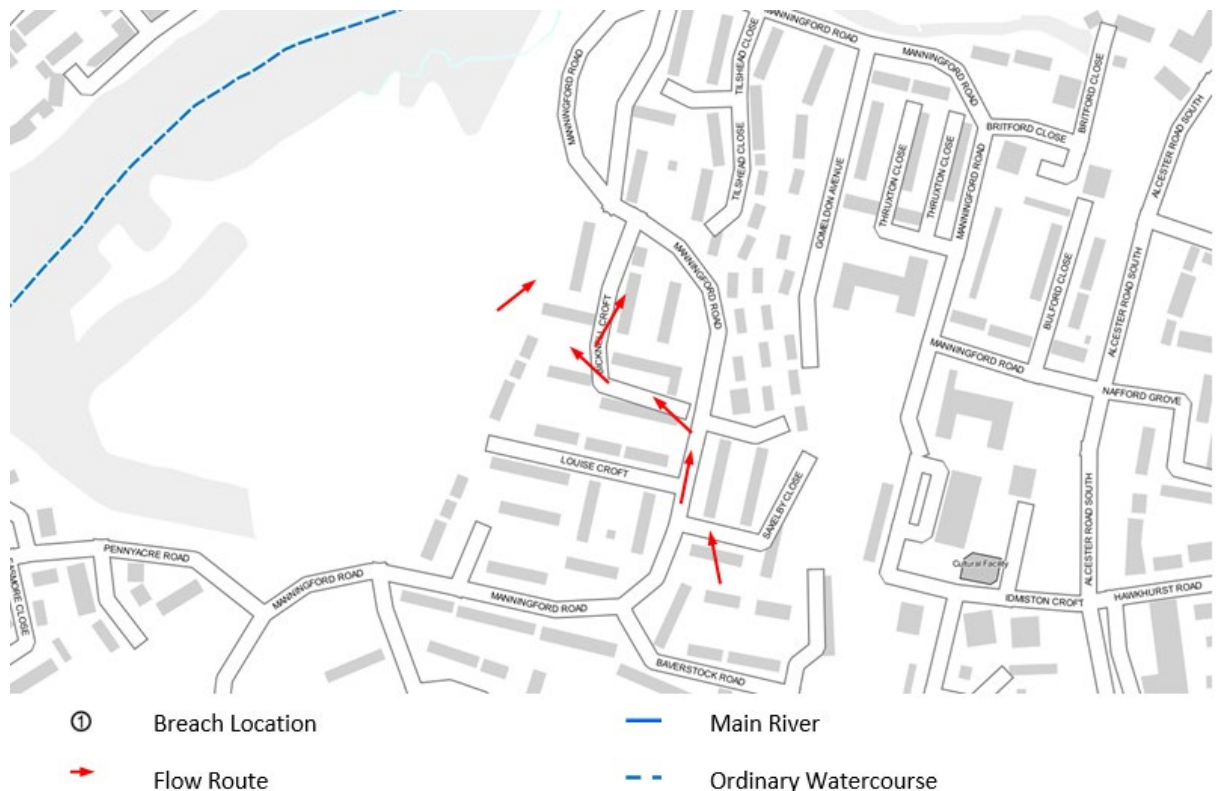
Figure 5.14 - Flood Flow Route

5.14.4 Due to the magnitude of the storm, runoff from the surrounding catchment, followed the natural topography of the area flowing from high land to low land. The main flow route was through properties in Saxelby Close, into Manningford Road where it followed the highway network before flowing into Bicknell Croft. A further flow route emanated from the public open space to the west, flowing into properties in Bicknell Croft.

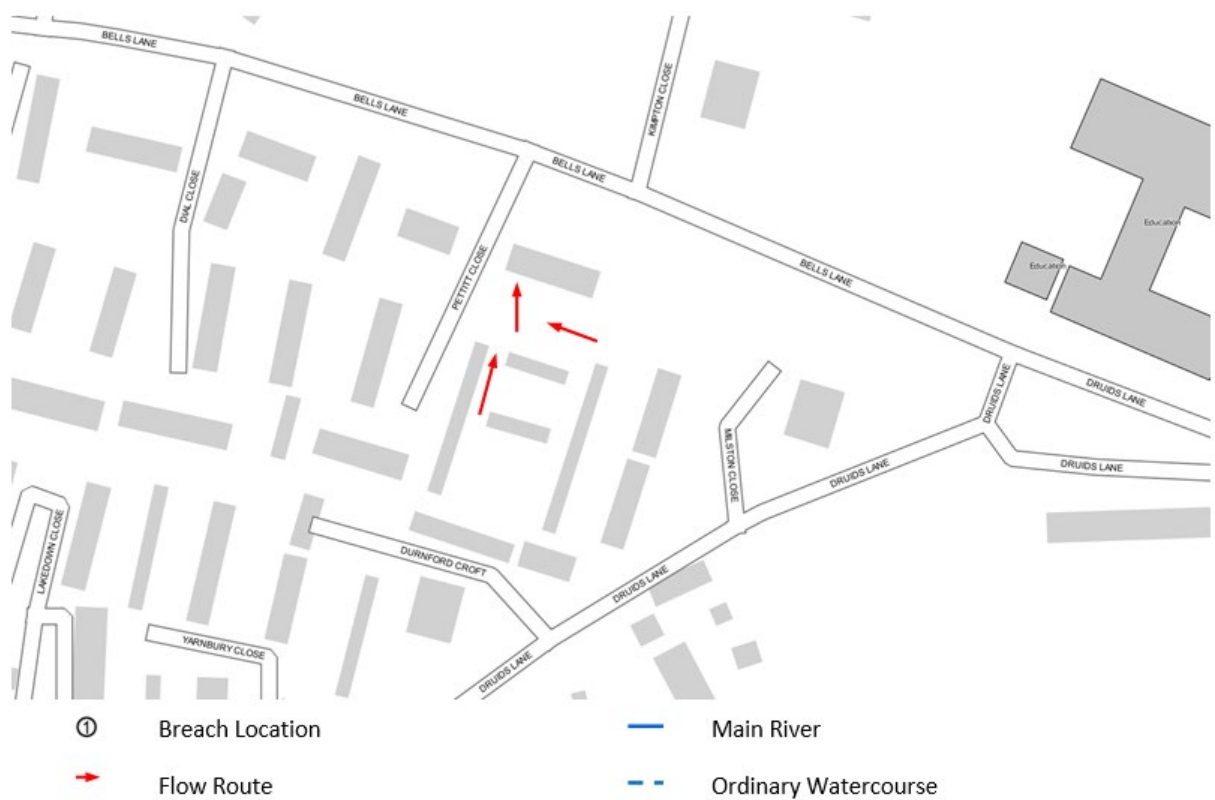
Figure 5.15 - Flood Flow Route

5.15.4 Due to the magnitude of the storm, runoff from the footpaths and gardens followed the natural topography of the area and flowed into the property that sits on lower lying land.

5.15.7 No further actions are recommended for this area.

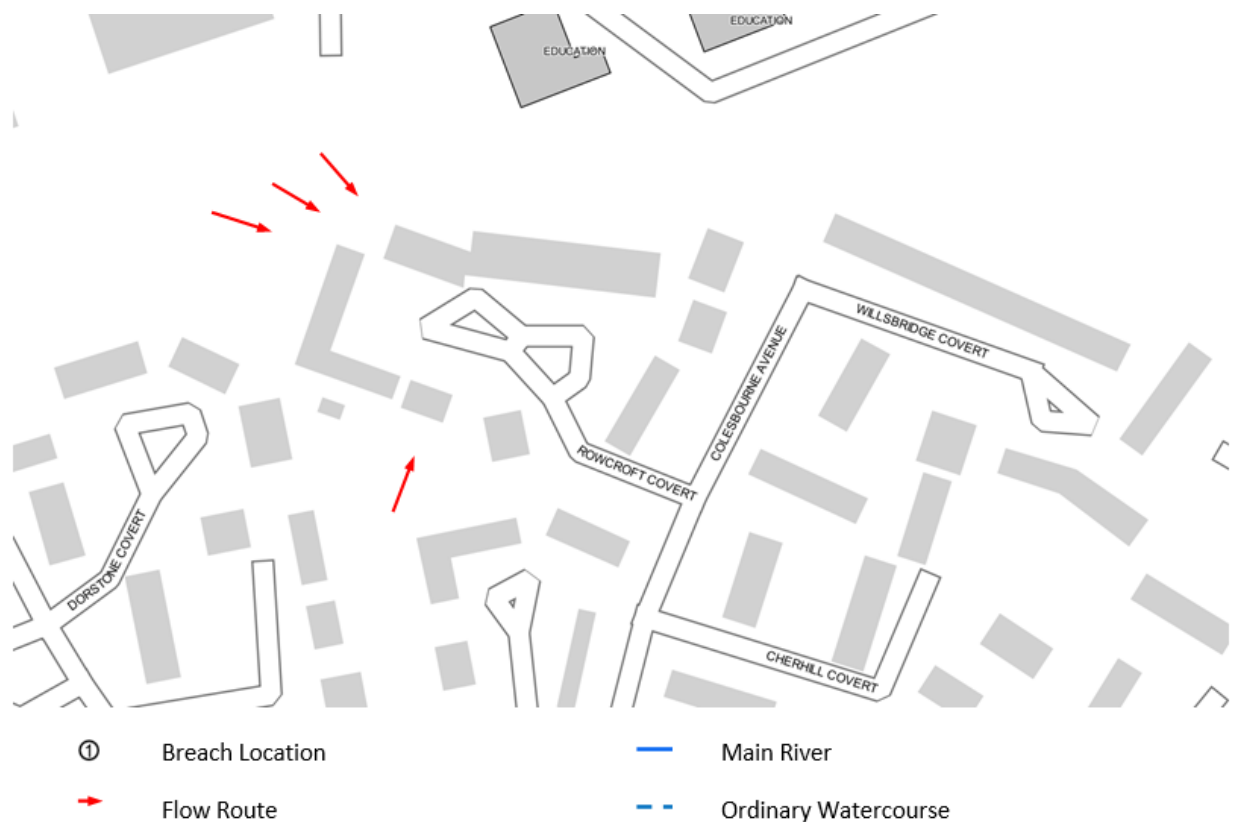
Figure 5.16 - Flood Flow Route

5.16.4 Due to the magnitude of the storm, runoff from the surrounding public open space followed the natural topography of the area flowing towards the rear of the properties. Existing drainage adjacent to the properties was overwhelmed and water levels rose and entered properties from the rear.
