# Birmingham City Council

## June 2016 Flooding: Flood and Water Management Act, Section 19 Investigation

May 2017

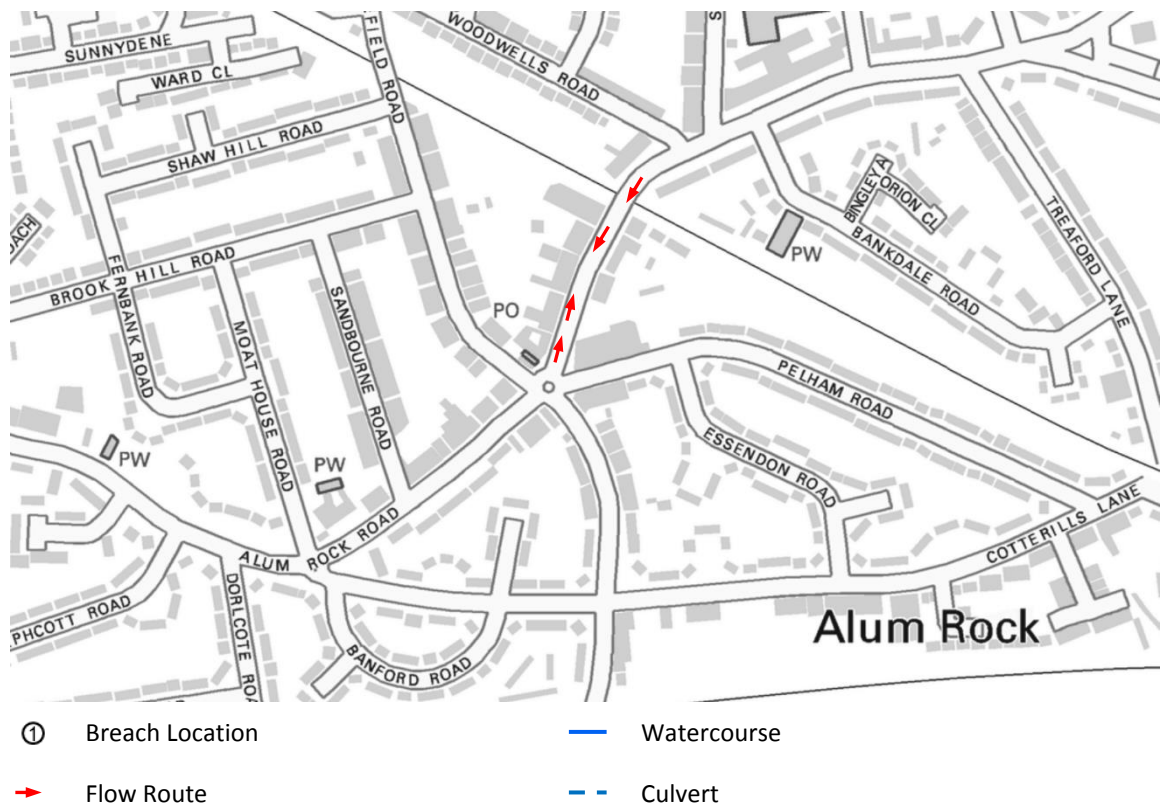
Figure 4-1 Potential overland flow routes

Over the course of the storm event, the prevailing topography directed rainwater to a low point in Alum Rock Road. Whilst a number of gullies are identified at this location, the capacity of these features appeared to be restricted by debris. As a result, the surrounding highway became inundated with water overflowing into the adjacent properties.

Recommended Actions	Identified Party / RMA
<b>Assess whether additional gullies are required to allow runoff to drain</b>	Birmingham City Council (Highways)
<b>Review maintenance regime to ensure gullies are free from debris</b>	Birmingham City Council (Highways)

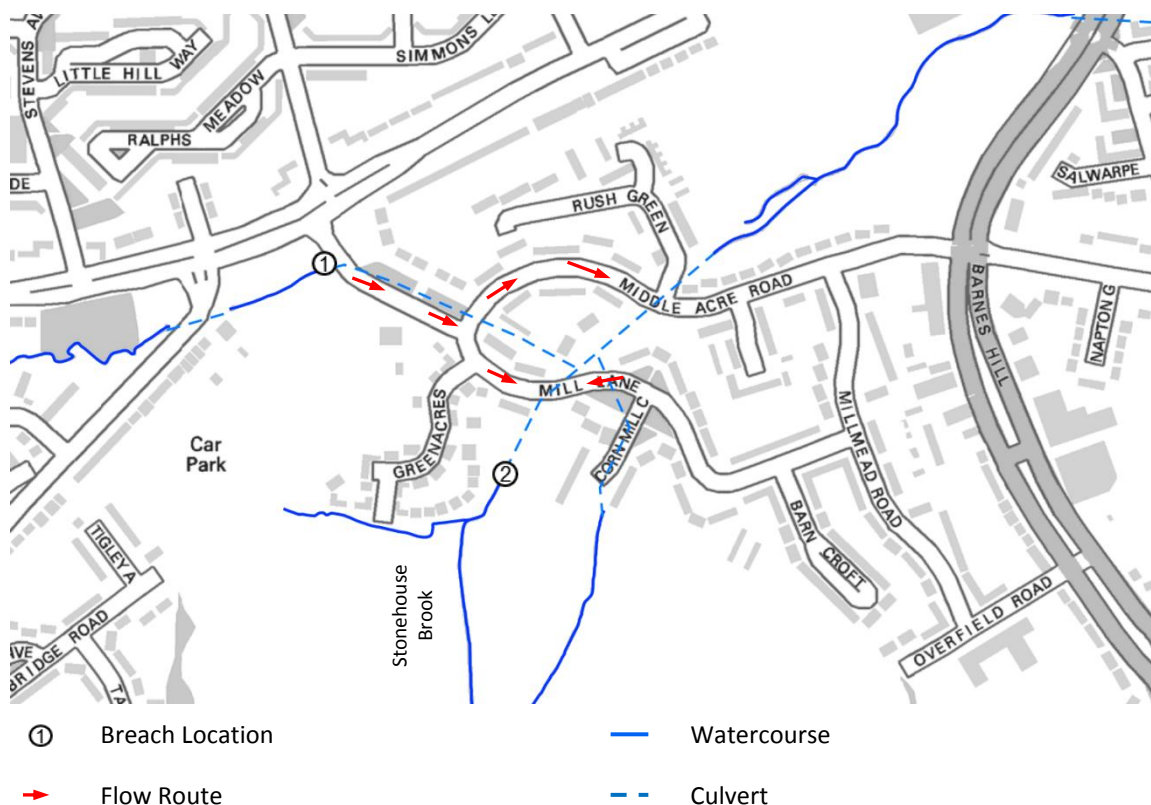
Figure 4-2 Potential watercourse breaches and overland flow routes

The Stonehouse Brook, an Environment Agency Main River, runs northwards from Bartley Reservoir, through Senneleys Park and onward through Bartley Green, before discharging into the Bourn Brook near Osmaston Road. In the vicinity of Senneleys Park, there are two other ordinary watercourses: the Bartley Brook which runs north-easterly to the rear of the properties on Ambleside and a smaller tributary of Stonehouse Brook within Senneleys Park. Flooding in the vicinity of Middle Acre Road was caused by breaches from two of the watercourses; the Bartley Brook and the Stonehouse Brook.

Recommended Actions	Identified Party / RMA
<b>Investigate the capacity of the Bartley Brook and culvert</b>	Birmingham City Council (LLFA) in partnership with Environment Agency
<b>Develop an updated model of the watercourse through Senneleys Park including the Bartley Brook and other watercourses</b>	Environment Agency in partnership with Birmingham City Council (LLFA)
<b>Investigate options to manage overland flows</b>	Birmingham City Council (LLFA)
<b>Investigate options for flood mitigation scheme</b>	Environment Agency in partnership with Birmingham City Council (LLFA)
<b>Develop catchment options across the upper Bourn Brook catchment to manage flooding from all sources.</b>	Birmingham City Council (LLFA), Severn Trent Water and Environment Agency
<b>Assess the effectiveness of the installed property level resilience measures</b>	Birmingham City Council (Housing)

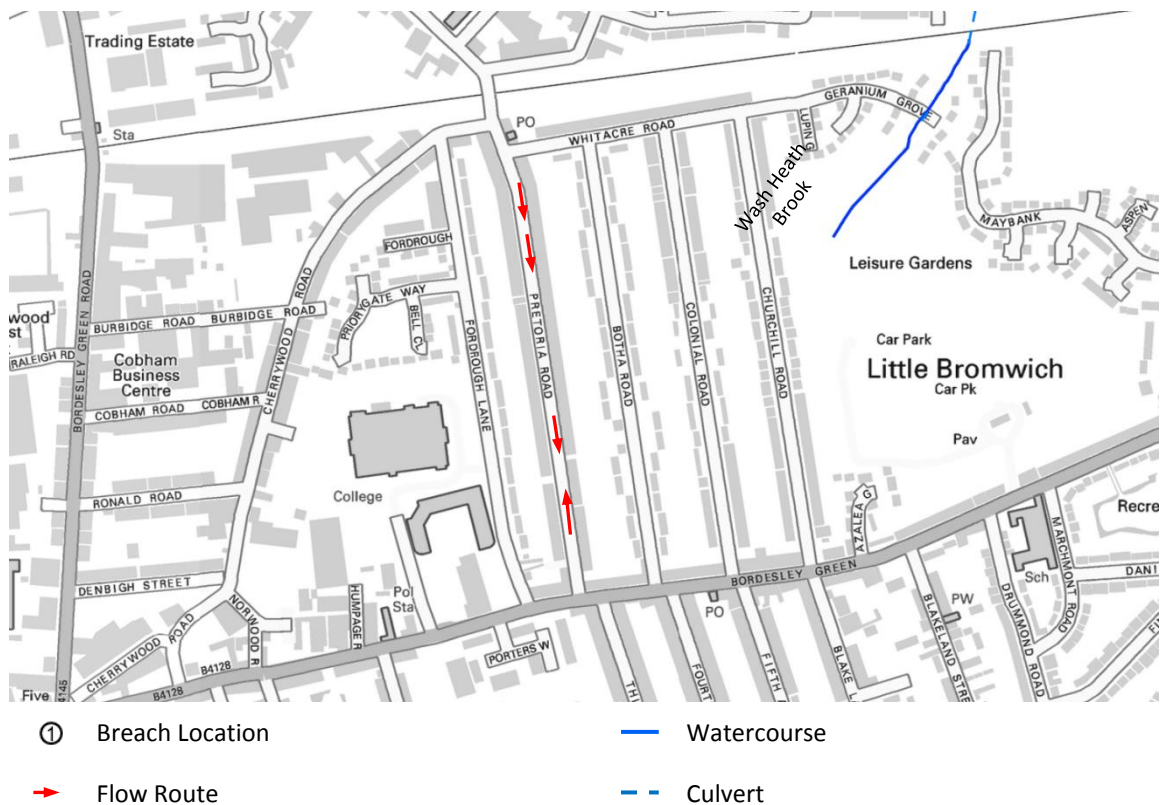
Figure 4-5 Potential overland flow routes

Following investigation of the flooding, it is highly likely that the intensity of the storm increased the amount of debris within the highway which did restrict flows entering the highway drainage system. As such, surface water runoff flowed down the highway as shown in Figure 4-5 and ponded in the low point of the highway. This was further exacerbated as the kerbs adjacent to the gullies are ‘drop kerbs’ meaning that they are at similar levels to the surface of the highway. As such, when water began to pond in this area it quickly overtopped the kerb and flowed over footpaths and gardens into properties.

Recommended Actions	Identified Party / RMA
<b>Review maintenance regime to ensure gullies are free from debris</b>	Birmingham City Council (Highways)
<b>Explore the potential for flood mitigation</b>	Birmingham City Council (LLFA) & Home owners

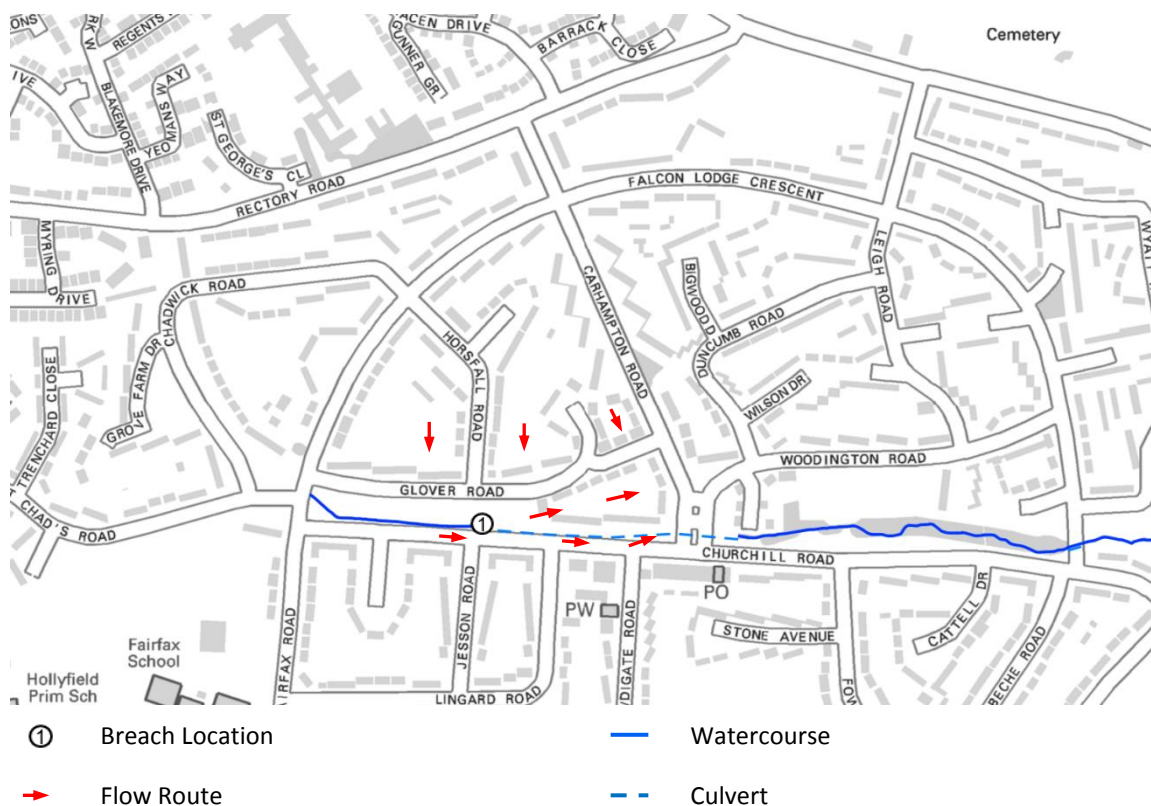
Figure 4-7 Potential watercourse breach and overland flow routes

The topography in the area forms a valley from Rectory Road in the north and Newdigate Road in the south sloping down to the low point located between Glover Road and Churchill Road. Due to the magnitude of the storm on 16<sup>th</sup> June, highway drainage and sewer infrastructure was overwhelmed by the volume of rainfall and as a result, the prevailing topography directed surface water runoff towards the low point of the valley, utilising the highways as conveyance channels. This was further exacerbated in some locations through the use of dropped kerbs, thereby allowing water to spill from the highways at shallower depths.

Recommended Actions	Identified Party / RMA
<b>Assess the condition and capacity of the sewer network in the vicinity of Carhampton Road, Glover Road and Churchill Road</b>	Severn Trent Water
<b>Assess the condition and capacity of the highway drainage network to establish if additional gullies are required</b>	Birmingham City Council (LLFA and Highways)
<b>Assess the condition and capacity of the Churchill Brook to establish if additional capacity is required</b>	Birmingham City Council (LLFA)
<b>Explore the potential for flood mitigation</b>	Birmingham City Council (LLFA and Housing)

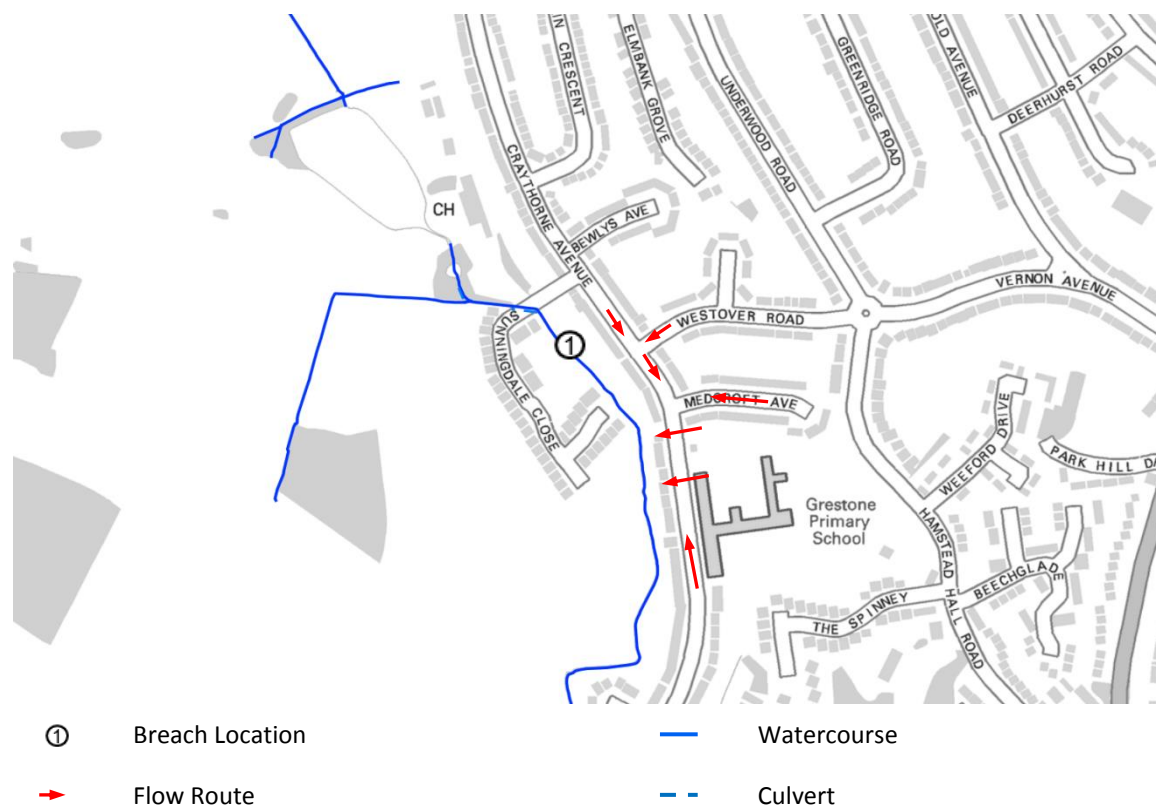
Figure 4-10 Potential watercourse breach and overland flow routes

Due to the magnitude of the storm on 8<sup>th</sup> June 2016, property drainage, highway drainage and sewer infrastructure was overwhelmed by the intensity of the rainfall. The resulting surface water runoff followed the topography of the area, using highways as conveyance channels, ultimately ponding in the low point in Greystone Avenue, Craythorne Avenue, Acfold Road and Sunningdale Close. As the storm progressed, the highway became inundated allowing water to overtop the kerbs and flow into properties that lie lower than the road level.

Recommended Actions	Identified Party / RMA
<b>Review of maintenance regime for Hilltop Brook</b>	Birmingham City Council (LLFA and Leisure Services) and Riparian Owners
<b>Assess the condition and capacity of the Hilltop Brook</b>	Birmingham City Council (LLFA and Leisure Services)
<b>Assess the condition and capacity of the sewer network</b>	Severn Trent Water
<b>Assess potential for future flood storage scheme on Hilltop Brook</b>	Birmingham City Council (LLFA and Leisure)

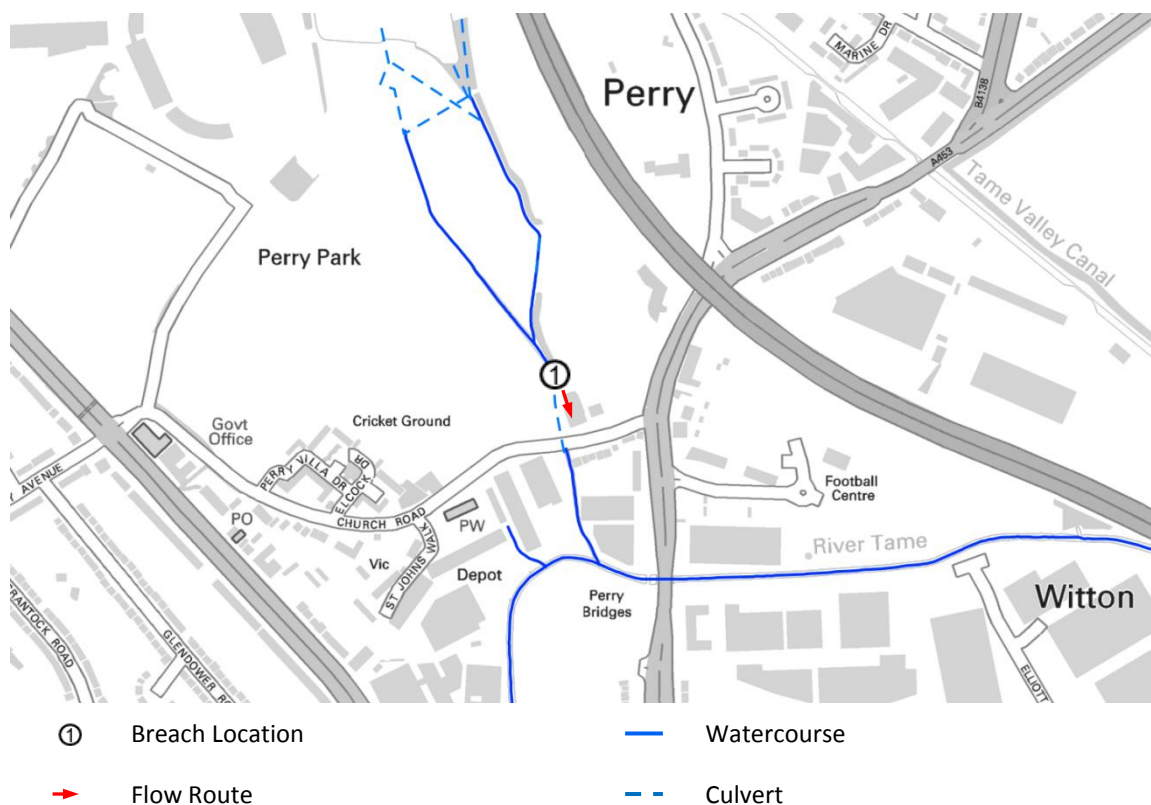
Figure 4-21 Potential watercourse breaches and overland flow routes

There is also a possibility that the flood defence wall built to protect properties from the River Tame backing up which runs at the side of the Church Road properties made the flooding worse because it stopped water flowing from Church Road back into the brook.

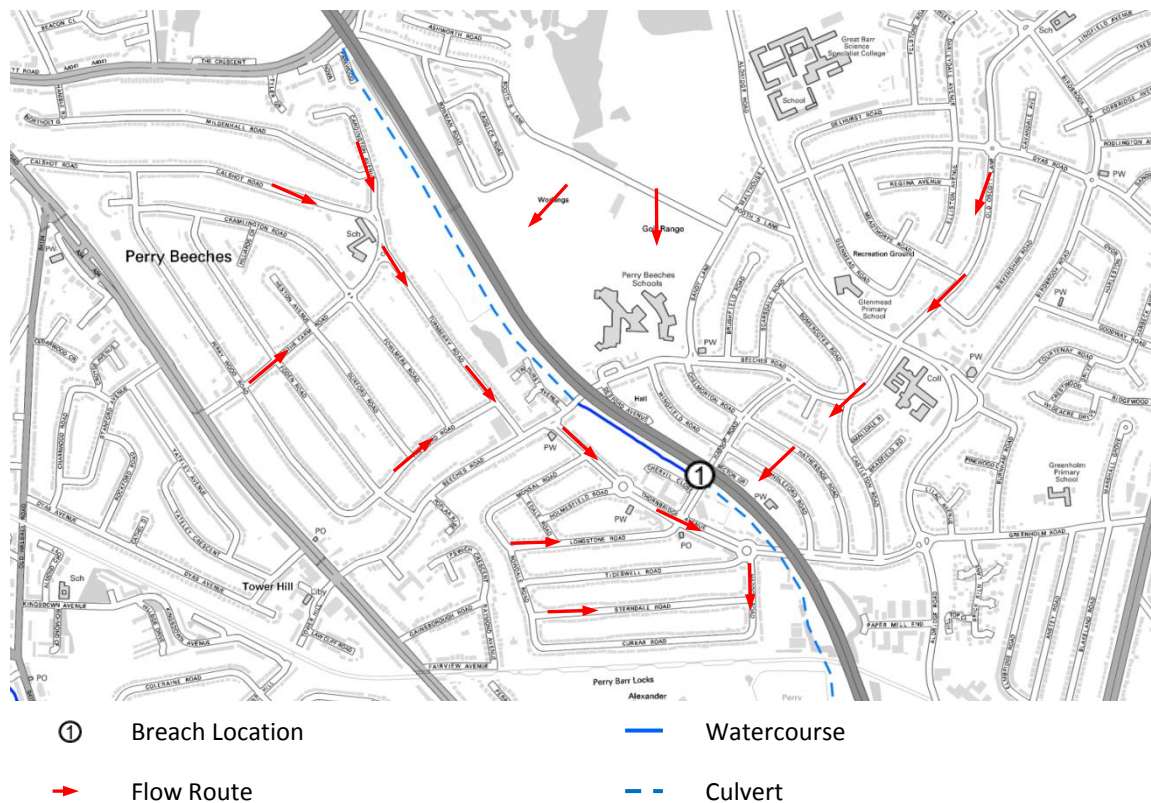
Figure 4-24 Potential watercourse breaches and flow routes

The Perry Brook is not a Main River therefore the responsibility for flood risk management and investigating flooding from the watercourse falls to the Lead Local Flood Authority, although the landowners above and either side of the watercourse are responsible for its structure and maintenance. The flood zones associated with the Perry Brook are shown in Figure 4-25. These flood zones correlate with those properties affected by river flooding on 8<sup>th</sup> June.

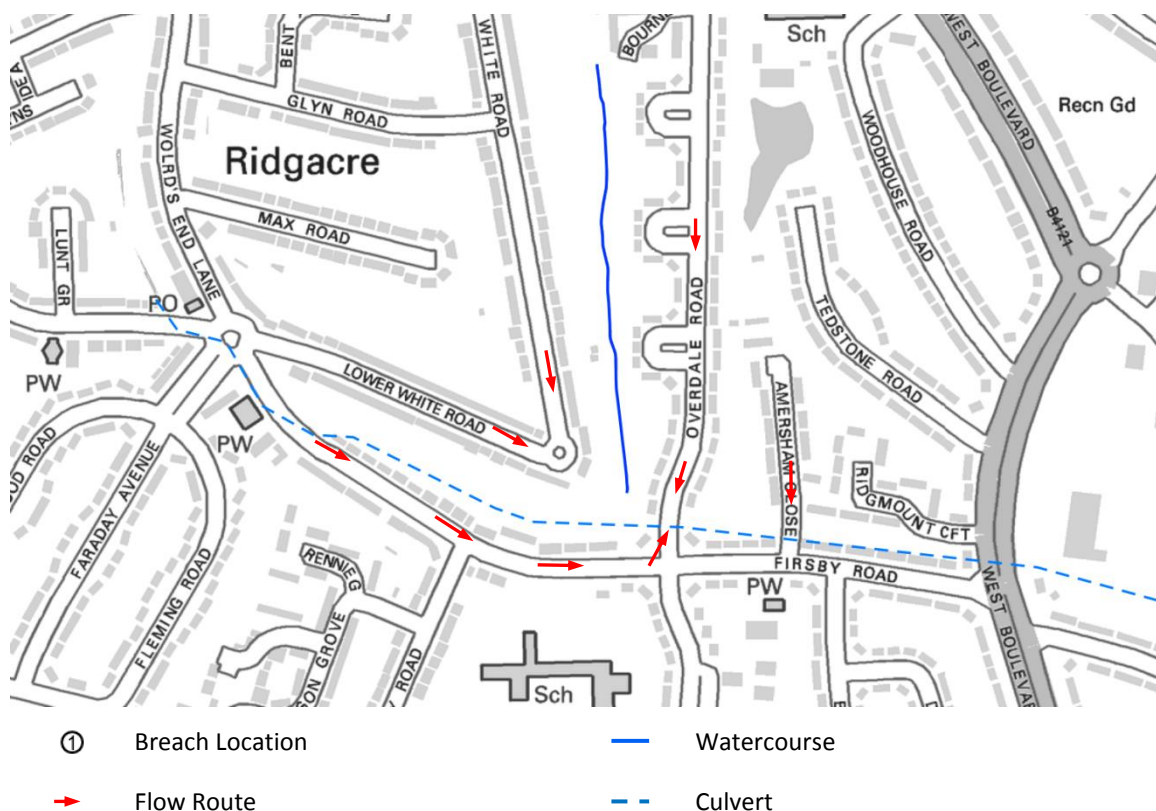
Figure 4-26 Potential overland flow routes

The affected properties in Ridgemont Croft, Overdale Road and Firsby Road are located at the low point of the surrounding topography, in a natural valley. As a result, surface water runoff followed the local topography and highways to pond at the lowest point resulting in the highway becoming inundated and water overtopping into the adjacent properties.

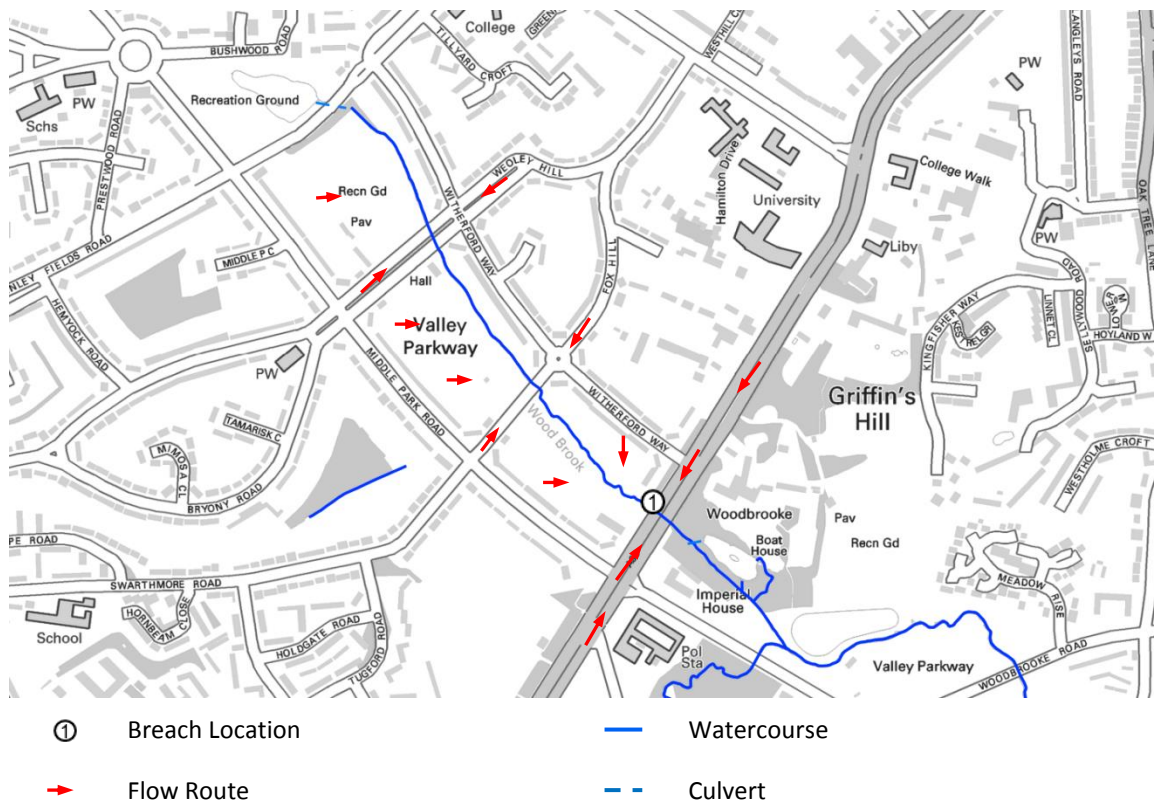
Figure 4-30 Potential watercourse breach and overland flow routes

The Wood Brook, an Environment Agency Main River, runs adjacent to the boundaries of the affected properties, flowing in a south-easterly direction. Water is discharged from the pond adjacent to Shenley Fields Road into the Wood Brook and this flows south-eastwards through the park area. This watercourse is culverted as it passes under a number of roads which include Weoley Hill, Fox Hill and the Bristol Road. Downstream of the Bristol Road the Wood Brook is joined by Giffin’s Brook and becomes The Bourn, ultimately discharging into the River Rea in Stirchley.

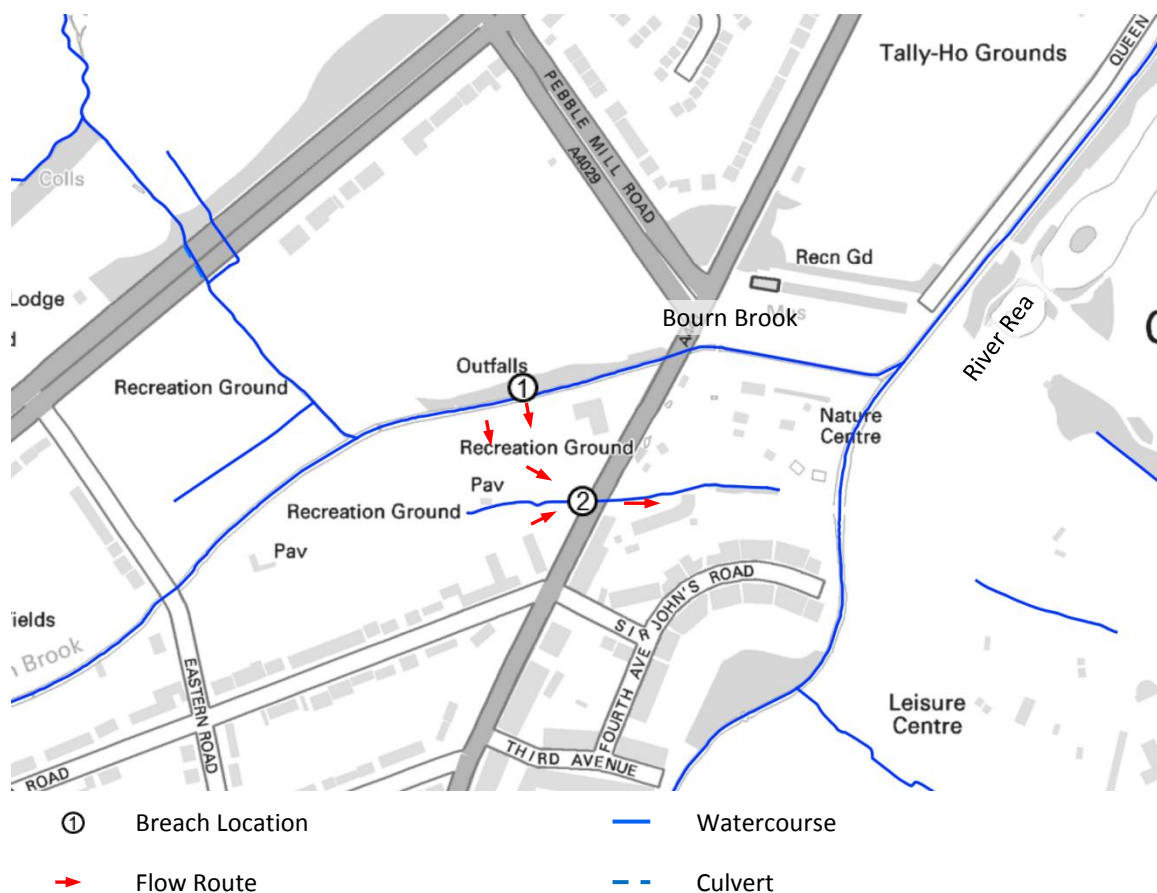
Figure 4-35 Potential overland flow routes

The capacity of the Bourn Brook was overwhelmed and it is understood to have breached as it flowed adjacent to Birmingham Dental Hospital, shown as Breach Location 1 in Figure 4-35, and flowed southwards through the Recreation Ground. This was then exacerbated by a further breach in another unnamed watercourse upstream of Pershore Road, shown as Breach Location 2, resulting in surface water flowing across Pershore Road into the front of properties fronting onto Riverside Drive. The topography and highway channels directed surface water runoff into St John’s Road, via Pershore Road, and from there into Fourth Avenue and Third Avenue.
