Birmingham City Council

**May 2018 Flooding:
Flood and Water Management Act,
Section 19 Investigation**

DATE ISSUED: 30 AUGUST 2019
VERSION: V2.0
STATUS: FINAL

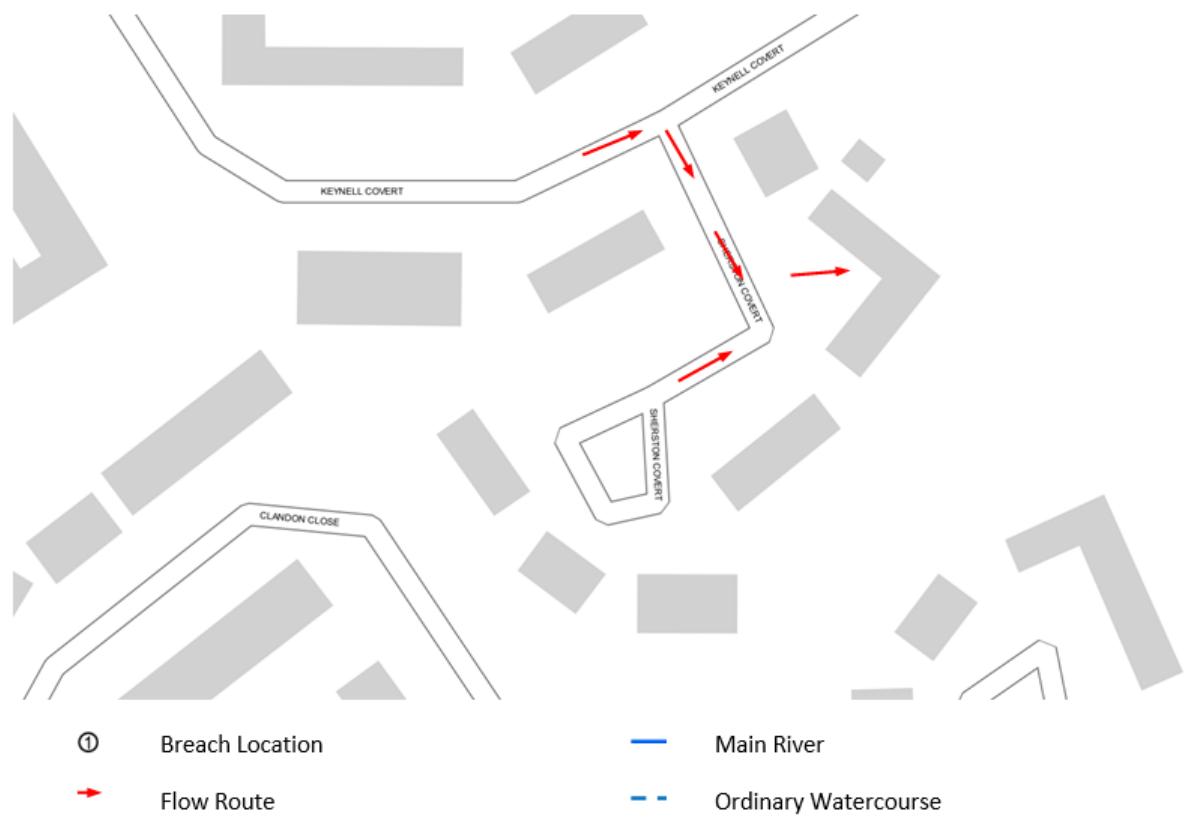
Figure 5.17 - Flood Flow Route

5.17.2 The flooding in this area has been identified to be from surface water.

5.17.4 Due to the magnitude of the storm, runoff from the surrounding area followed the natural topography of the land via the highway network and ponded at the low spot in Sherston Covert. Water levels built up and water flowed into low lying property.

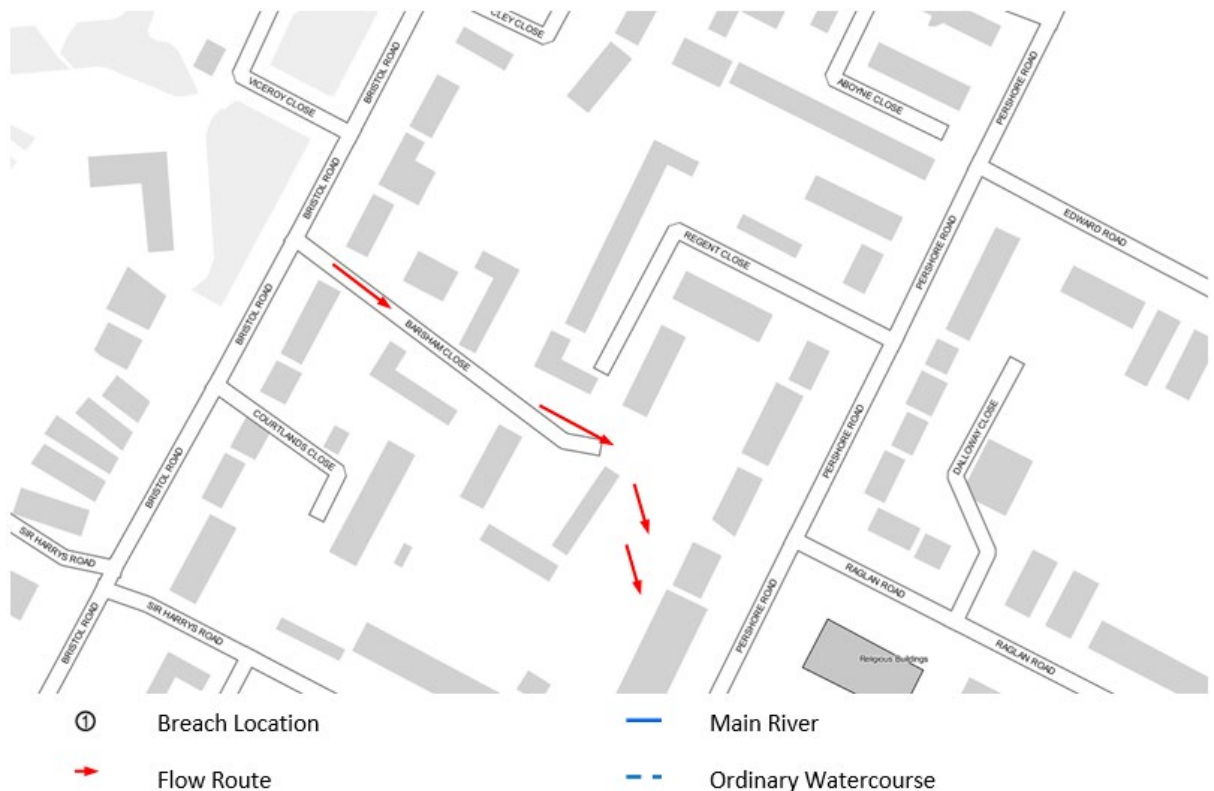
Figure 5.18 - Flood Flow Route

5.18.2 The flooding in this area has been identified to be from surface water and highway drainage.

5.18.4 Due to the magnitude of the storm, runoff from the surrounding area followed the natural topography of the land via the highway network and ponded at the low spot in Barsham Close. Water levels built up and water flowed into low lying property. As Barsham Close is a private road, the highway drainage is the responsibility of Birmingham City Council Housing.

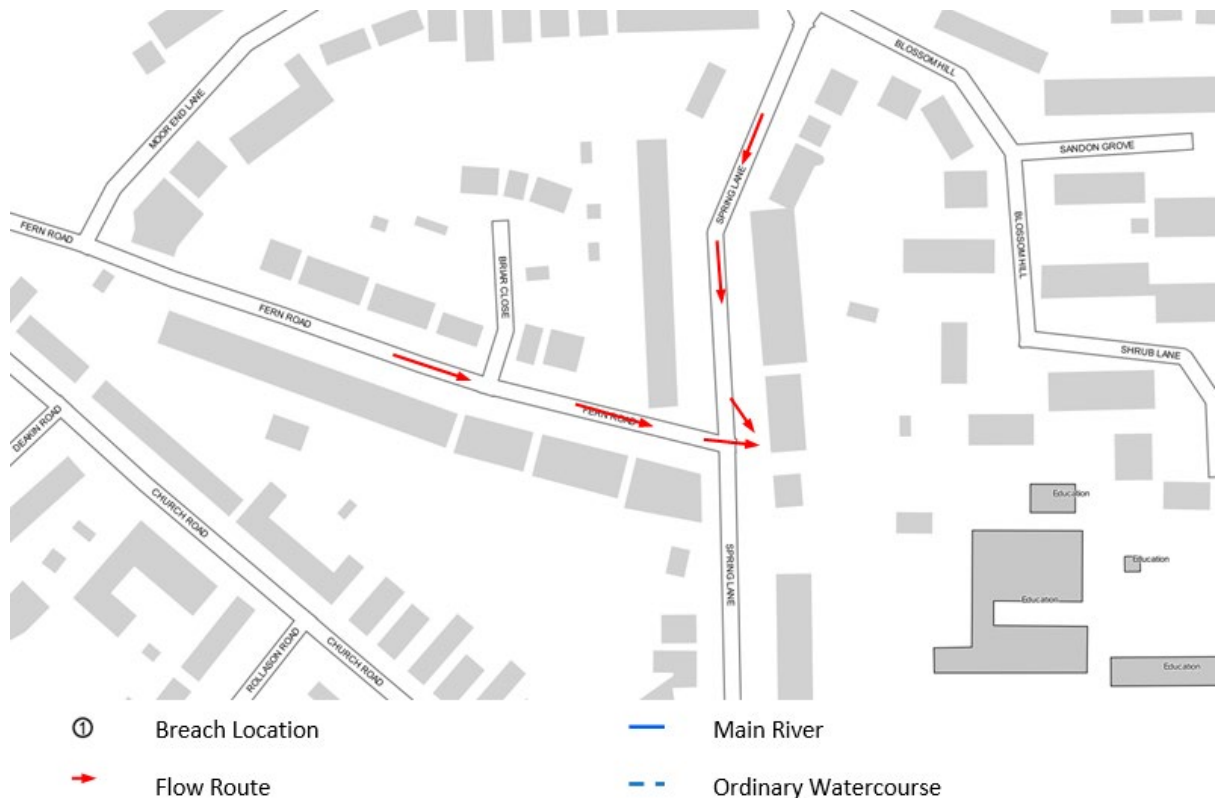
Figure 5.19 - Flood Flow Route

5.19.2 The flooding in this area has been identified to be from surface water and sewer flooding.

5.19.4 Due to the magnitude of the storm, runoff from Spring Lane and Fern Road followed the natural topography of the land via the highway network and ponded at the low spot in Spring Lane. The surface water sewers may have been at full capacity and therefore the highway gullies were unable to discharge into the sewer. Flood water overtopped dropped kerbs and flooded into lower lying property.

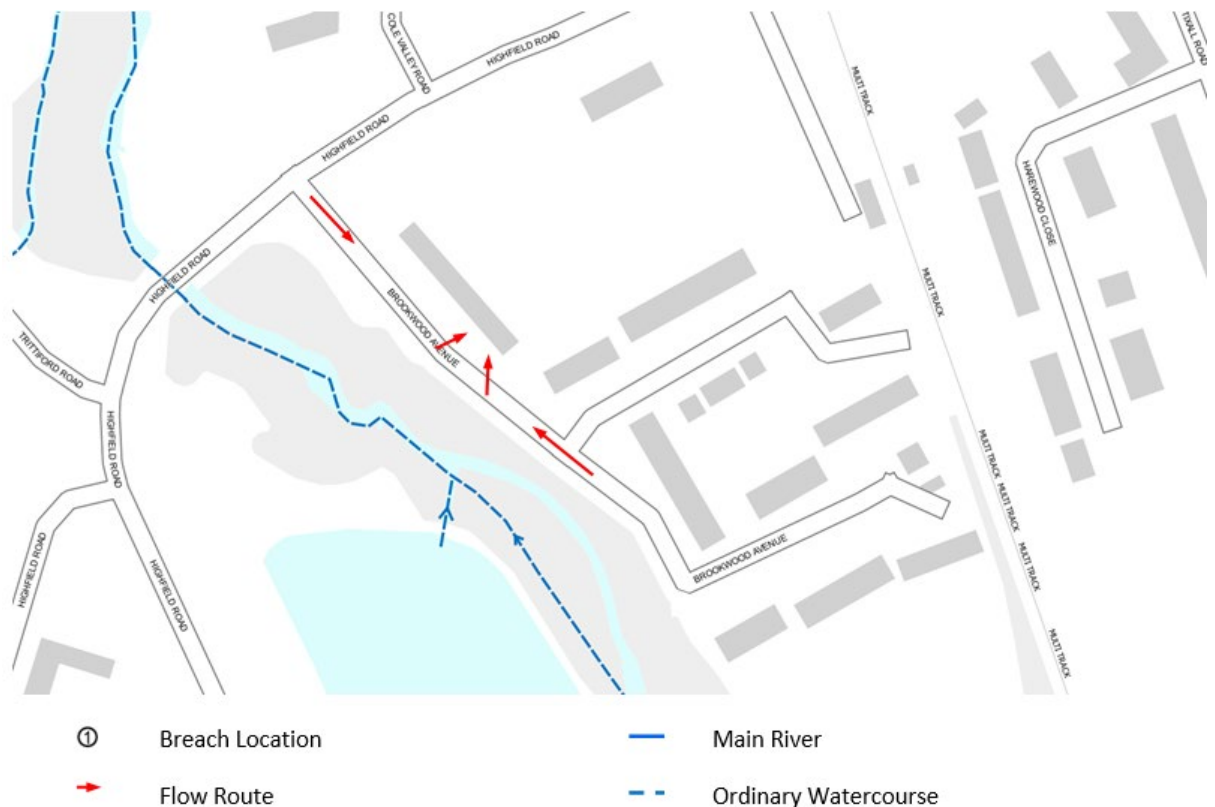
Figure 5.20 - Flood Flow Route

5.20.2 The flooding in this area has been identified to be from surface water and fluvial flooding.

5.20.4 Due to the magnitude of the storm, runoff from the surrounding catchment followed the natural topography of the land via the highway network and ponded at the low spot in Brookwood Close. Water was unable to disperse through the highway gullies due to the high river level in the River Cole. Blockages in the River Cole may have exacerbated the problem by increasing river levels.

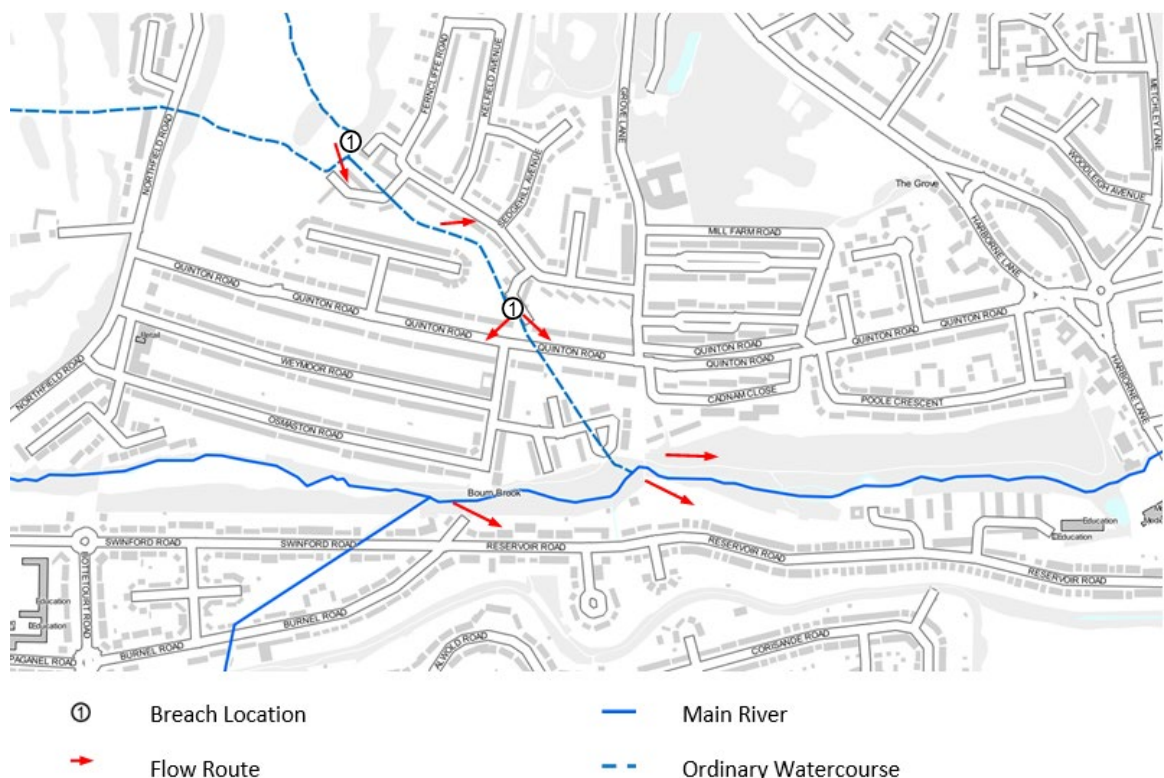
Figure 5.21 - Flood Flow Route

5.21.2 The flooding in this area has been identified to be from fluvial flooding.

5.21.4 Due to the magnitude of the storm, the capacity of Harts Green Brook and Bourn Brook was exceeded and the flow overtopped the channel and flooded into adjacent property. Flooding was exacerbated by blockages along Harts Green Brook due to accumulations of debris and fallen trees. Restrictions due to accumulations of silt were also reported in Bourn Brook, possibly as a result of reductions in maintenance.

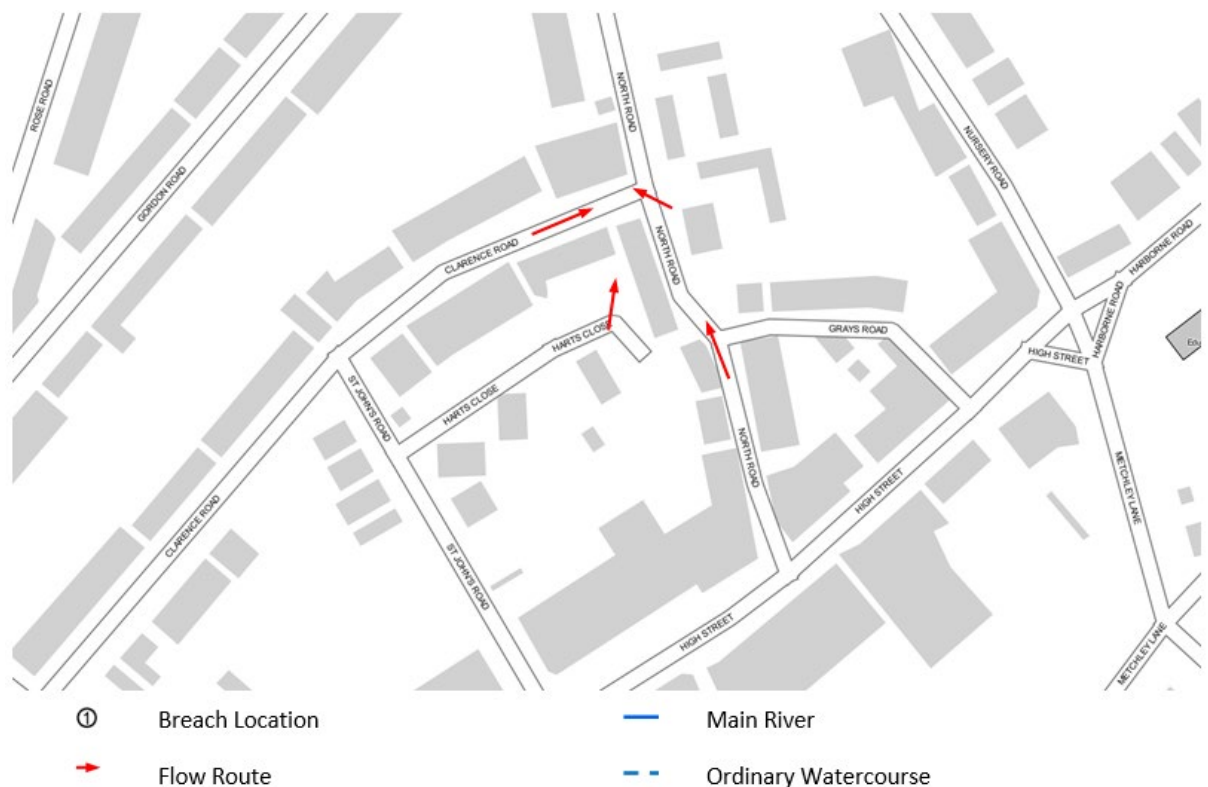
Figure 5.22 - Flood Flow Route

5.22.2 The flooding in this area has been identified to be from surface water and highway drainage.

5.22.4 Due to the magnitude of the storm runoff from the surrounding catchment made its way towards the properties via the highway network causing flooding from two mechanisms:

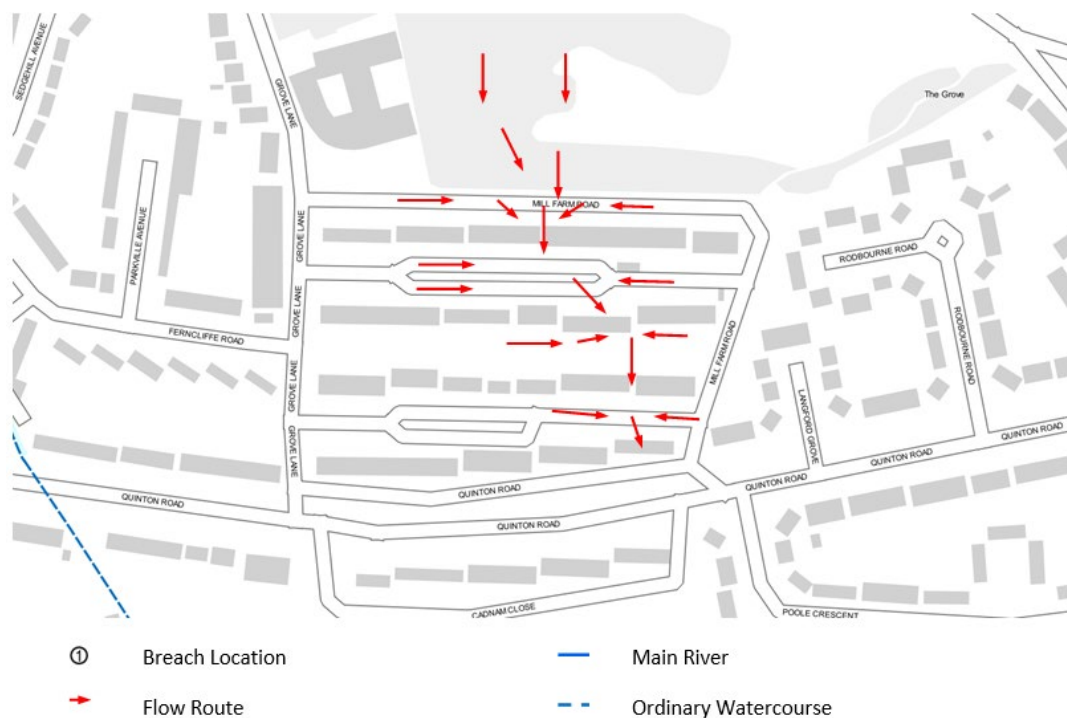
Figure 5.23 - Flood Flow Route

5.23.2 The flooding in this area has been identified to be from surface water and highway drainage.

5.23.4 Due to the magnitude of the storm runoff from the surrounding catchment made its way towards the properties from two mechanisms:

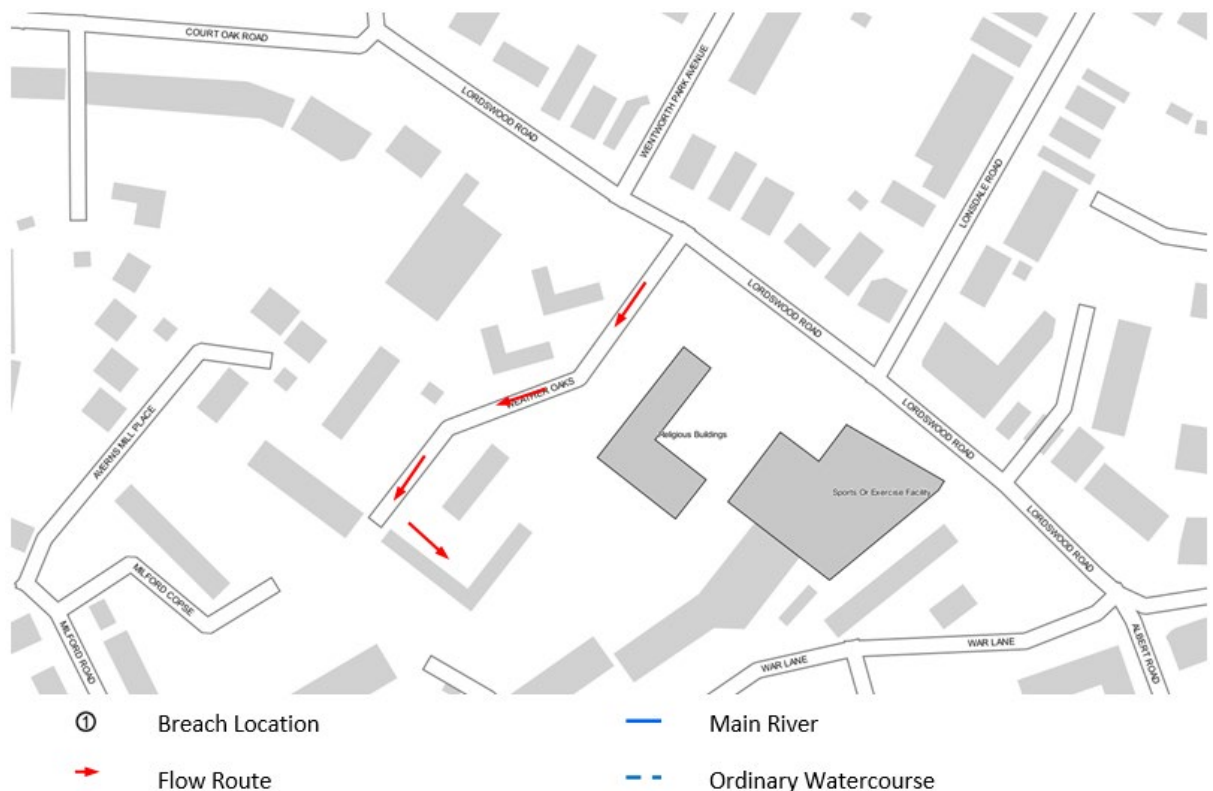
Figure 5.24 - Flood Flow Route

5.24.2 The flooding in this area has been identified to be from surface water and highway drainage.

5.24.4 Due to the magnitude of the storm, runoff from the surrounding catchment followed the natural topography of the land via the highway network and ponded at the low spot in Weather Oaks. Water was unable to disperse through the highway gullies, possibly due to blockage and water overtopped the kerbs and flowed across gardens/footpaths and into the lower lying properties.

Recommended Actions	Identified Party / RMA
Assess the condition and capacity of local drainage	Private Road Owner via management company MetroPM
Review of maintenance regime schedule of local drainage assets	Private Road Owner via management company MetroPM
Explore the potential to minimise leaf litter	Private Road Owner via management company MetroPM
Assess the condition and capacity of local drainage	Birmingham City Council (Housing)

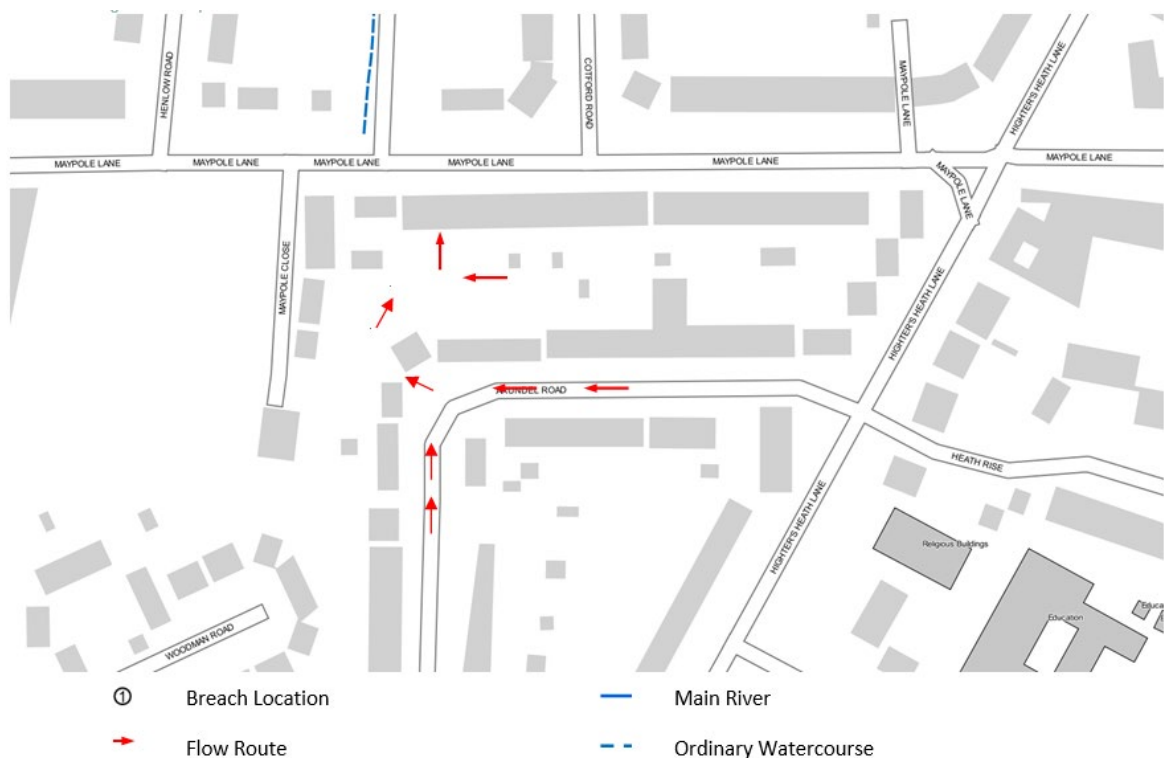
Figure 5.25 - Flood Flow Route

5.25.2 The flooding in this area has been identified to be from surface water and highway drainage.

5.25.4 Due to the magnitude of the storm, runoff from the surrounding catchment followed the natural topography of the land via the highway network and ponded at the low spot in Arundel Road. Due to the volume of runoff water was unable to disperse through the highway gullies, and water overtopped the dropped kerbs and flowed into the lower lying properties. Runoff also ran between properties flooding properties in Maypole Lane for the rear.

Recommended Actions	Identified Party / RMA
Assess the capacity of the highway drainage network	Highway Maintenance and Management Partner
Explore the potential for property flood resilience	Birmingham City Council (LLFA) Property Owners

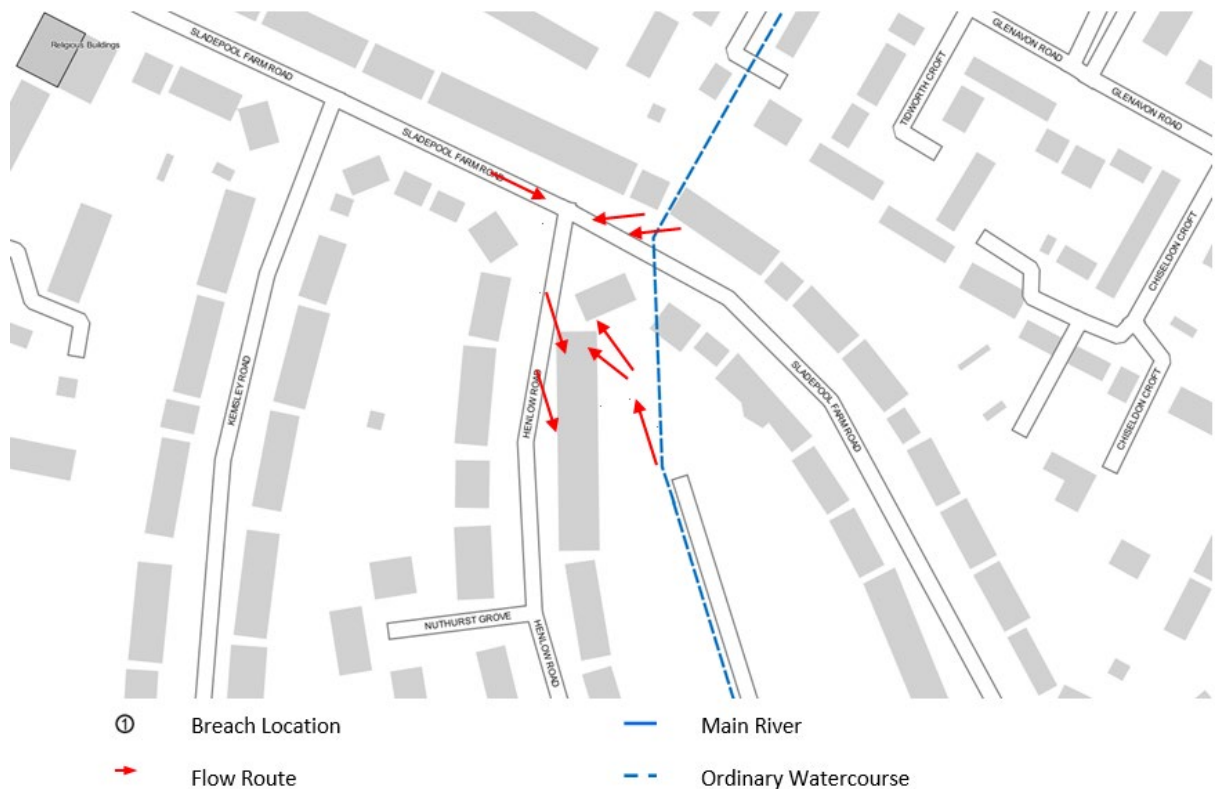
Figure 5.26 - Flood Flow Route

5.26.2 The flooding in this area has been identified to be from rivers and surface water.

5.26.4 Due to the magnitude of the storm, runoff from the surrounding catchment followed the natural topography of the land via the highway network and ponded at the low spot in Henlow Road. Due to the volume of runoff water was unable to disperse through the highway gullies, and water overtopped the dropped kerbs and flowed into properties from the front. In addition to exceedance runoff from watercourse in the allotments flowed into the rear of properties.

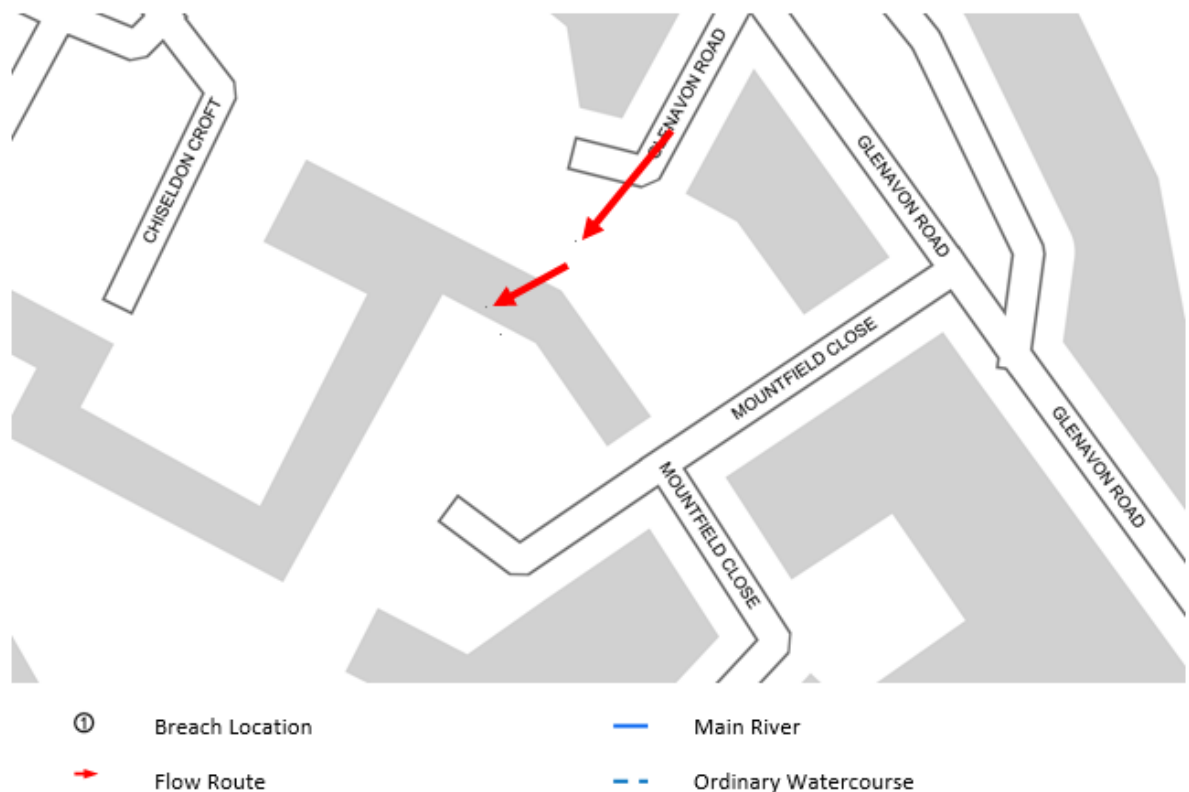
Figure 5.27 - Flood Flow Route

5.27.4 Due to the magnitude of the storm, runoff from the surrounding catchment followed the natural topography of the land via the highway network and ponded at the low spot in Mountfield Close and in the garage area off Glenavon Road. Due to the volume of runoff water was unable to disperse through the gullies, and water overtopped the kerbs and flowed into the lower lying properties.

5.27.6 Highway gullies have been cleansed by the Highway Maintenance and Management Partner and a significant accumulation of leaf fall was noted.

Recommended Actions	Identified Party / RMA
Review maintenance schedule of highway assets	Highway Maintenance and Management Partner
Assess the condition and capacity of local drainage	Birmingham City Council (Housing)

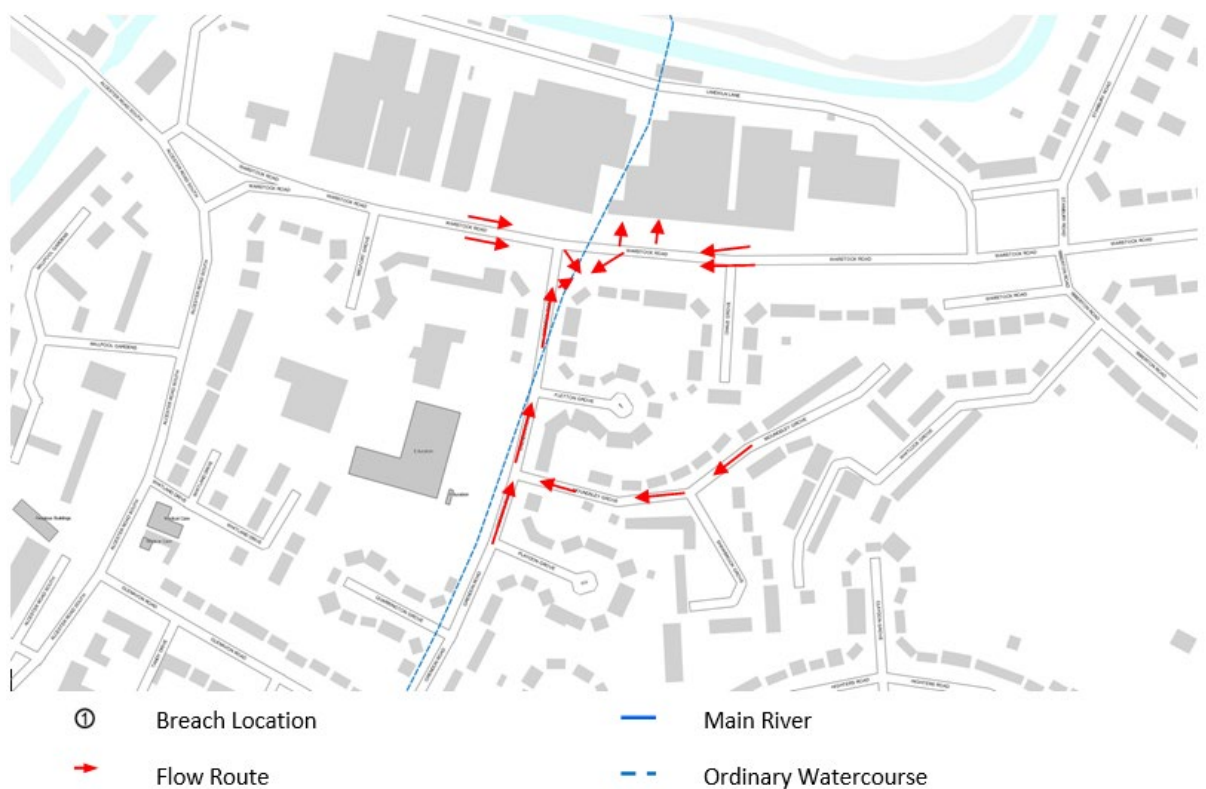
Figure 5.28 - Flood Flow Route

5.28.4 Due to the magnitude of the storm, runoff from the surrounding catchment followed the natural topography of the land via the highway network and ponded at the low spot in Warstock Road/Grendon Avenue Road. At this location, a pump on the sewer network became blocked while trying to pump away the volume of silt and dirt that had washed down in the storm, resulting in surface water runoff being unable to enter the sewer system and hence water levels rose, overtopping kerbs and resulting in flooding to properties which are located lower than the road.

Recommended Actions	Identified Party / RMA
Assess the condition and capacity of the sewer network	Severn Trent Water

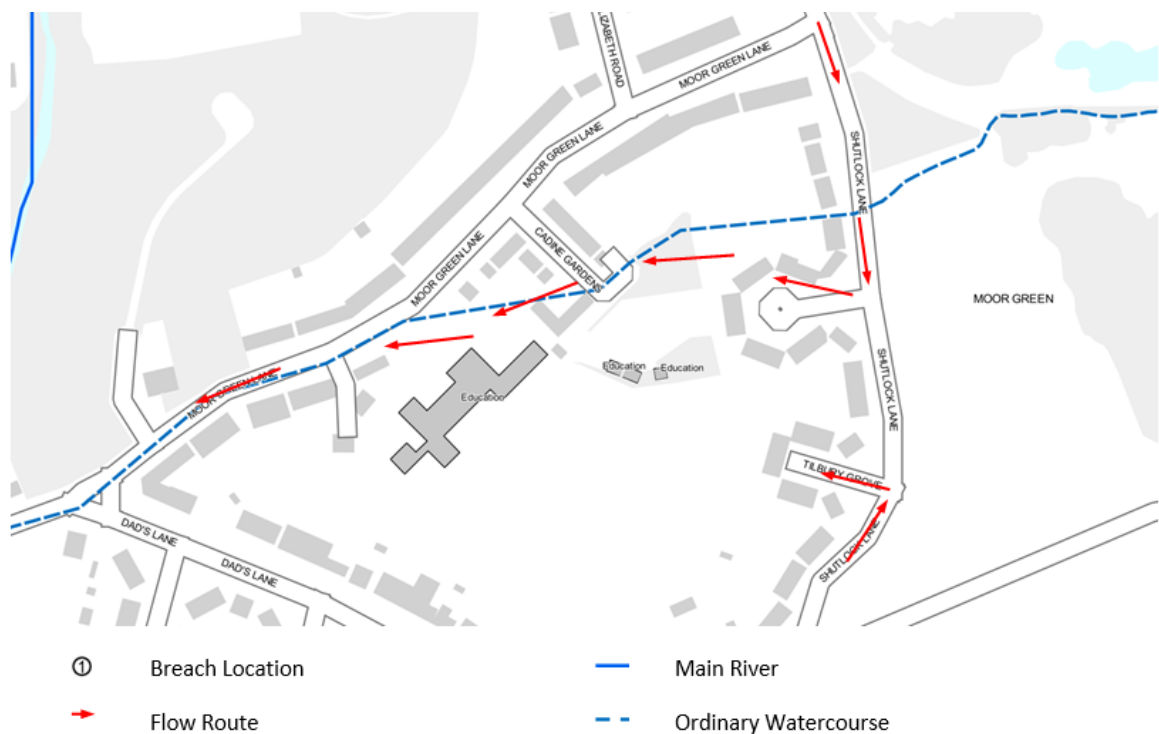
Figure 5.29 - Flood Flow Route

5.29.4 Due to the magnitude of the storm, runoff from Highbury Park and the surrounding highway catchment followed the natural topography of the land via the highway network into Seaton Grove, where it overtopped into lower lying property and made its way between houses into Cadine Gardens and Moor Green Lane flooding properties along this route.

Recommended Actions	Identified Party / RMA
Assess the condition and capacity of the highway drainage network	Highway Maintenance and Management Partner Birmingham City Council (Leisure)
Explore the potential for community scale flood mitigation	Birmingham City Council (Leisure)

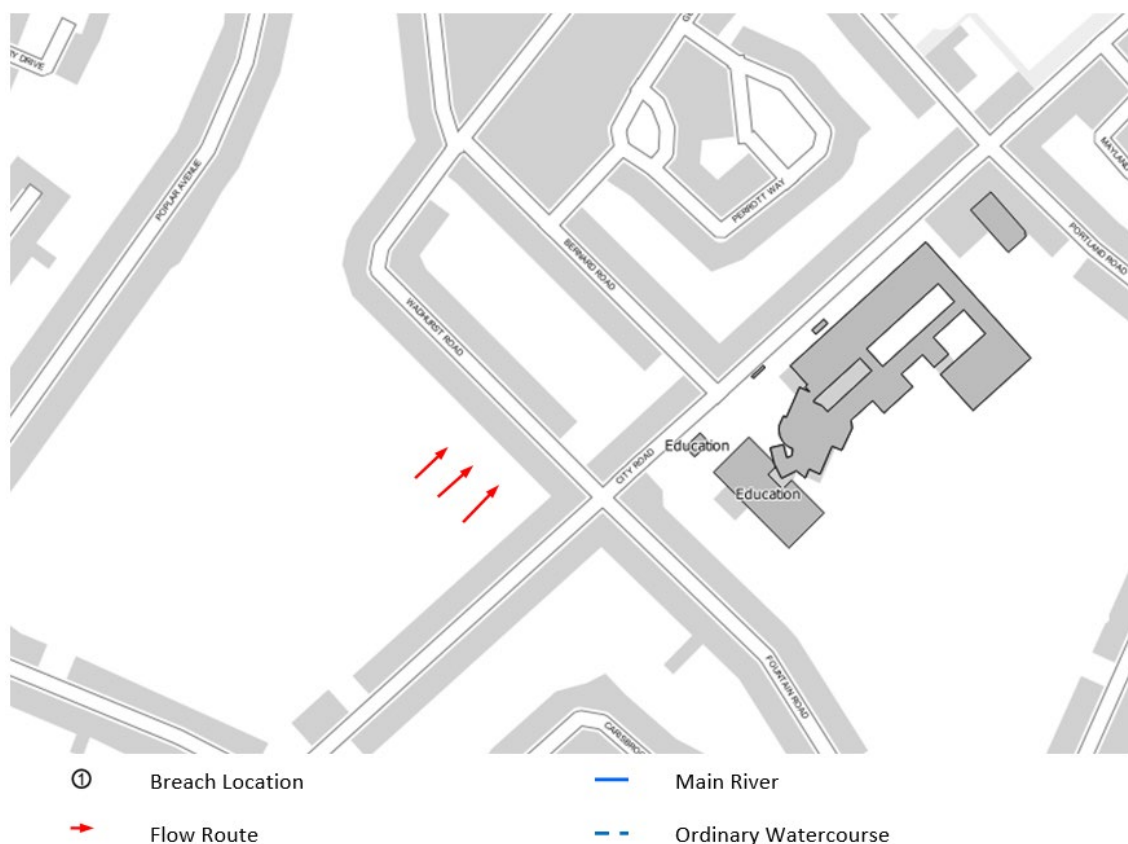
Figure 5.30 - Flood Flow Route

5.30.4 Due to the magnitude of the storm, runoff from the field at the rear of the properties which was under development into sports pitches followed the topography of the land and into the rear of properties in Wadhurst Road. From here it made its way between properties and on to the highway entering properties on the opposite side of the road.

5.30.6 Work was undertaken on the sports pitch development prior to the drainage conditions of the planning application being met. Discussions have been held and are continuing with the residents, planning officers and the developer, Avery Fields Community Sports Trust.

5.30.8 The Highway Maintenance and Management Provider has cleansed all of the gullies, these were all found to be functioning fully.

5.30.7 A discharge of condition application has been submitted to the Council and Avery Fields Community Sports Trust have started work on flood mitigation works.

Recommended Actions	Identified Party / RMA
Planning to agree a way forward with developers	Birmingham City Council (Planning) Avery Fields Community Sports Trust

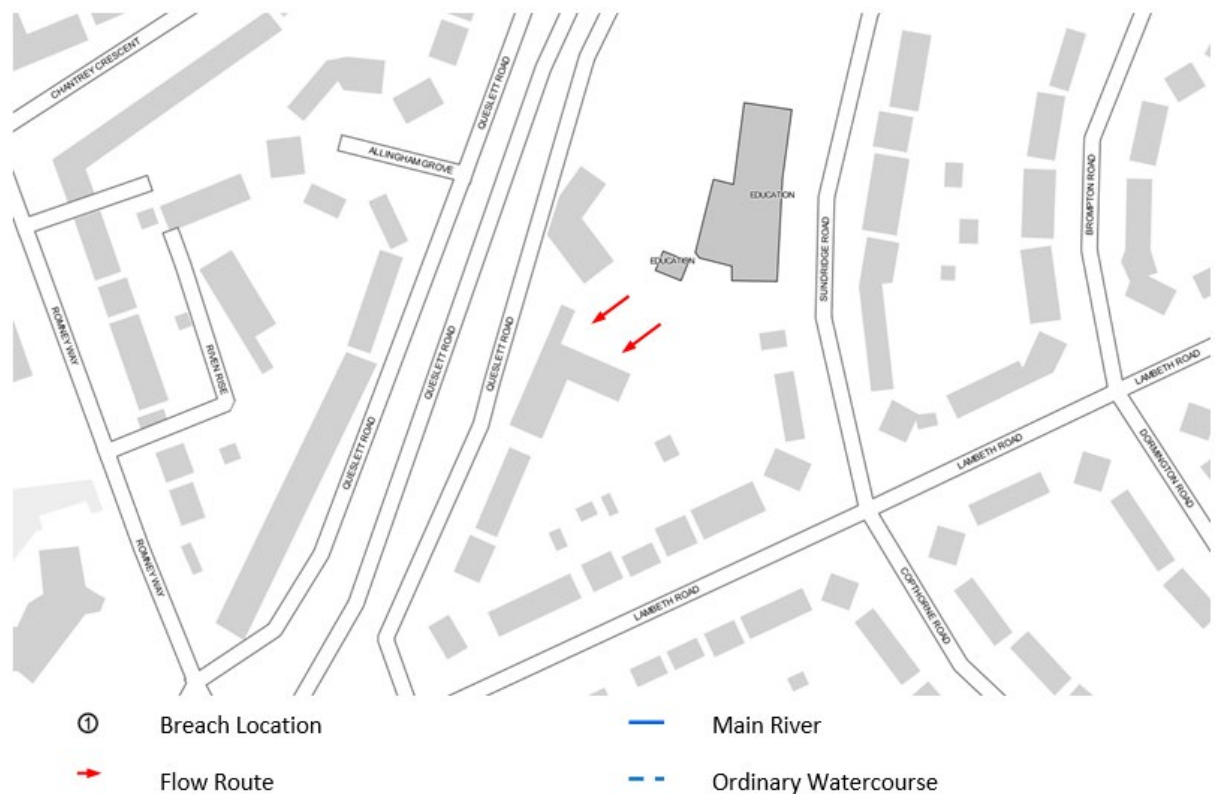
Figure 5.31 - Flood Flow Route

5.31.4 Due to the magnitude of the storm, runoff from the adjacent Sundridge Primary School car park exceeded the capacity of the local drainage and followed the natural topography of the land, flooding into lower lying property.

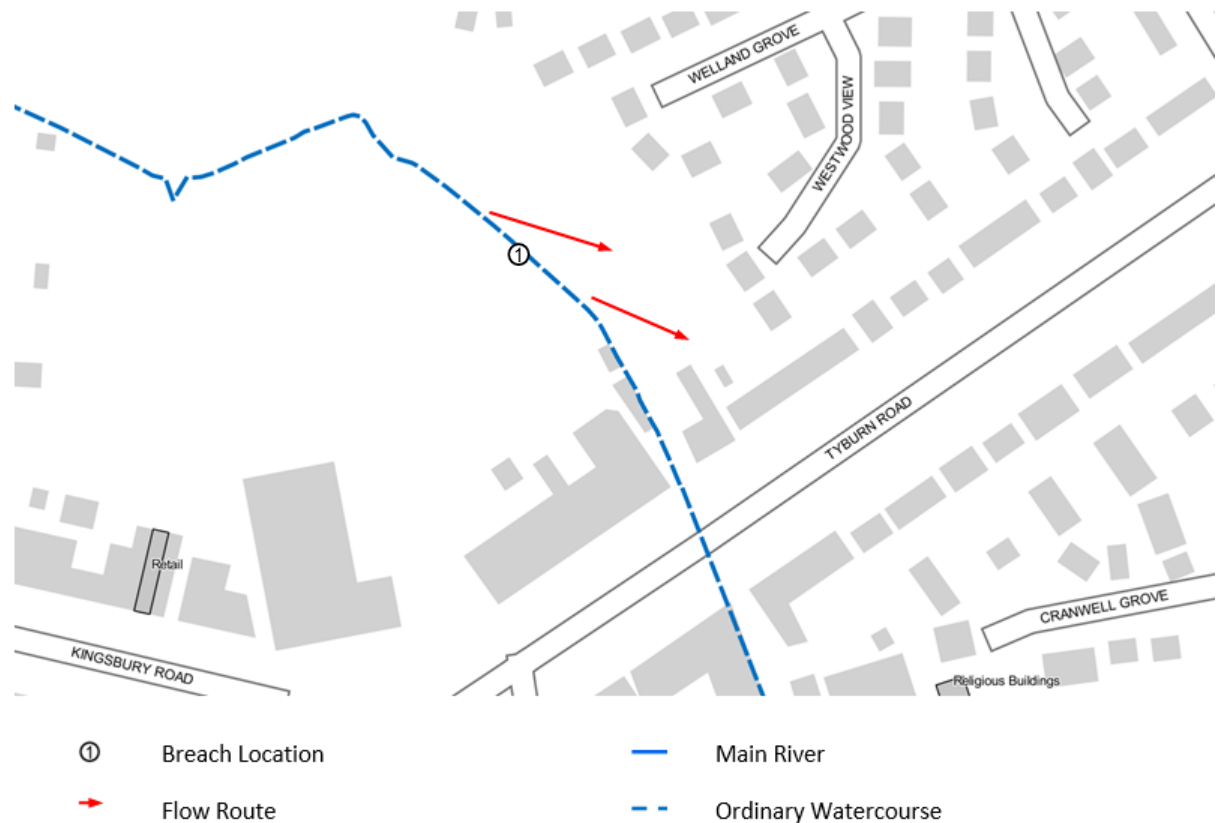
Figure 5.32 - Flood Flow Route

5.32.4 Due to the magnitude of the storm, the capacity of Erdington Brook was exceeded, and the flow overtopped the channel and flooded into adjacent property from the rear.

Recommended Actions	Identified Party / RMA
Review maintenance regime for the watercourse	Birmingham City Council (Leisure) Birmingham City Council (LLFA)
Explore the potential for property level flood resilience	Birmingham City Council (LLFA) Property Owners

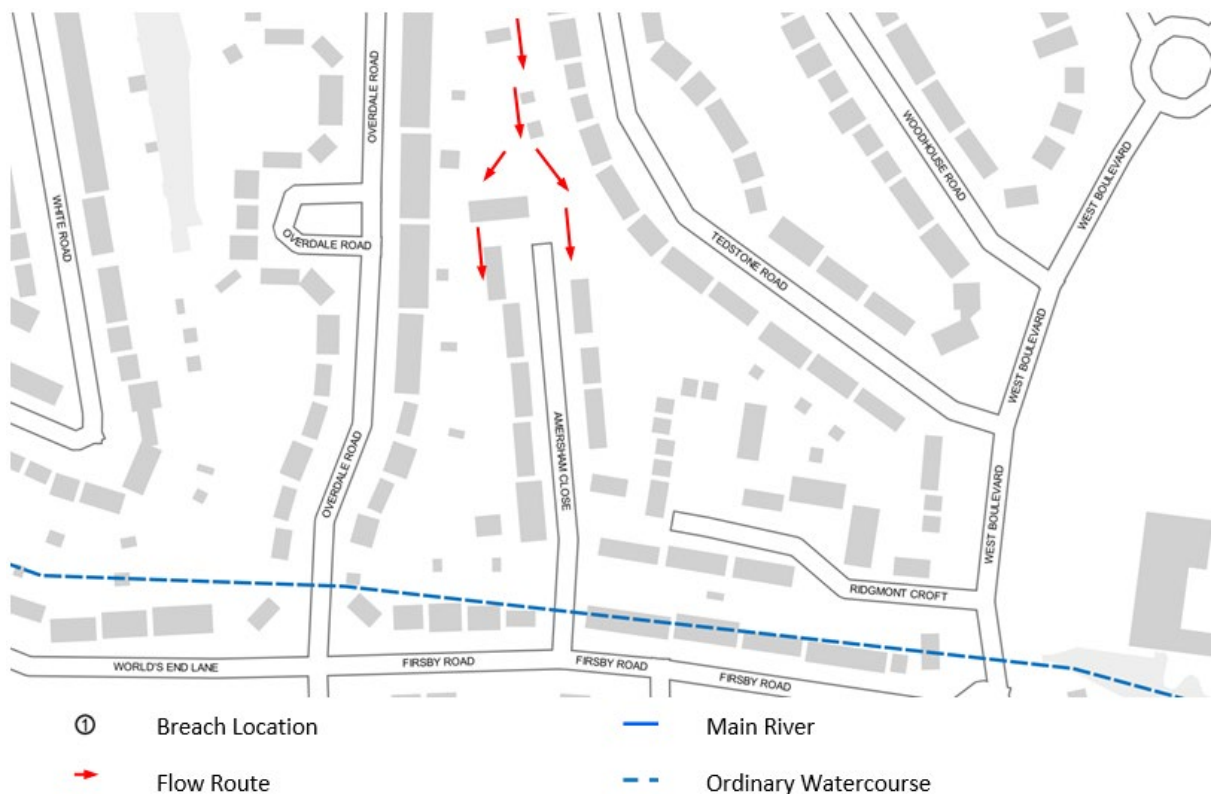
Figure 5.33 - Flood Flow Route

5.33.4 Due to the magnitude of the storm, runoff from the derelict land to the rear of the properties followed the natural topography of the land and flowed into the rear of lower lying property. A block of garages on the derelict land has recently been demolished, previously this was deflecting flows around the properties and into the highway network.

Recommended Actions	Identified Party / RMA
Assess the condition and capacity of the local drainage	Birmingham City Council (Housing)
Explore the potential for community scale flood mitigation	Birmingham City Council (Housing)

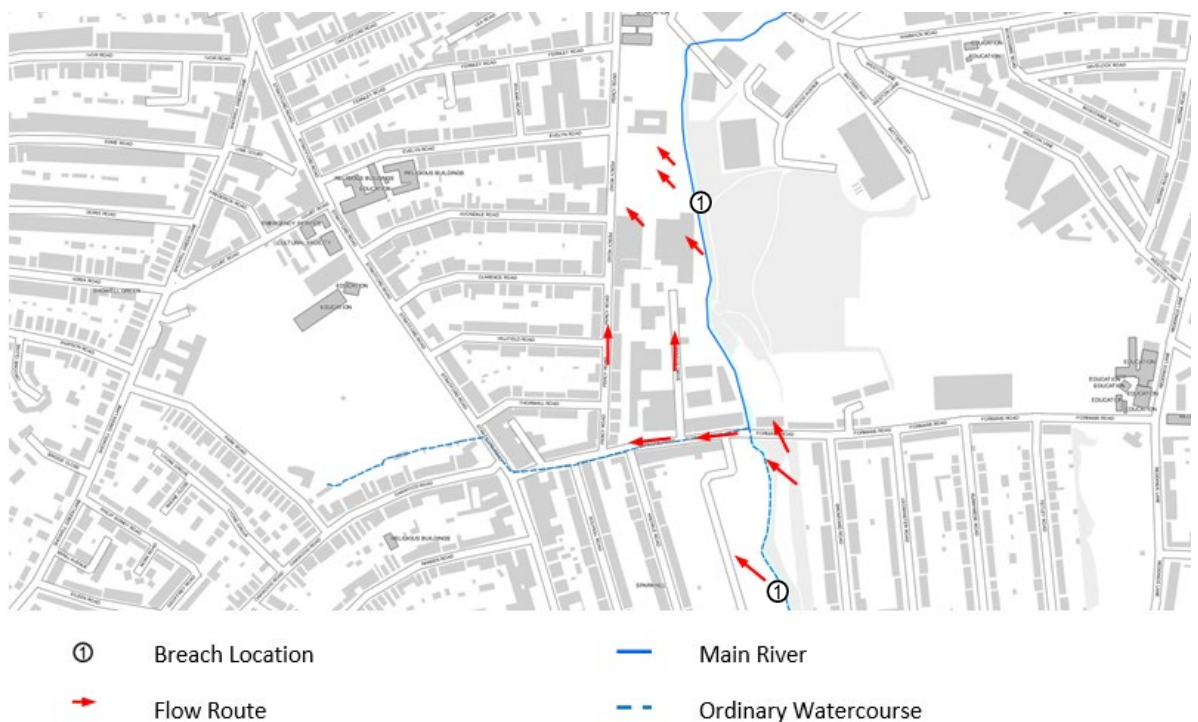
Figure 5.34 - Flood Flow Route

5.34.4 Due to the magnitude of the storm, the capacity of the River Cole was exceeded, flow overtopped the channel and flooded across surrounding land and highways into properties.

5.34.7 All highway drainage has been cleaned and defective gullies replaced.

Recommended Actions	Identified Party / RMA
Explore the potential for catchment wide flood mitigation	Environment Agency Birmingham City Council (LLFA) Solihull Metropolitan Borough Council (LLFA) Worcestershire County Council (LLFA)

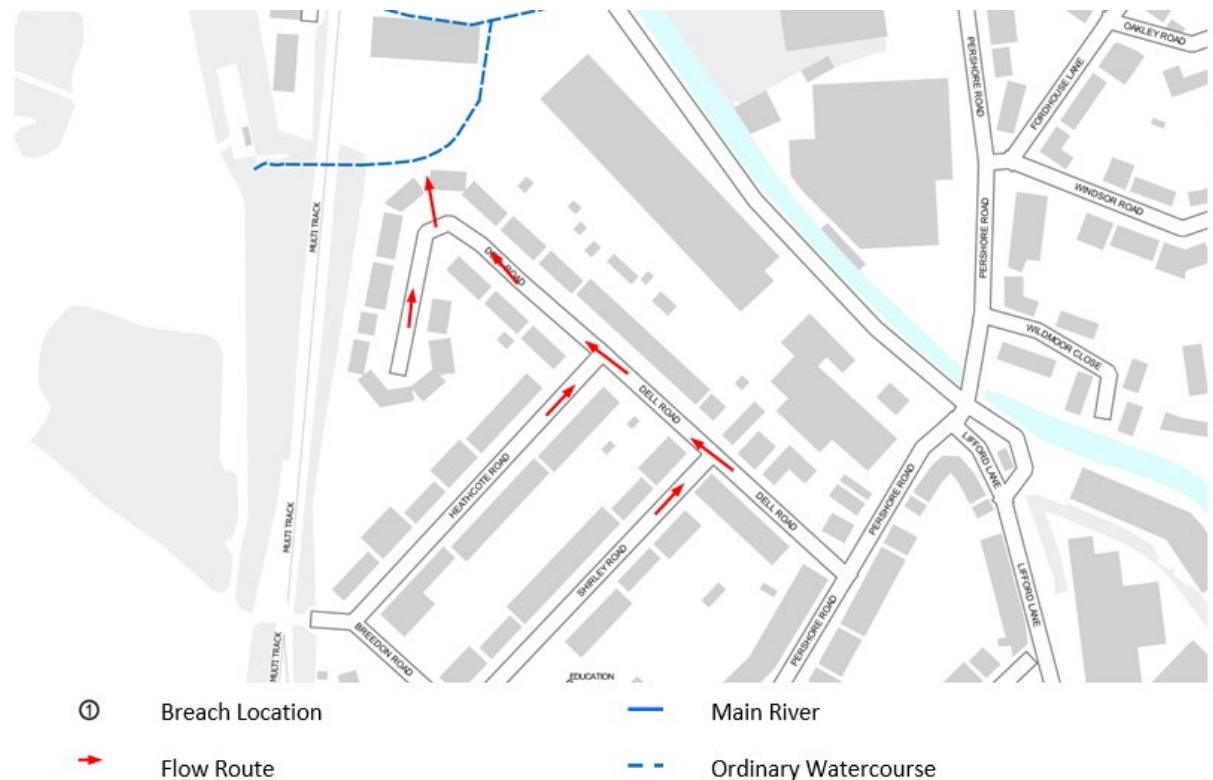
Figure 5.35 - Flood Flow Route

5.35.4 Due to the magnitude of the storm, runoff from surrounding highway catchment was conveyed via the highway to the low point in Dell Road. Due to the elevated water level in the Cotteridge Brook which runs to the rear of the properties and the alignment of the sewer, the surface water sewer and hence gullies may have been unable to discharge into the brook. Therefore, flood water overtopped highway and followed low lying land through the property to the watercourse in the rear garden.

Recommended Actions	Identified Party / RMA
Assess the condition and capacity of the sewer network	Severn Trent Water Birmingham City Council (LLFA)

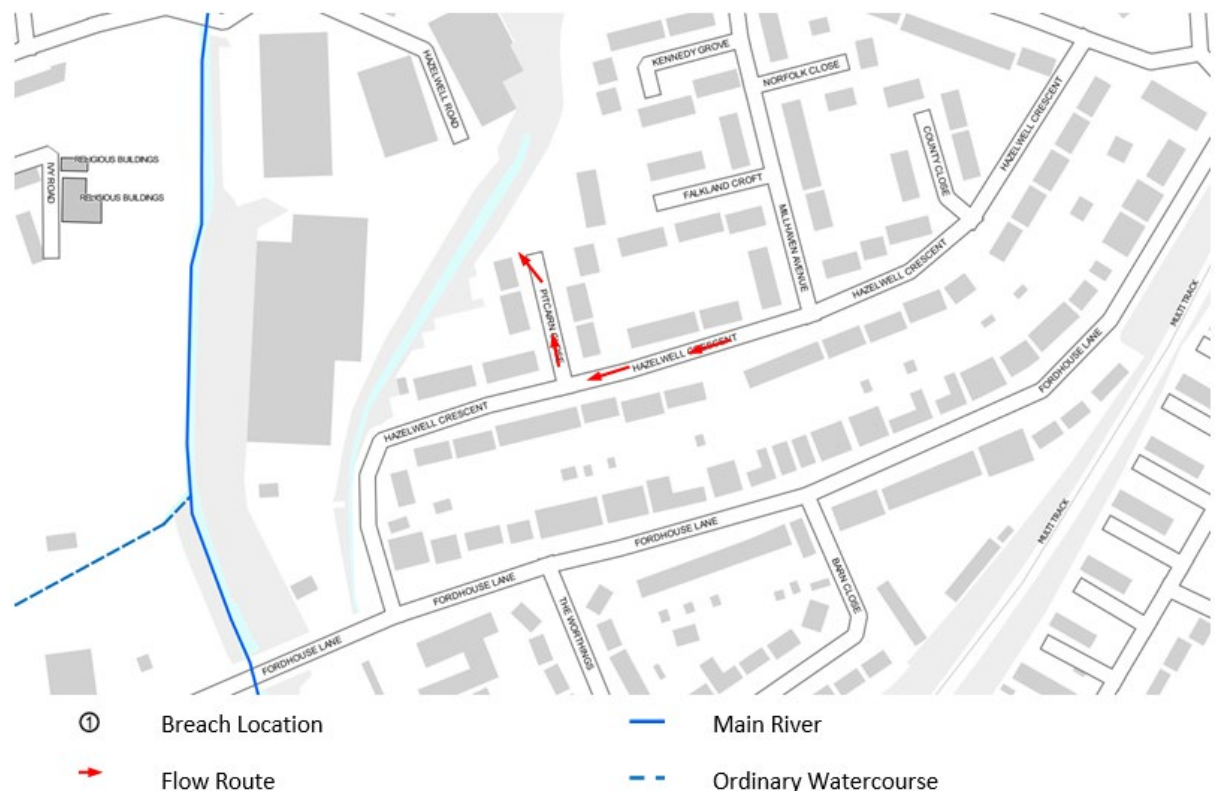
Figure 5.36 - Flood Flow Route

5.36.4 Due to the magnitude of the storm, runoff from surrounding catchment was conveyed via the highway network to the lowspot in Pitcairn Close. As the storm progressed the level of water built up as it couldn't discharge into the drainage system quickly enough, eventually overtopping kerbs and flooding into properties that lie lower than the road level.

Recommended Actions	Identified Party / RMA
Explore the potential for community scale flood mitigation	Birmingham City Council (LLFA)
