Birmingham City Council

**May 2018 Flooding:
Flood and Water Management Act,
Section 19 Investigation**

DATE ISSUED: 30 AUGUST 2019
VERSION: V2.0
STATUS: FINAL

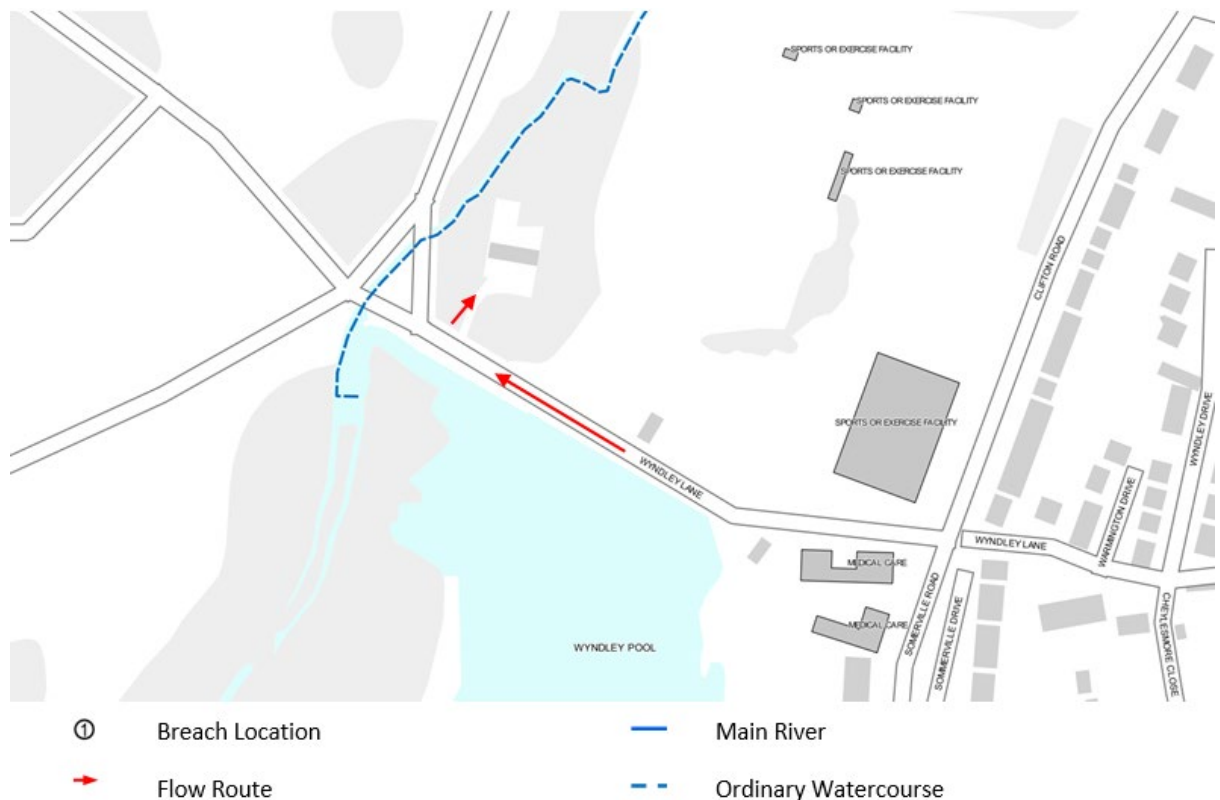
Figure 5.37 - Flood Flow Route

5.37.4 Due to the magnitude of the storm, runoff from surrounding catchment was conveyed via the highway network to the low spot in Wyndley Lane from where it flowed into lower lying property. The flooding was reported to be caused as a result of blocked highway drainage.

Recommended Actions	Identified Party / RMA
Review maintenance schedule of highway assets	Leisure Centre Management

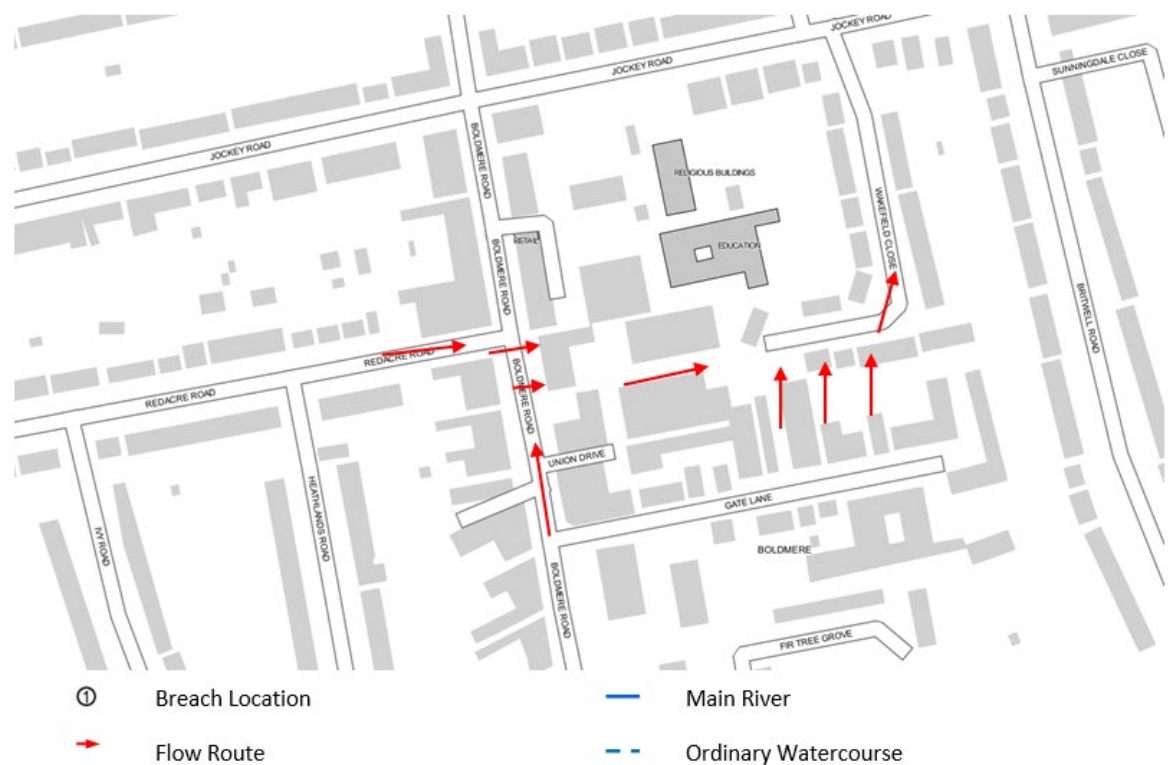
Figure 5.38 - Flood Flow Route

5.38.4 Due to the magnitude of the storm, runoff from Boldmere Road, Gate Lane, Wakefield Road and the surrounding catchment overwhelmed the surface water sewers and gullies in the area. Water was conveyed along Boldmere Road down to the low side of Boldmere Road where bow waves from passing vehicles caused flood water to enter properties. Runoff from Gate Lane, followed the natural topography of the land into the rear gardens of properties and flowed into the buildings in Wakefield Close.

Recommended Actions	Identified Party / RMA
Assess condition and capacity of the sewer network	Severn Trent Water
Assess condition and capacity of local drainage	Highway Maintenance and Management Partner

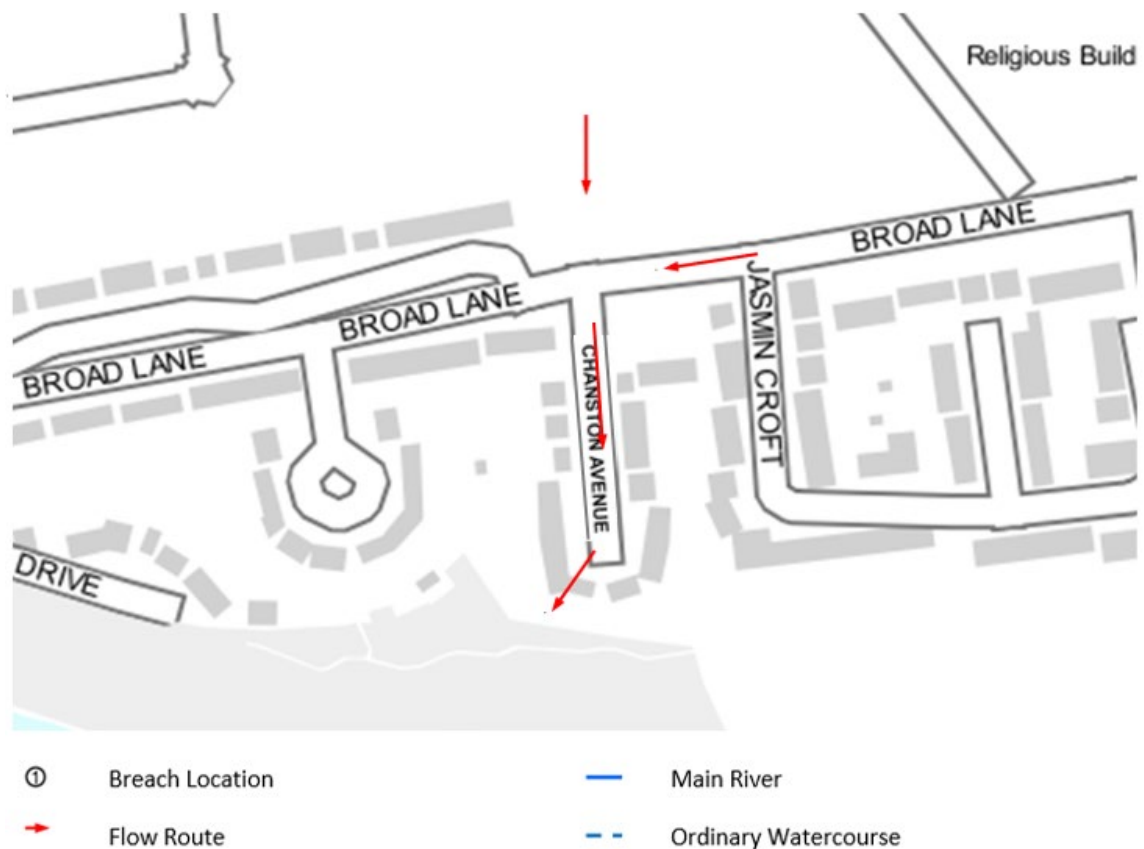
Figure 5.39 - Flood Flow Route

5.39.4 Due to the magnitude of the storm, runoff from Brandwood Cemetery overwhelmed the cemetery drainage and flowed out onto Broad Lane, this then combined with runoff from the surrounding highway network and flowed down Chanston Avenue following the natural topography of the land. As the storm progressed the level of water built up as it couldn't discharge into the drainage system quickly enough, overtopping kerbs and flooding into properties that lie lower than the road level. It is understood that the combined sewer system serving the area may have been at full capacity as there were reports of water coming out of manholes and therefore the highway gullies were unable to discharge into the sewer.

Recommended Actions	Identified Party / RMA
Explore the potential for community scale mitigation	Birmingham City Council (Bereavement)
Explore the potential for property level flood resilience	Birmingham City Council (LLFA) Property Owners
Assess condition and capacity of the sewer network	Severn Trent Water

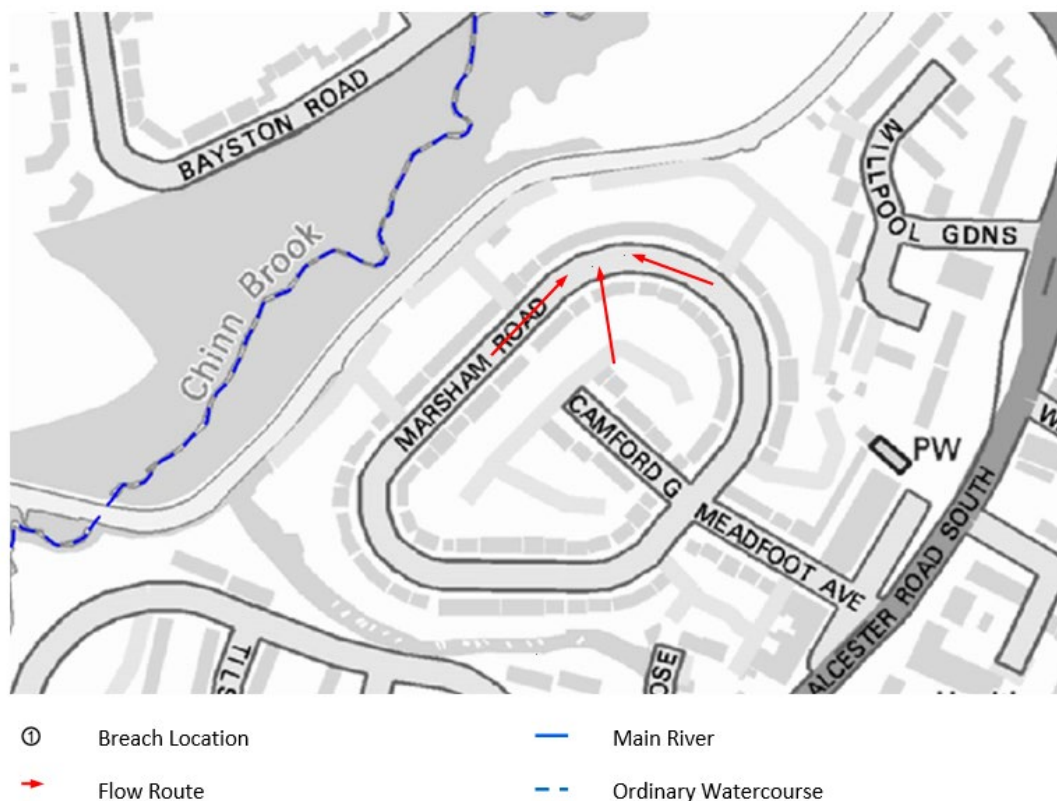
Figure 5.40 - Flood Flow Route

5.40.4 Due to the magnitude of the storm, runoff from the surrounding catchment was conveyed via the highway to the low spot Marsham Road. As the storm progressed the level of water built up and couldn't discharge into the drainage system quickly enough, eventually overtopping kerbs and flooding into properties that lie lower than the road level. Some reports suggest that blockage highway gullies may have exacerbated the problem,

Recommended Actions	Identified Party / RMA
Assess condition and capacity of highway drainage network	Highway Maintenance and Management Partner

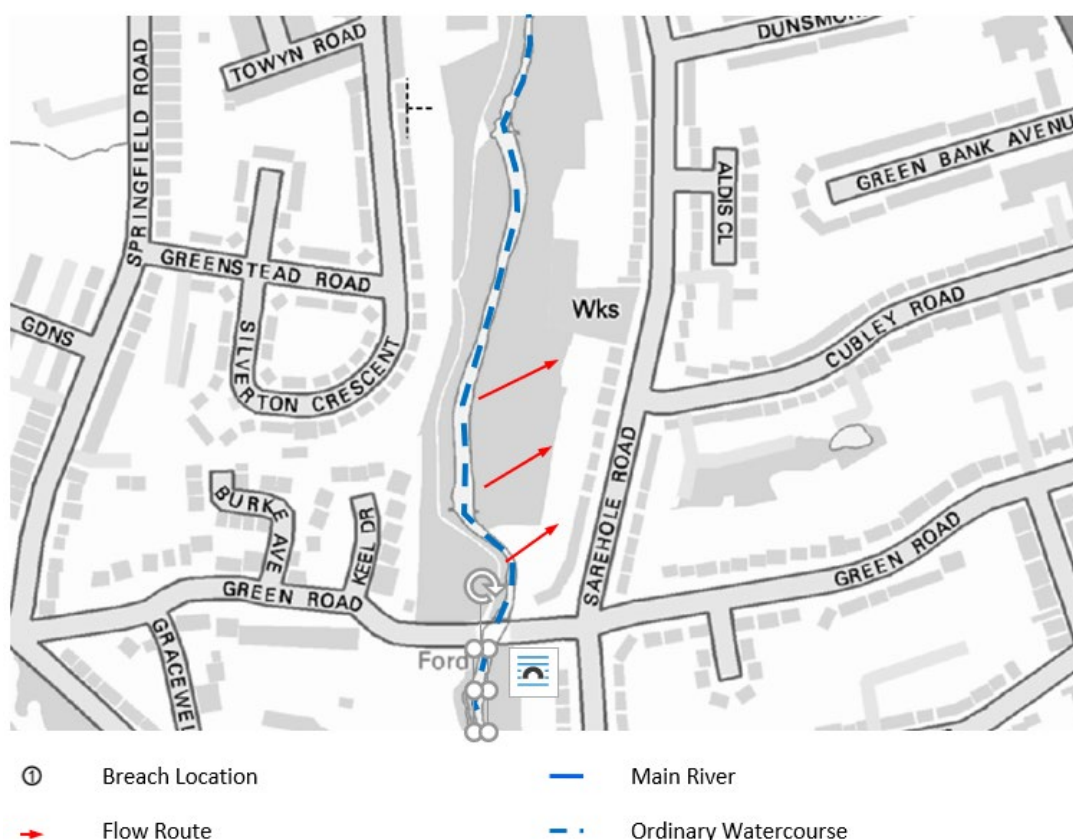
Figure 5.41 - Flood Flow Route

5.41.4 Due to the magnitude of the storm, the capacity of the River Cole was exceeded, flow overtopped the channel and flooded across surrounding land into properties. The flood level was exacerbated as a section of the floodplain was occupied by artificially raised ground formed of urban debris, knitted vegetation and earth.

Recommended Actions	Identified Party / RMA
Assess the condition and capacity of the watercourse	Birmingham City Council (Leisure)
