# Birmingham City Council

## June 2016 Flooding: Flood and Water Management Act, Section 19 Investigation

May 2017

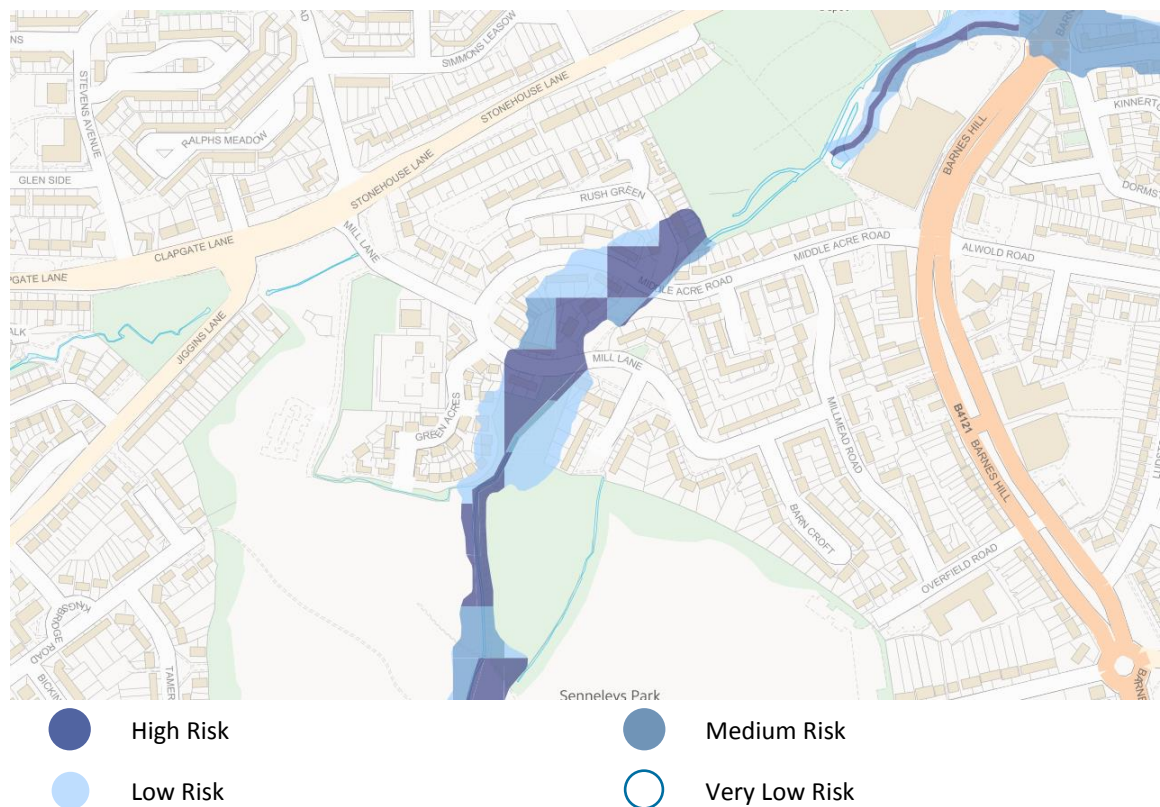
Figure 4-3 Flood Risk from Rivers or the Sea map

In both cases, the flooding was likely due to the flow in the watercourses exceeding the capacity of the culverts causing water levels upstream of the culverts to increase and spill from the banks into the adjacent Mill Lane and then flowing into Middle Acre Road and Rush Green.

The Stonehouse Brook is a Main River and the Environment Agency has modelled this brook as part of the wider River Rea catchment. The areas at risk of flooding from the Stonehouse Brook are shown on the extract of the Flood Risk from Rivers or the Sea map shown in Figure 4-3. The flooding reported correlates with the high risk areas from the mapping further emphasising the source of flooding was the watercourses within the immediate area.

Recommended Actions	Identified Party / RMA
<b>Investigate the capacity of the Bartley Brook and culvert</b>	Birmingham City Council (LLFA) in partnership with Environment Agency
<b>Develop an updated model of the watercourse through Senneleys Park including the Bartley Brook and other watercourses</b>	Environment Agency in partnership with Birmingham City Council (LLFA)
<b>Investigate options to manage overland flows</b>	Birmingham City Council (LLFA)
<b>Investigate options for flood mitigation scheme</b>	Environment Agency in partnership with Birmingham City Council (LLFA)
<b>Develop catchment options across the upper Bourn Brook catchment to manage flooding from all sources.</b>	Birmingham City Council (LLFA), Severn Trent Water and Environment Agency
<b>Assess the effectiveness of the installed property level resilience measures</b>	Birmingham City Council (Housing)

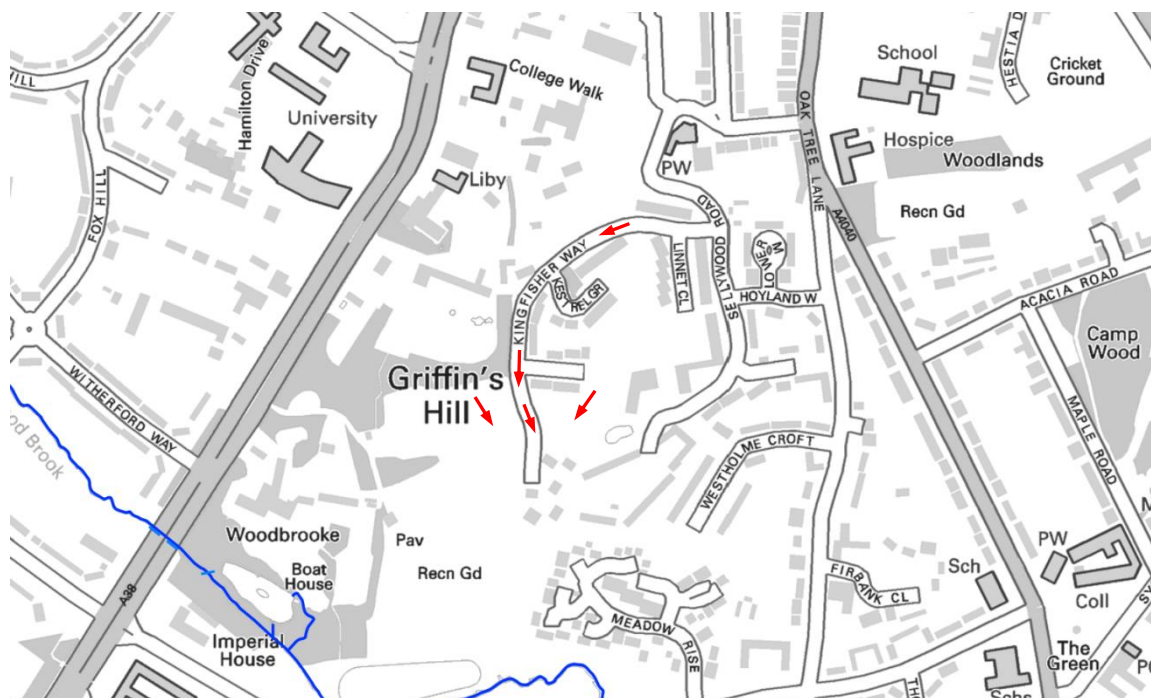
Figure 4-6 Potential overland flow routes

Kingfisher Way is a steep highway catchment falling in a southerly direction. Located adjacent to Kingfisher Way is a significant amount of open space which is managed and maintained by Bournville Village Trust. Due to the intensity of the rainfall, it is likely the rain falling on the open space was unable to soak into the ground and resulted in surface water flowing over the open space, following the local topography, into the highway and towards the properties in Kingfisher Way. The potential surface water flow routes are shown in Figure 4-6.

Recommended Actions	Identified Party / RMA
<b>Explore the potential to manage surface water flows within the public open space through SuDS and other measures</b>	Bournville Village Trust

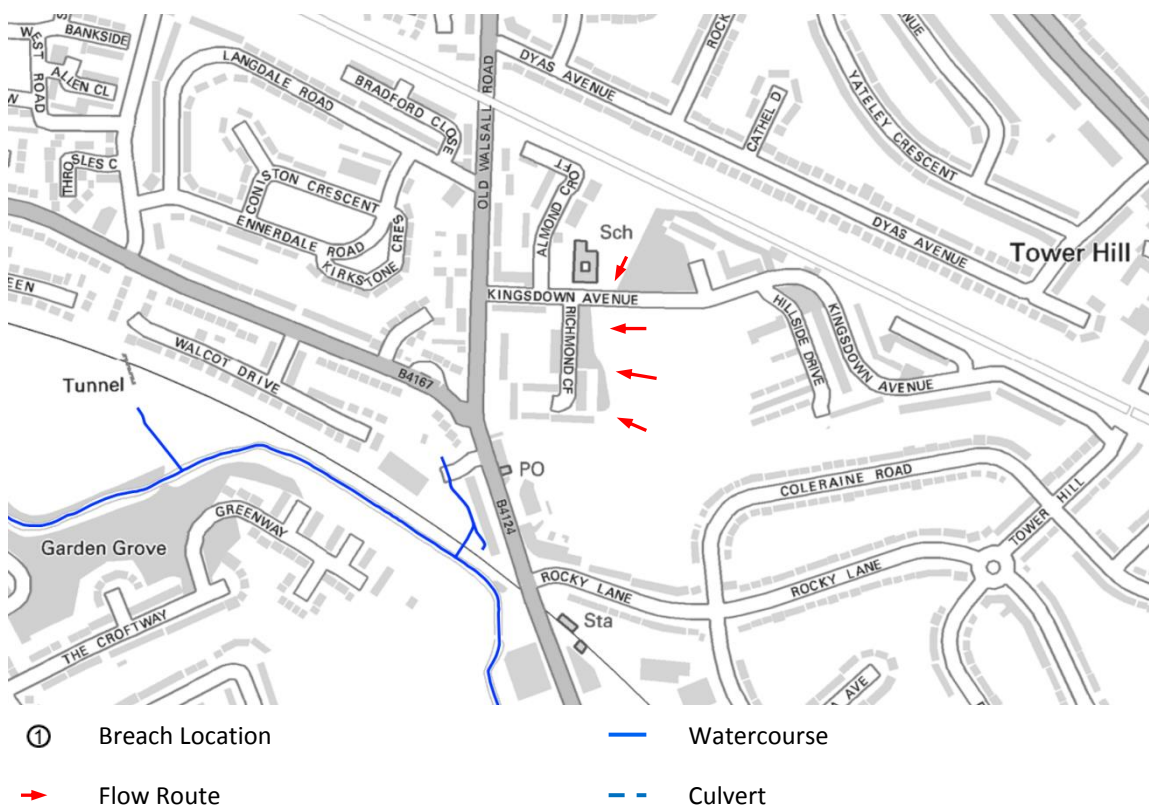
Figure 4-9 Potential overland flow routes

Richmond Croft, located to the east of Old Walsall Road, is adjacent to a large area of public open space. Due to the intensity of the rainfall, it is likely that the rain falling on the open space was unable to soak into the ground. This resulted in surface water flowing from east to west, following the local topography, into the rear gardens of properties in Old Walsall Road as shown in Figure 4-9.

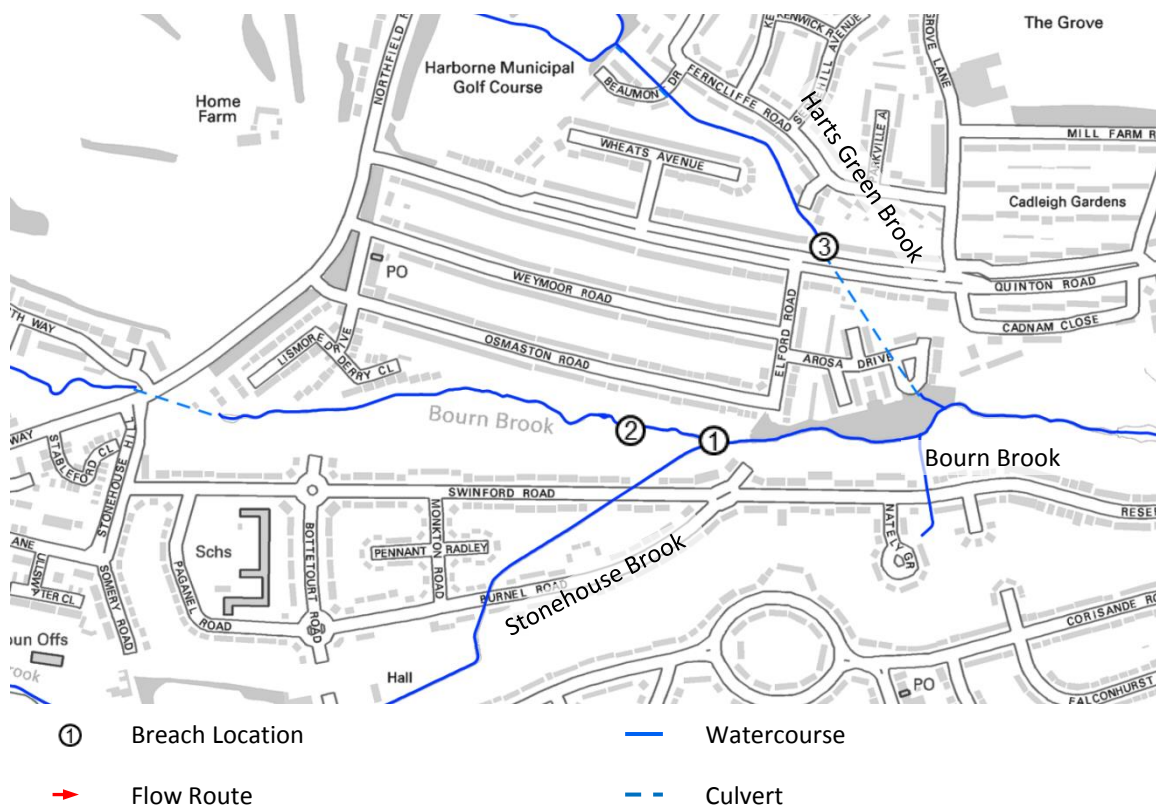
Figure 4-12 Potential watercourse breach and overland flow routes

This was exacerbated by an accumulation of debris and vegetation in the channel, possibly due to reductions in maintenance over the last few years, together with increasing levels of silt most notably reducing the capacity of the bridge arches at the Elford Road crossing, shown as Breach Location 1 in Figure 4-12.

In addition to this it was suggested the debris caught on the new Bourn Brook Walkway footbridge upstream of the confluence with Stonehouse Brook marked as Breach Location 2. There was also reported blockage at the entrance to the culvert of Harts Green Brook approximately 250m from its confluence with Bourn Brook, resulting in the channel overtopping and flooding properties in Quinton Road; this is marked as Breach Location 3.

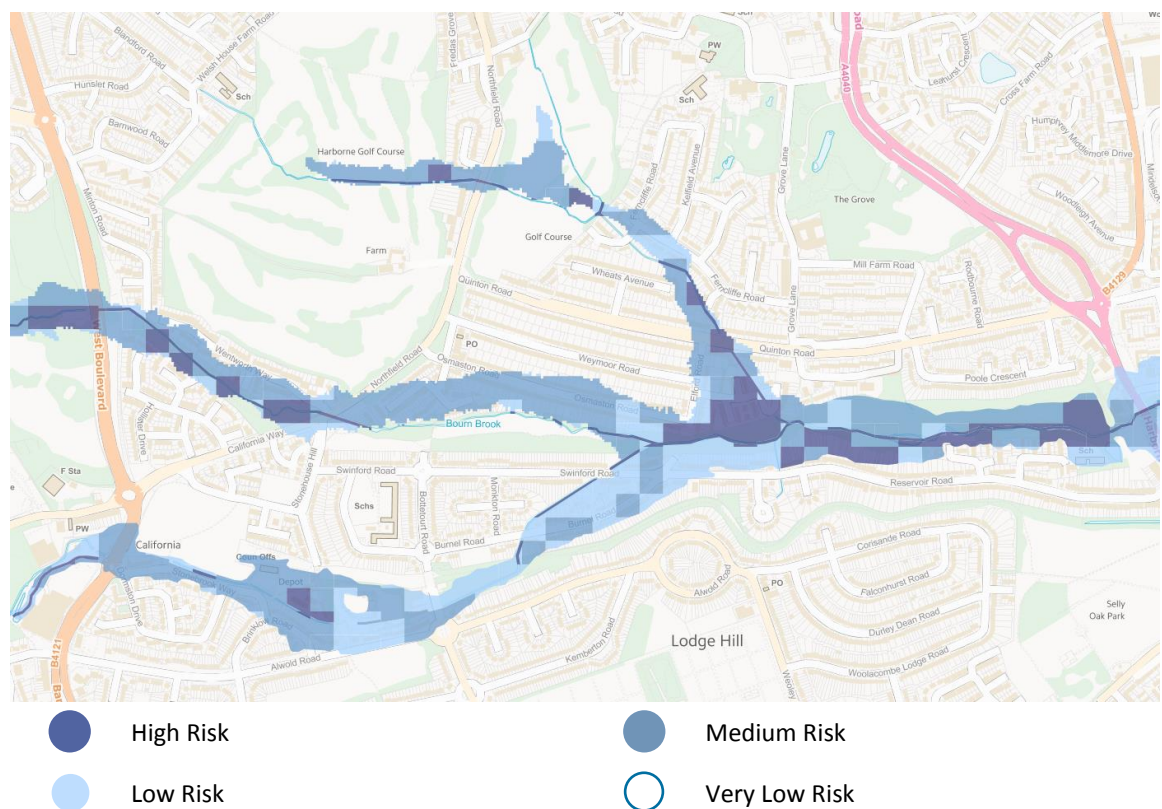
Figure 4-13 Flood Risk from Rivers or the Sea map

Both the Bourn Brook and the Stonehouse brook are classified as Main Rivers and are therefore the responsibility of the Environment Agency. The areas at highest risk of flooding from these watercourses are shown on the Flood Risk from Rivers or the Sea, an extract of which is shown below in Figure 4-13.

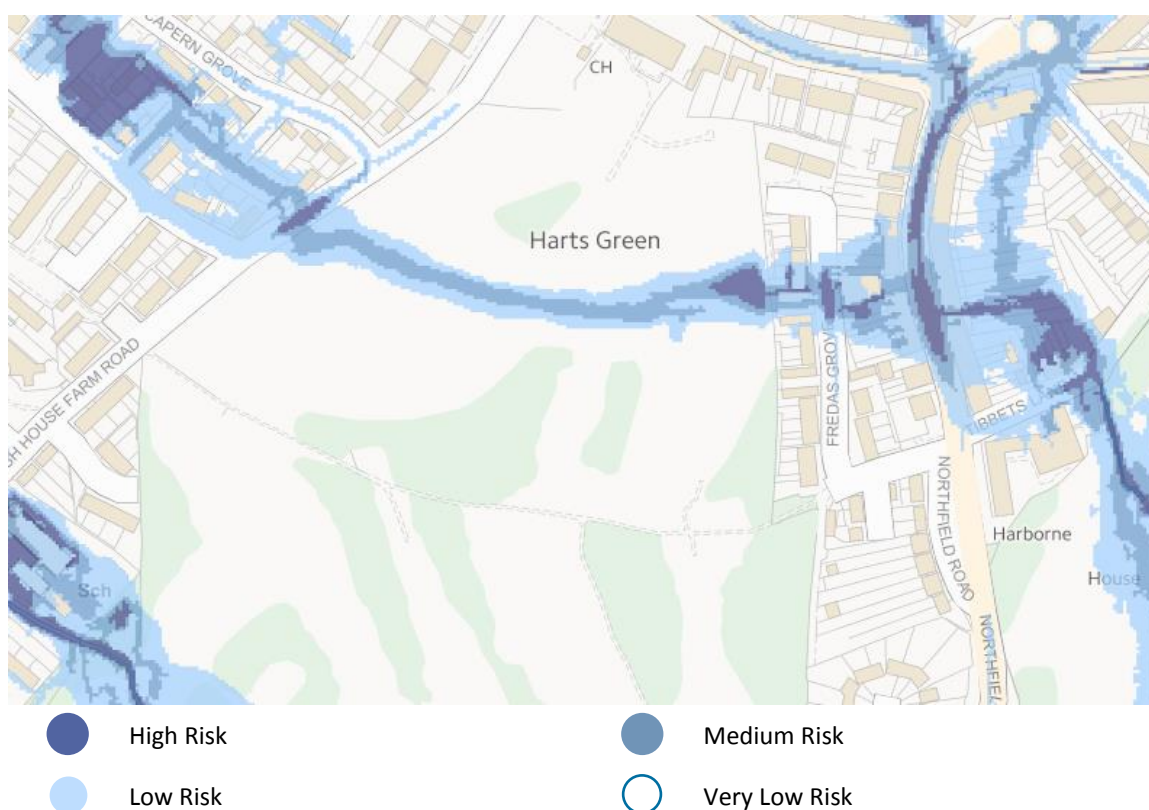
Figure 4-14 Flood Risk from Surface Water map

Fredas Grove is bound to the west by Harborne Golf Course and is located within a natural valley, whereby the surrounding topography falls towards Fredas Grove generating a significant flow path, as shown on the flood risk from surface water mapping in Figure 4-14.

Due to the magnitude of the storm on 16<sup>th</sup> June 2016, the rate of rainfall exceeded the rate at which it was able to soak into the ground within the Golf Course which resulted in substantial surface water runoff. As a result of the topography, surface water runoff collected at the low point immediately west of properties in Fredas Grove. As the event continued, surface water began to flow through rear gardens and properties into the highway, where the highway drainage and sewer infrastructure was unable to accommodate this runoff.

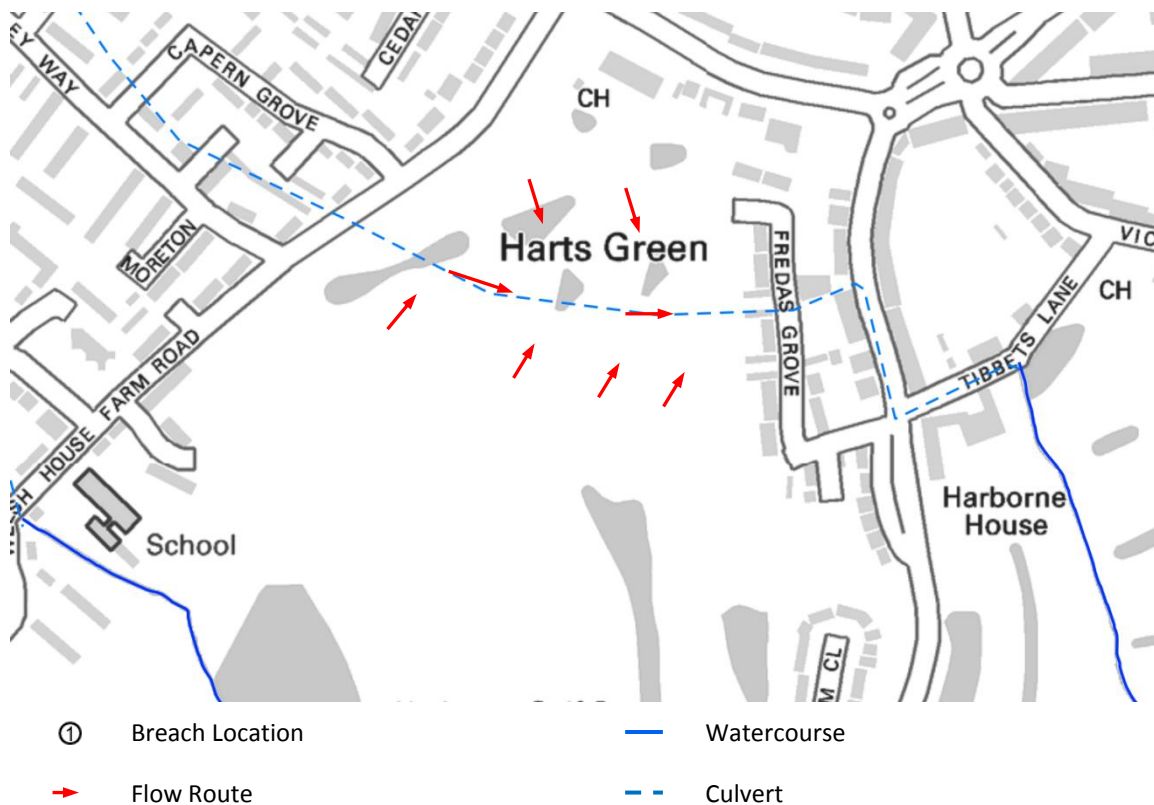
Figure 4-15 Potential overland flow routes

There is a historic watercourse that once flowed through the Golf Course, which has been culverted and now forms part of the sewer infrastructure; this is shown below in Figure 4-15. This may have further exacerbated the surface water flooding from the Golf Course as there is no longer a watercourse for surface water to discharge to, and as such surface water currently leaves the Golf Course in an uncontrolled manner. The potential surface water flow routes are also shown in Figure 4-15.

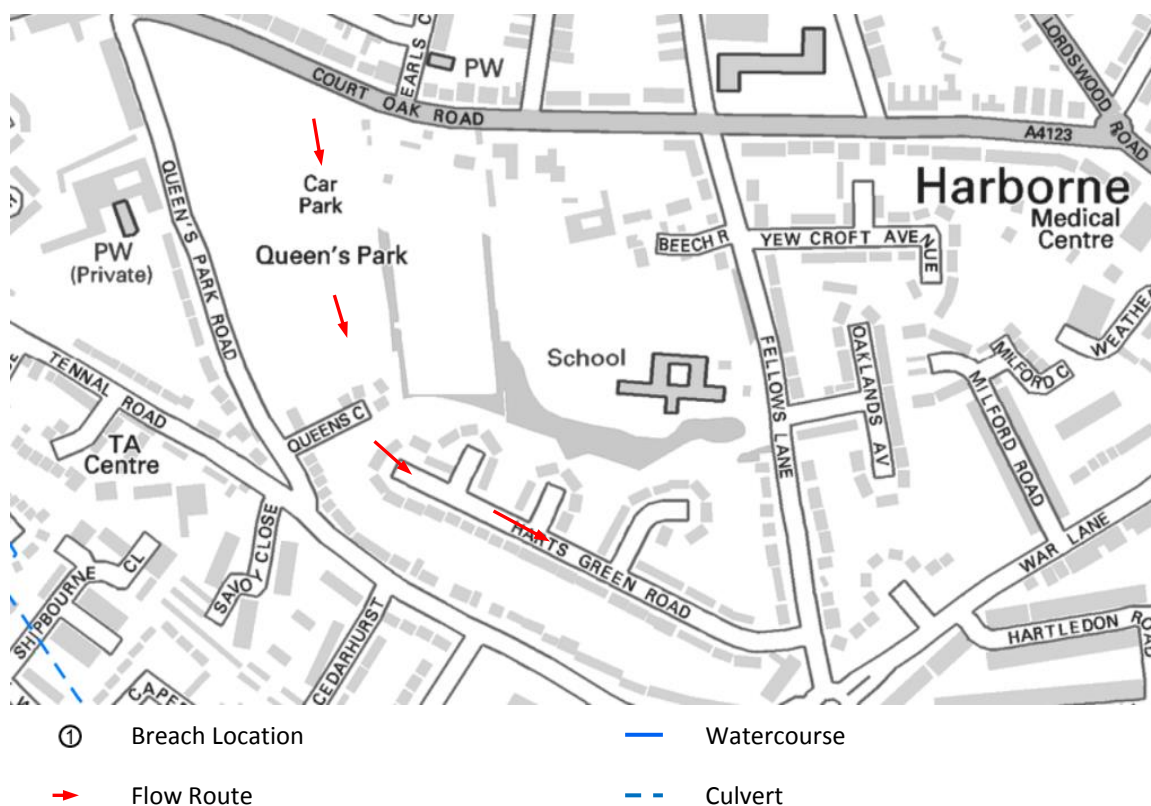
Figure 4-16 Potential overland flow routes

Due to the intensity of the storm on 16<sup>th</sup> June 2016, the rate of rainfall exceeded the rate at which it was able to soak into the ground within the park resulting in surface water runoff. The prevailing topography then directed runoff southwards through Queen’s Park and into Queen’s Court and Harts Green Road with further flows passing through Green Road, Lelant Grove, Conington Grove and Battenhall Road as shown in Figure 4-16; runoff then accumulated in the low point of Harts Green Road at the south-east end.

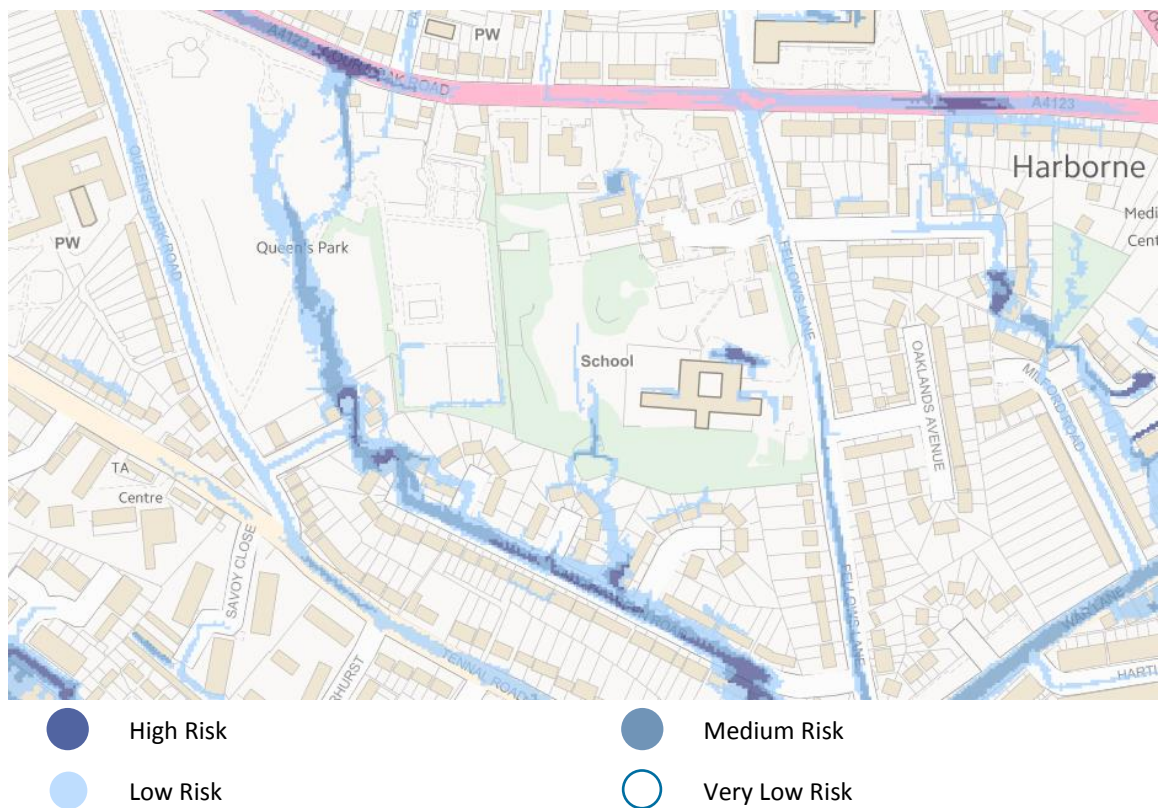
Figure 4-17 Flood Risk from Surface Water map

Further surface water flow paths were noted by residents; however these are considered to be minor flow paths and did not result in internal property flooding, as shown in Figure 4-17.

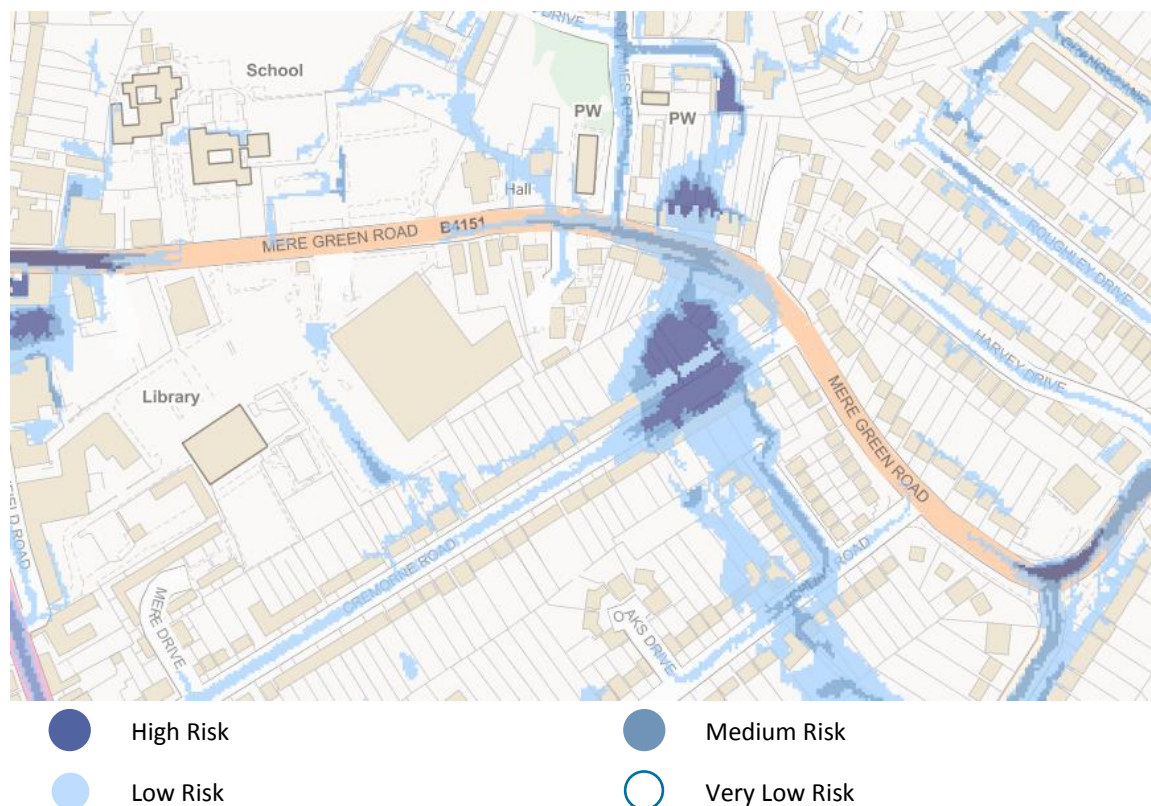
Figure 4-18 Flood Risk from Surface Water map

The area of reported internal flooding in Cremorne Road is at the lowest point of the surrounding ground. Reports of the flooding suggest that surface water flow entered the properties from the rear, which is consistent with available surface water mapping, as shown in Figure 4-18 below, where flows follow the slope of the land from north to south.

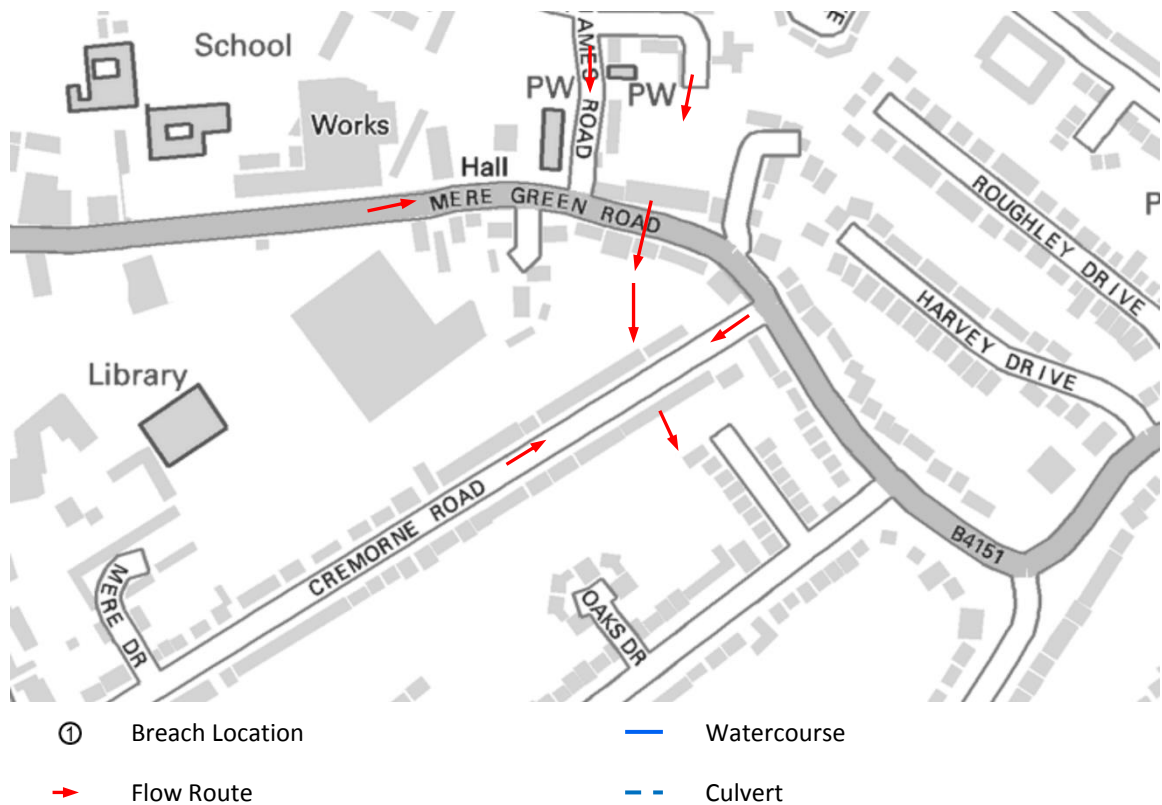
Figure 4-19 Potential overland flow routes

Due to the intensity of the storms in June 2016, it is likely that highway drainage and the overall sewer infrastructure in Mere Green Road was overwhelmed and was unable to accommodate the volume of runoff within the system. This excess water was initially contained within highways, however as the storm progressed the highways became inundated with water overtopping into adjacent properties. The potential overland flow routes are shown below in Figure 4-19.

Following receipt of the flooding surveys distributed to residents, some reports indicate that the highway drainage and sewer infrastructure surcharged and water was seen to flow back out of gullies and manholes into the highway.

Recommended Actions	Identified Party / RMA
<b>Assess the condition and capacity of the sewer network</b>	Severn Trent Water
<b>Assess the condition and capacity of the highway drainage network</b>	Birmingham City Council (Highways)
<b>Explore the potential for flood mitigation</b>	Birmingham City Council (LLFA), Severn Trent Water and Home owners
<b>Assess the effectiveness of the installed property level resilience measures</b>	Severn Trent Water

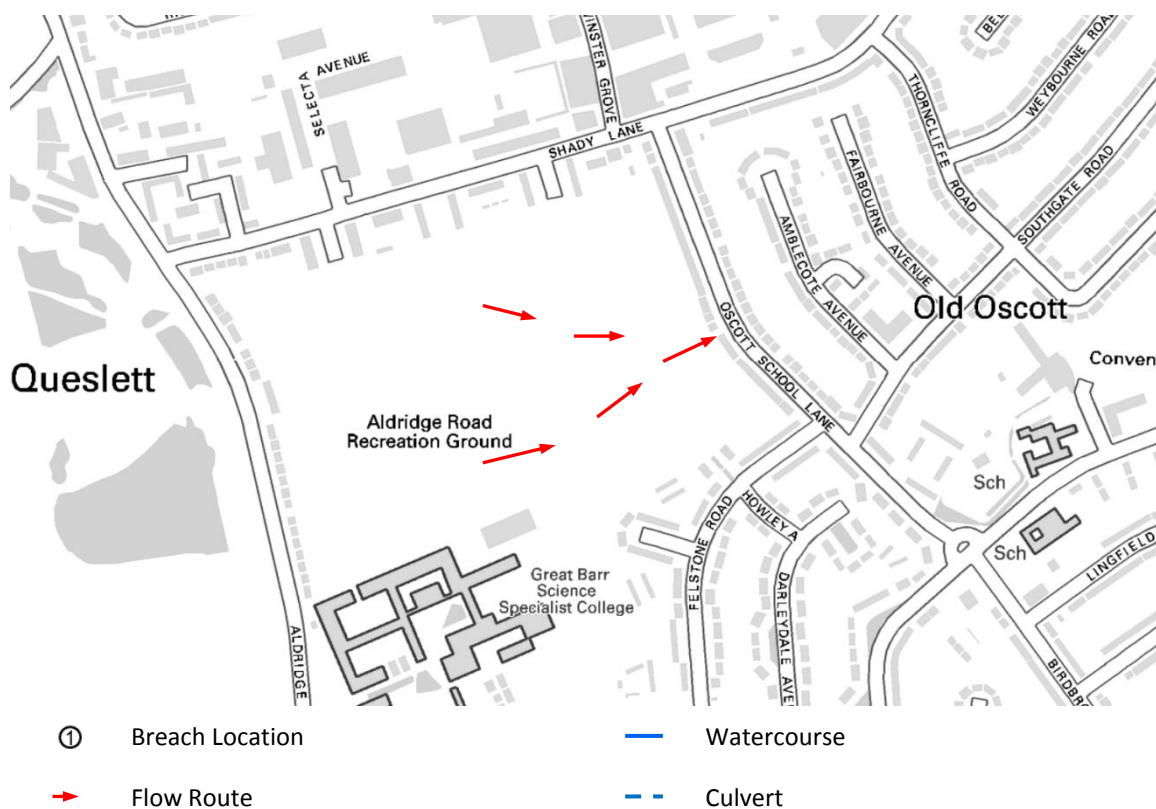
Figure 4-20 Potential overland flow route

No. of flooded properties: 2

Recommended Actions	Identified Party / RMA
<b>Investigate options to manage overland flows from the recreation ground</b>	Birmingham City Council (LLFA and Leisure Services)
<b>Explore the potential for flood mitigation</b>	Birmingham City Council (LLFA) and Home owners

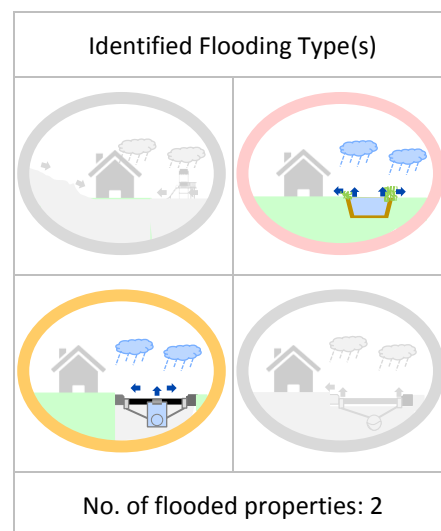
Figure 4-21 Potential watercourse breaches and overland flow routes

Due to the magnitude of the event, the Perry brook came out of channel where the watercourse enters the culvert to the rear of the Church Tavern; marked as Breach Location 1 in Figure 4-21. The volume of water was so great that it overtopped the flood defence bund within Perry Park, and flowed into Church Road flooding properties.

In addition to the river flooding, the surface water and foul water sewers in Church Road were exceeded by the storm event causing manholes to surcharge and flood, preventing the highway gullies from being able to convey water from the highway, exacerbating flooding.

There is also a possibility that the flood defence wall built to protect properties from the River Tame backing up which runs at the side of the Church Road properties made the flooding worse because it stopped water flowing from Church Road back into the brook.

<b>Recommended Actions</b>	<b>Identified Party / RMA</b>
<b>Investigate options to manage overland flows from the Perry Park, including increasing the height of the bund</b>	Birmingham City Council (Leisure Services)
<b>Investigate capacity of Perry Brook culvert and interaction with River Tame defences</b>	Environment Agency
<b>Assess the condition of the sewer network in the catchment area</b>	Severn Trent Water

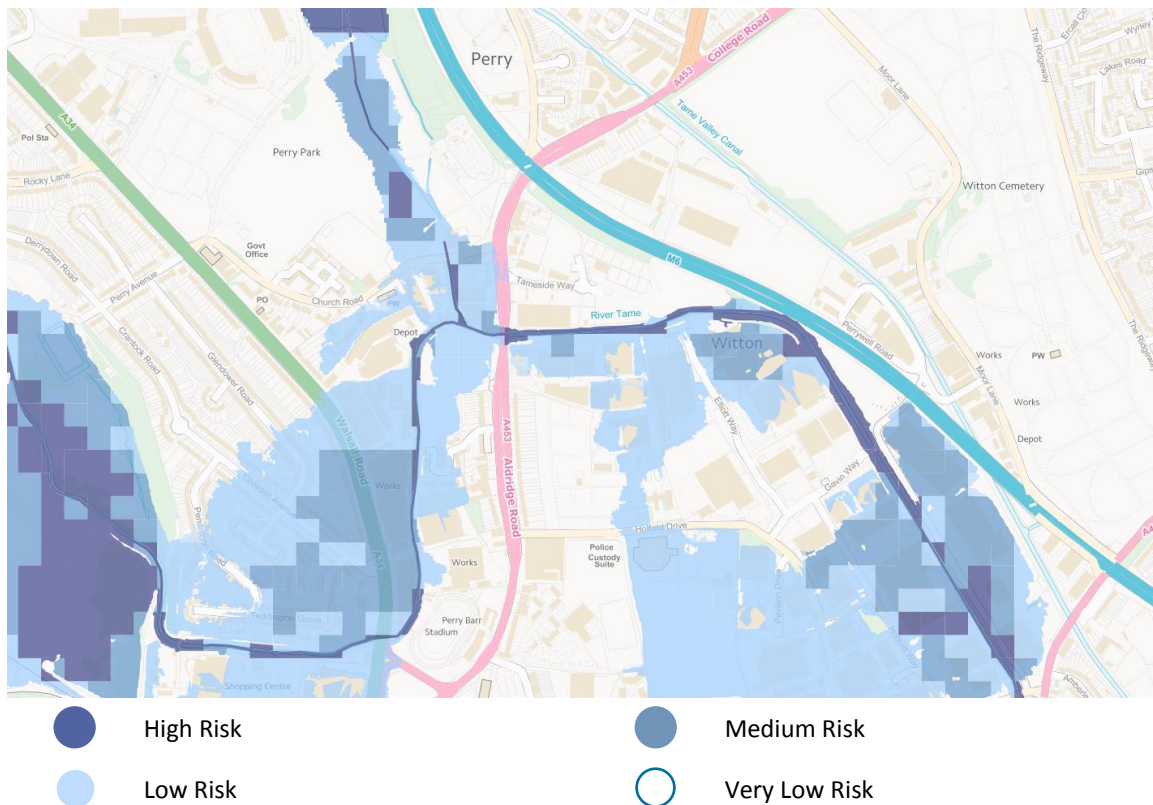
Figure 4-22 Flood Risk from Rivers or the Sea map

The Perry Brook is a Main River from the point it enters the culvert to the rear of the Church Tavern and the Environment Agency has modelled this watercourse as part of the wider River Tame catchment modelling. The areas at high risk of flooding from the watercourses are shown on the extract of the Flood Risk from Rivers or the Sea map in Figure 4-22.

The flooding reported correlates with the high risk areas in the Flood Risk from Rivers or the Sea map, emphasising the primary source of flooding was the watercourse.

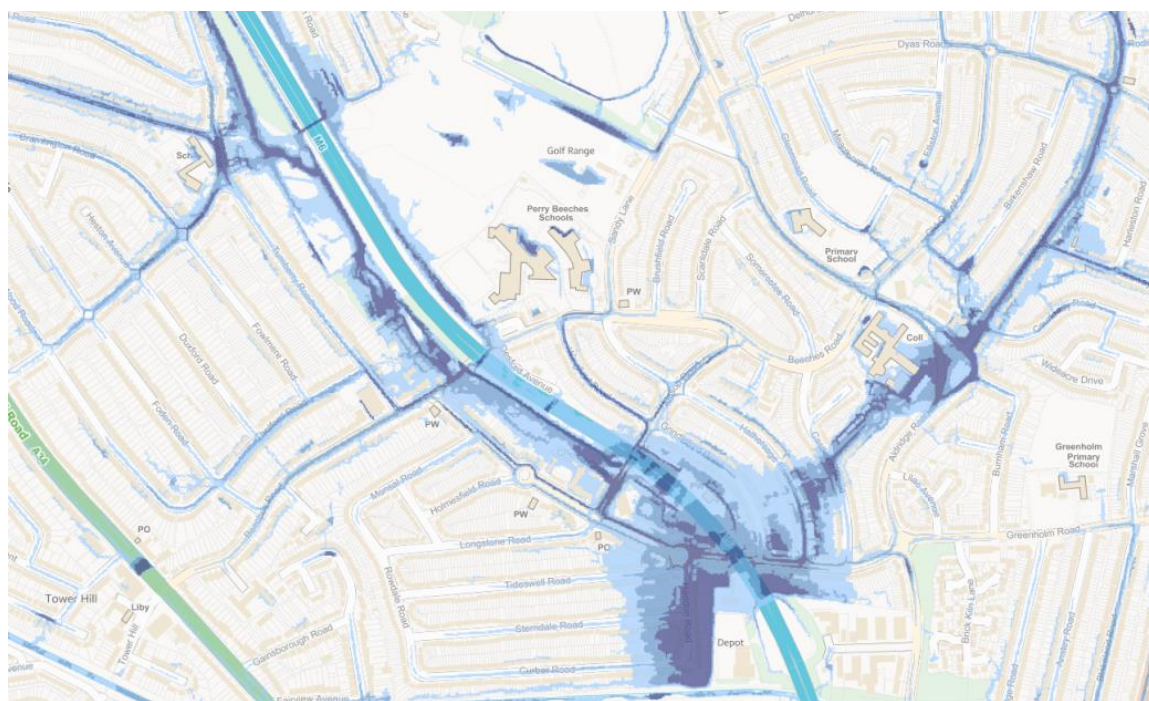
Figure 4-23 Flood Risk from Surface Water map

The Risk of Flooding from Surface Water map covering Perry Beeches is shown in Figure 4-23. This shows the surface water flow routes through the area as a result of runoff from the surrounding higher areas and correlates with the areas affected by flooding on the 8<sup>th</sup> June.

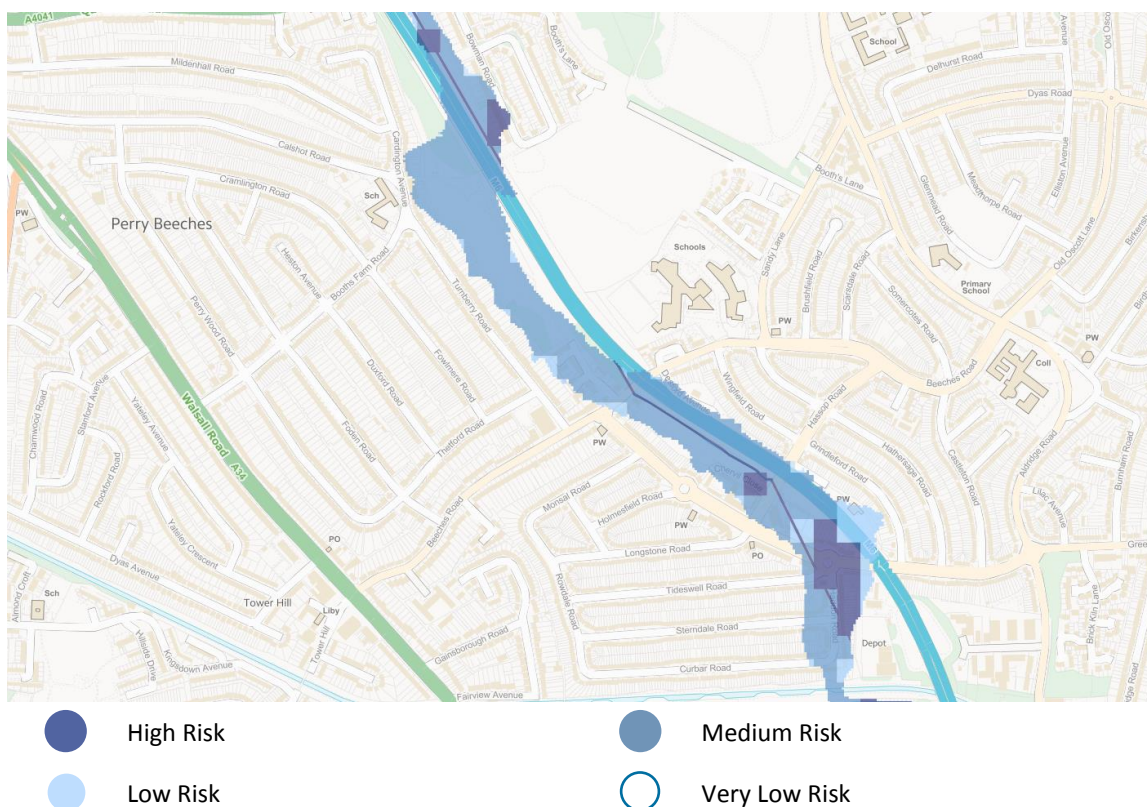
Figure 4-25 Flood Risk from Rivers or the Sea map

The Perry Brook is not a Main River therefore the responsibility for flood risk management and investigating flooding from the watercourse falls to the Lead Local Flood Authority, although the landowners above and either side of the watercourse are responsible for its structure and maintenance. The flood zones associated with the Perry Brook are shown in Figure 4-25. These flood zones correlate with those properties affected by river flooding on 8<sup>th</sup> June.

Recommended Actions	Identified Party / RMA
<b>Assess the condition and capacity of the sewer network in the catchment area</b>	Severn Trent Water
<b>Construct a hydraulic model to enhance understanding of flooding mechanisms and develop a set of options to mitigate flooding within the area</b>	Birmingham City Council (LLFA)
<b>Review maintenance regime to ensure gullies are free from debris</b>	Birmingham City Council (Highways)
<b>Fix and maintain the drainage infrastructure from the elevated sections of the M6.</b>	Highways England
<b>Regular inspections of the Perry Brook culverts</b>	Highways England
<b>Regular inspections and maintenance of the open channel through Perry Park</b>	Birmingham City Council (Leisure)

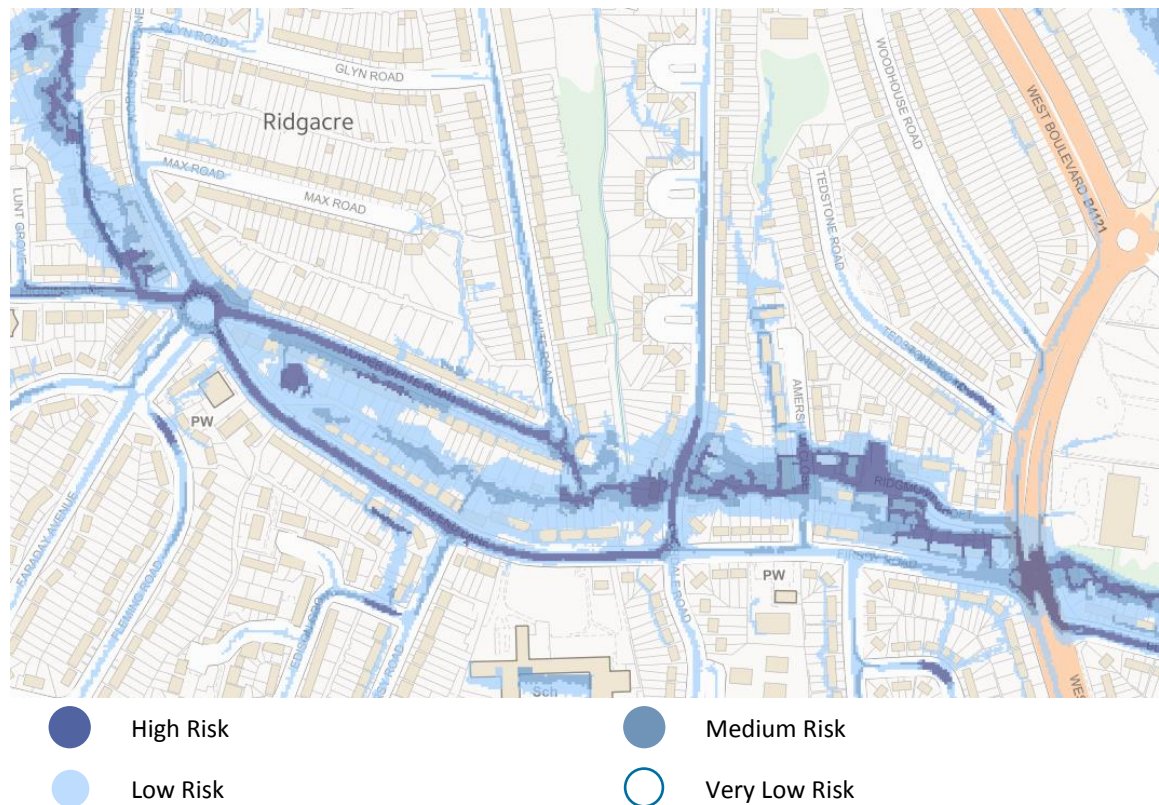
Figure 4-27 Flood Risk from Surface Water map

As a result of the local topography, the affected properties all sit within a significant surface water flow route as shown on the Risk of Flooding from Surface Water mapping in Figure 4-27.

Responses to the flooding investigation questionnaires suggest following the storm events, water was able to drain away which suggests the highway drainage and sewer infrastructure were not blocked and instead the system was overwhelmed as it was operating above its design capacity. Further to this, the catchment and the highways are relatively steep and as such, due to the intensity of the storm and volume of rainfall, it is likely that surface water runoff flowed over gullies and onto the next one.

Recommended Actions	Identified Party / RMA
<b>Assess the condition and capacity of the sewer network in the catchment area</b>	Severn Trent Water
<b>Assess the condition and capacity of the culverted Quinton Brook</b>	Birmingham City Council (Housing)
<b>Review maintenance regime to ensure gullies are free from debris</b>	Birmingham City Council (Highways)
<b>Develop catchment options across the upper Bourne Brook catchment to manage flooding from all sources</b>	Birmingham City Council (LLFA), Severn Trent Water and Environment Agency
<b>Review property level resilience scheme in Overdale Road</b>	Birmingham City Council (LLFA)

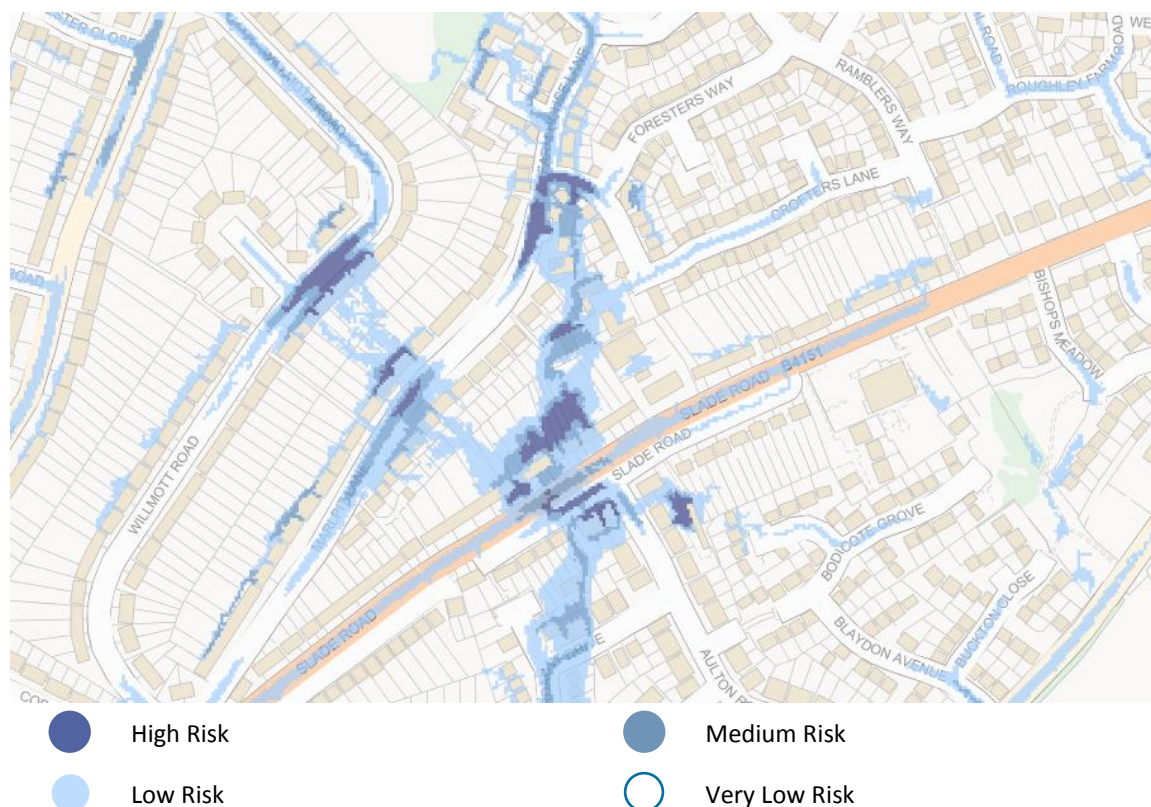
Figure 4-28 Flood Risk from Surface Water map

Due to the magnitude of the storm, surface water runoff followed the topography of the area, flowing south on Willmott Road before accumulating in the low point in the highway. The underlying sewer infrastructure and highway drainage was unable to cope with the volume of water in this area, resulting in ponding within the highway. Water levels rose in this area, overtopping kerbs and flowing into the curtilage of properties where it flowed down the hill, through rear gardens and entered properties in Marlpit Lane and on through properties in Slade Road. This is indicated in the public surface water flood risk mapping; as shown in Figure 4-28.

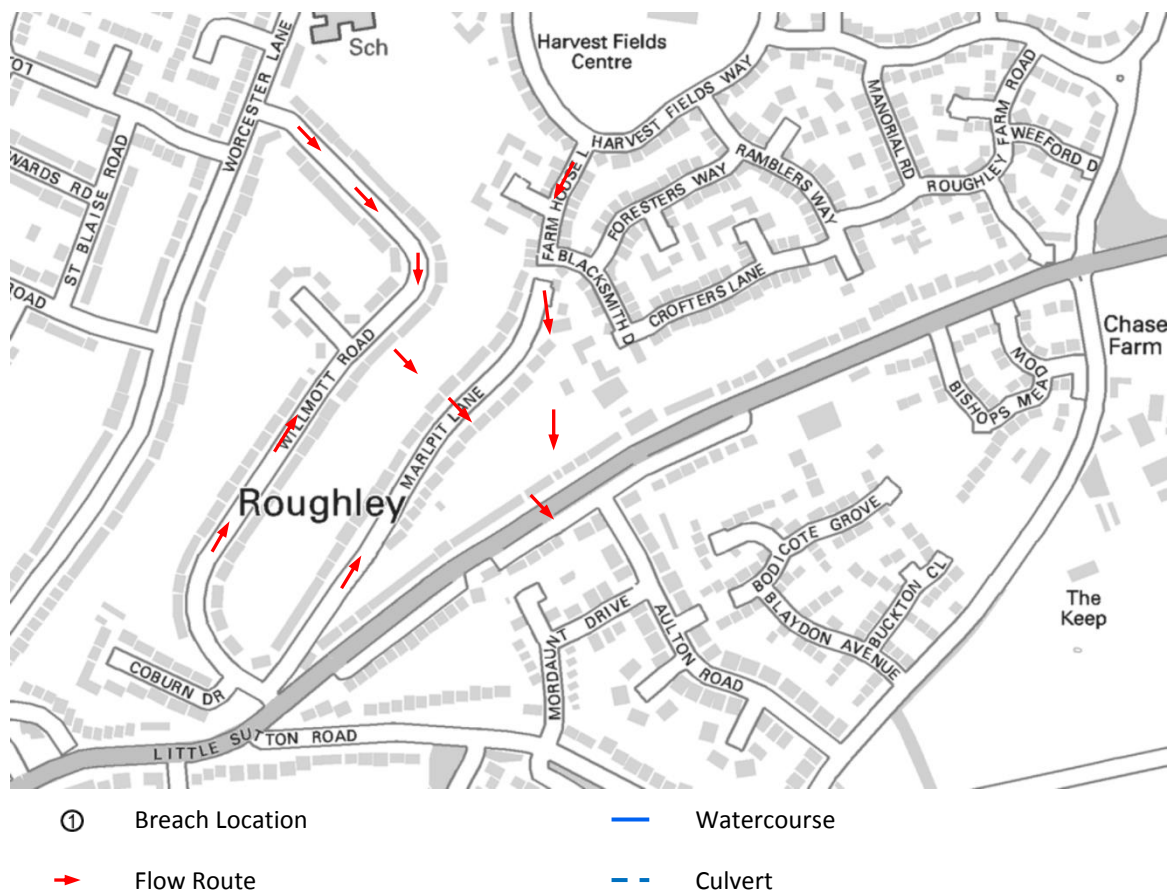
Figure 4-29 Potential overland flow routes

A second flow path was also observed with flows accumulating in Farmhouse Lane before following the topography of the area, through multiple properties, before accumulating in Slade Road. The flooding in Slade Road was further exacerbated, as the capacity of the sewer infrastructure was overwhelmed and began to surcharge from the underground system onto the highway. It is also understood that electrical components and pumps failed during the storm.

Following the storm event, flood waters receded with water draining through gullies as capacity became available in the highway drainage and sewer infrastructure.

Recommended Actions	Identified Party / RMA
<b>Assess the condition and capacity of the sewer network in the vicinity of Slade Road and Willmott Road</b>	Severn Trent Water
<b>Assess the condition and capacity of the highway drainage network to establish if additional gullies are required</b>	Birmingham City Council (Highways)
<b>Review of maintenance schedule of highway assets (e.g. gullies)</b>	Birmingham City Council (Highways)
<b>Explore the potential for flood mitigation measures</b>	Severn Trent Water
<b>Assess the effectiveness of the installed property level resilience measures</b>	Severn Trent Water

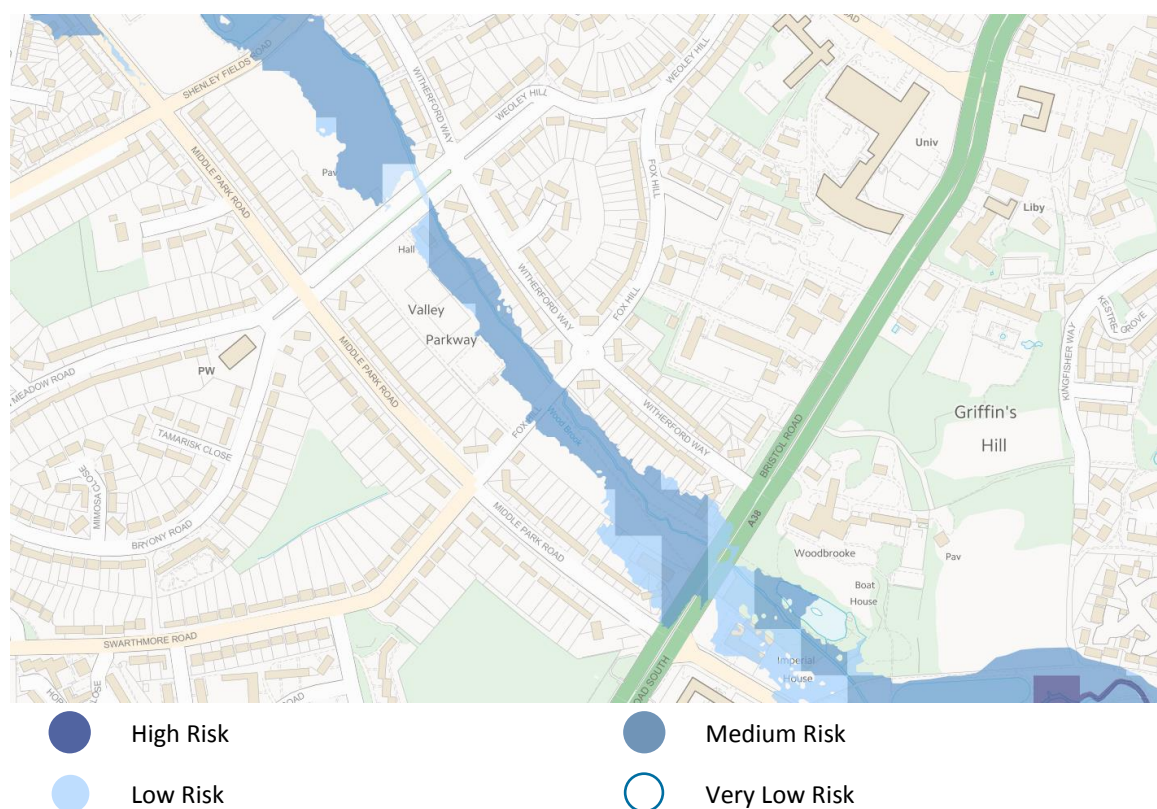
Figure 4-31 Flood Risk from Rivers or the Sea map

The Wood Brook is a Main River and the Environment Agency has modelled this brook as part of the wider River Rea catchment. The areas at risk of flooding from the wood brook are shown on the extract of the Flood Risk from Rivers or the Sea map shown in Figure 4-31. The flooding report correlates with the high risk areas in the mapping further emphasising the source of flooding was the watercourse.

Recommended Actions	Identified Party / RMA
<b>Continue to explore options for funding contributions towards Bourn Brook scheme</b>	Environment Agency
<b>Assess the condition and capacity of the sewer network in the Bristol Road</b>	Severn Trent Water
<b>Assess the condition and capacity of the highway drainage network to establish if additional gullies are required</b>	Birmingham City Council (Highways)
<b>Review of maintenance schedule of highway assets (e.g. gullies)</b>	Birmingham City Council (Highways)
