# Birmingham City Council

## June 2016 Flooding: Flood and Water Management Act, Section 19 Investigation

May 2017

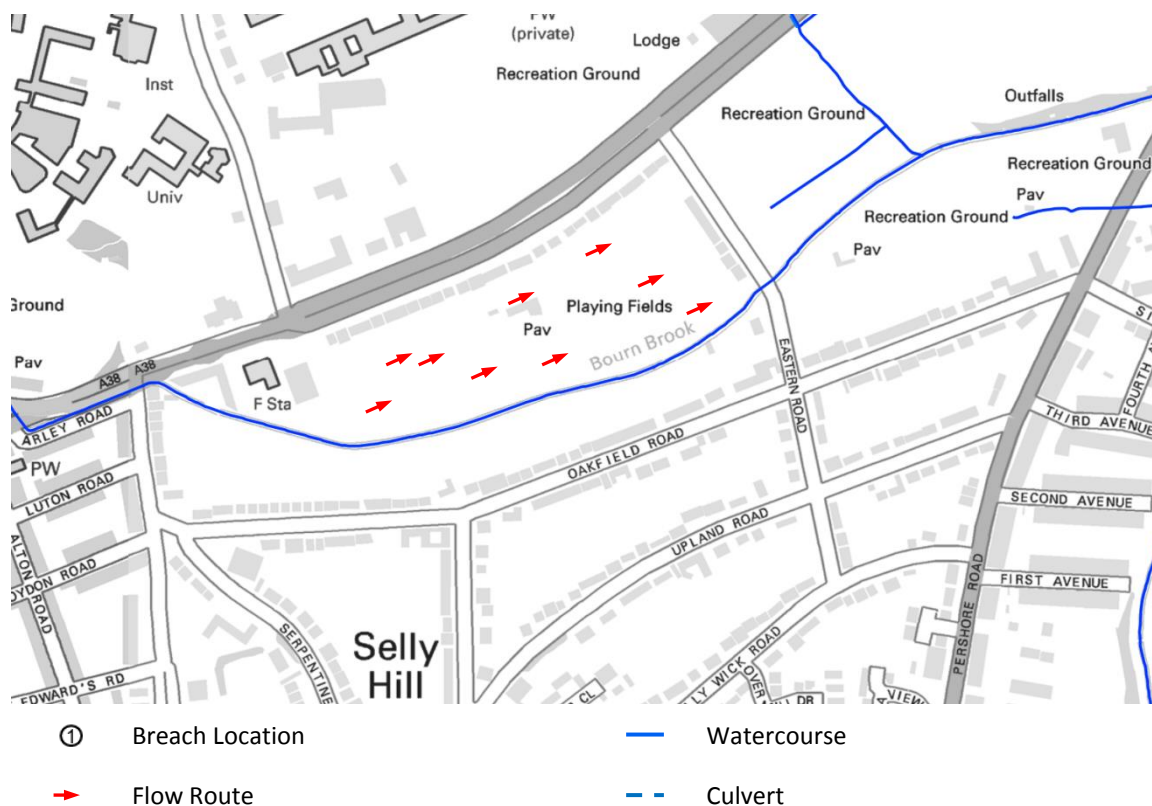
Figure 4-33 Potential overland flow routes

The flooding to the properties in Eastern Road was as a result of uncontrolled runoff from the King Edwards School playing fields to the rear of the properties. It is likely that due to the intensity of the storms, rain fell onto the playing field at a rate that exceeded the rate that it could soak into the ground and therefore resulted in significant overland flows. These flows, shown in Figure 4-33, followed the slope of the existing ground, falling from west to east and entered properties through the rear gardens.

Recommended Actions	Identified Party / RMA
Explore the potential for flood mitigation measures	Birmingham City Council (LLFA) and King Edwards School
Develop catchment options across the upper Bourn Brook catchment to manage flooding from all sources	Birmingham City Council (LLFA), Severn Trent Water and Environment Agency

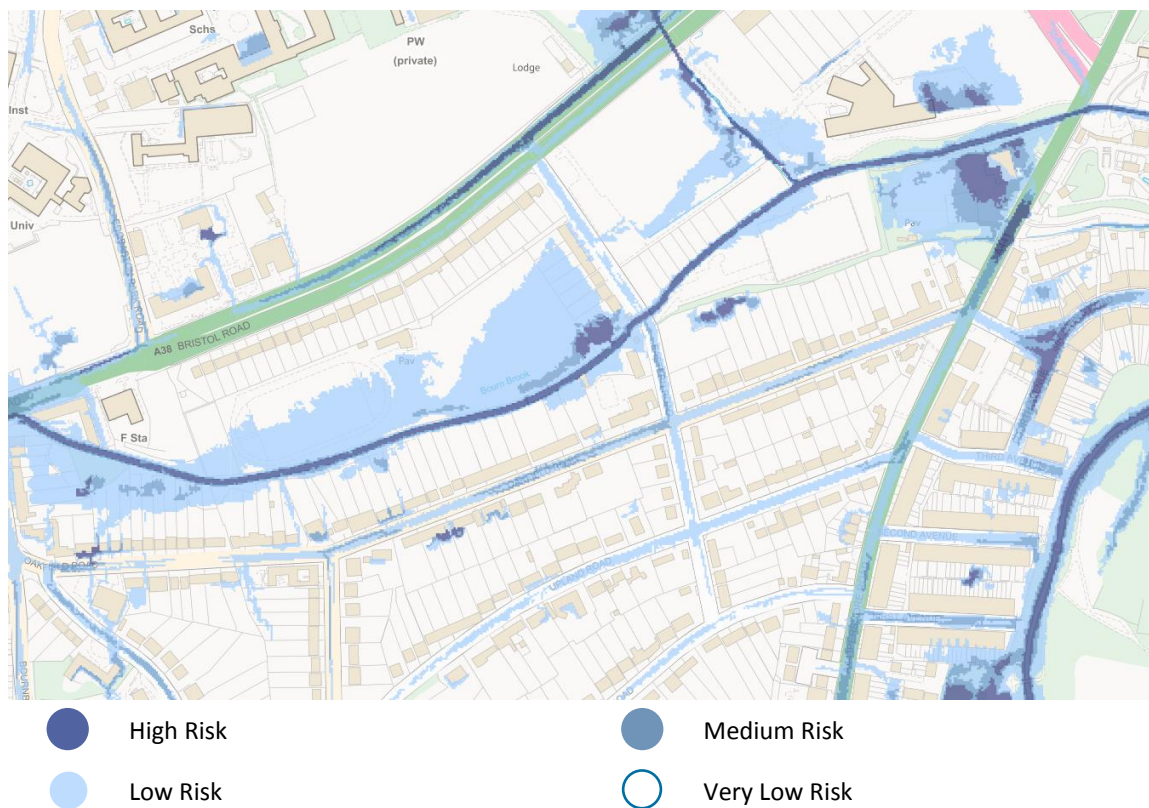
Figure 4-34 Flood Risk from Surface Water map

This is indicated in the public surface water mapping; as shown in Figure 4-34 which contains an extract from the 'Risk of Flooding from Surface Water' mapping.

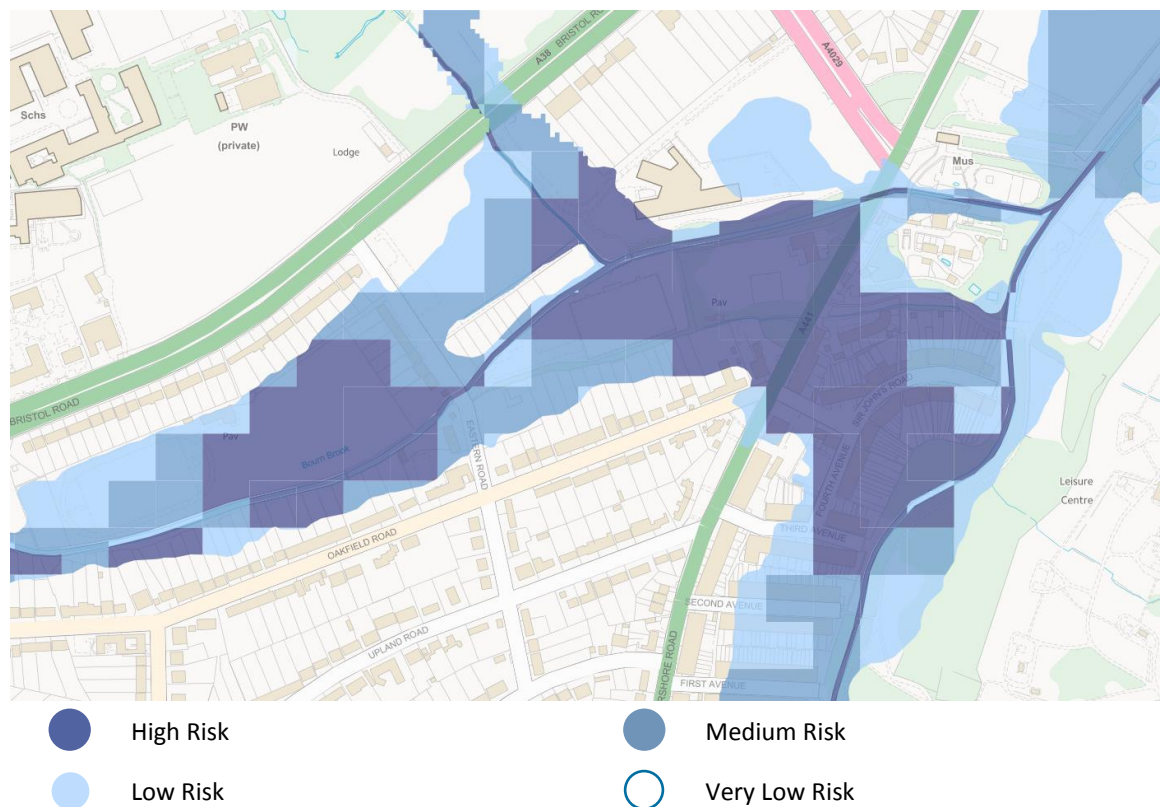
Figure 4-36 Flood Risk from Rivers or the Sea map

The Flood Risk from Rivers or the Sea map, shown in Figure 4-36, indicates that the area in the vicinity of the affected properties is identified to be within a high risk area. This suggests that when flood waters exceed the capacity of the Bourn Brook, they will spill south-eastwards, flowing overland towards the River Rea. It is highly likely that this was experienced during the June 2016 storms.

A boundary wall at the end of St John's Road, between the highway and the River Rea prevented surface water flows draining into the River Rea which is likely to have exacerbated flooding and resulted in increased flood depths than that which may have been experienced should this wall not have been present. Such a wall is not in place at the end of Third Avenue and therefore surface water runoff drained into the River Rea which prevented surface ponding and minimised the flood depths experienced here. As a result, flood depths experienced were higher in St John's Road than Third Avenue.

Recommended Actions	Identified Party / RMA
<b>Modification of the private boundary wall and review of maintenance regime in Riverside Drive to accommodate surface water flows</b>	Birmingham City Council (LLFA and Leisure Services) and Homeowners
<b>Implementation of the flood alleviation scheme</b>	Environment Agency, Birmingham City Council (LLFA) and Severn Trent Water
<b>Assess the condition and capacity of the sewer network in catchment area</b>	Severn Trent Water

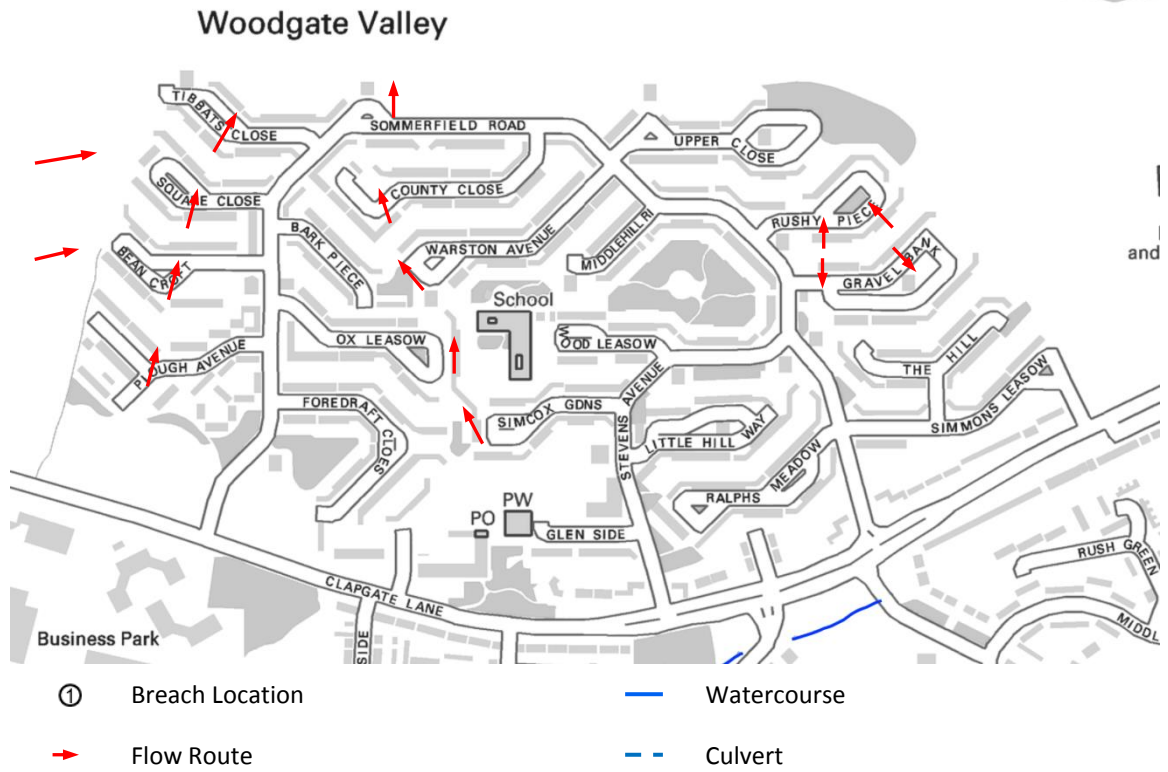
Figure 4-37 Potential overland flow routes

Figure 4-37 shows the primary overland flow paths experienced across Woodgate Valley, which illustrate the flooding that occurred during the events in June 2016. In the **West**, this shows the primary flow route whereby runoff from the Country Park passes through the residential area on route to the Bourn Brook to the north. Along part of the western boundary there is a heavily silted and poorly maintained unnamed watercourse which did not have the capacity to convey any flows.

Following the storm event, flood waters receded with water draining through gullies as capacity became available in the highway drainage and sewer infrastructure.

Recommended Actions	Identified Party / RMA
<b>Construct a hydraulic model to enhance understanding of flooding mechanisms and develop a set of options to mitigate flooding within the area</b>	Birmingham City Council (LLFA)
<b>Assess the condition and capacity of the sewer network</b>	Severn Trent Water
<b>Assess the condition and capacity of the highway drainage</b>	Birmingham City Council (Highways)
<b>Review of maintenance schedule of highway assets (e.g. gullies)</b>	Birmingham City Council (Highways)
<b>Review property level resilience scheme in Bean Croft</b>	Birmingham City Council (LLFA)
<b>Remove blockages and review maintenance regime of unnamed watercourse</b>	Birmingham City Council (Leisure Services)
<b>Develop catchment options across the upper Bourne Brook catchment to manage flooding from all sources</b>	Birmingham City Council (LLFA), Severn Trent Water and Environment Agency

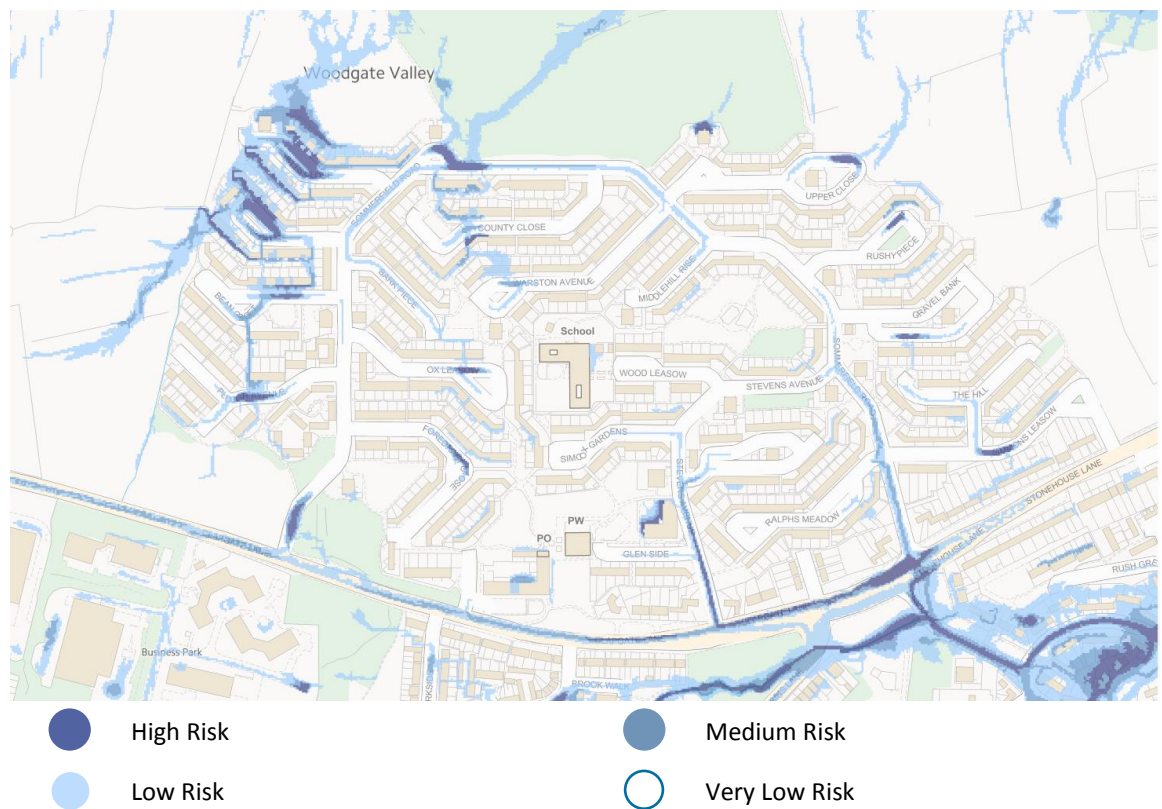
Figure 4-38 Flood Risk from Surface Water map

These routes are indicated in the public surface water mapping as shown in Figure 4-38.
